**QUINQUENNIAL INSPECTION REPORT  
OF  
RYHOPE, ST. PAUL**

**QUINQUENNIAL INSPECTION AND REPORT**

**February 2022**

**David Beaumont BA (Hons) Grad Dip, RIBA, AABC**

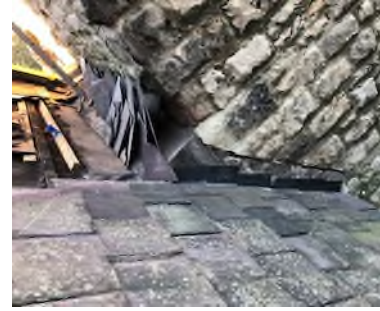
*Tower back gutter being remade during inspection*

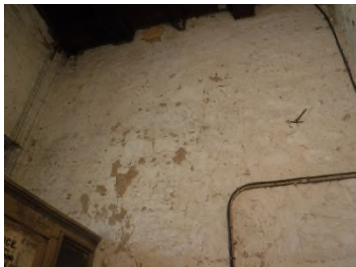
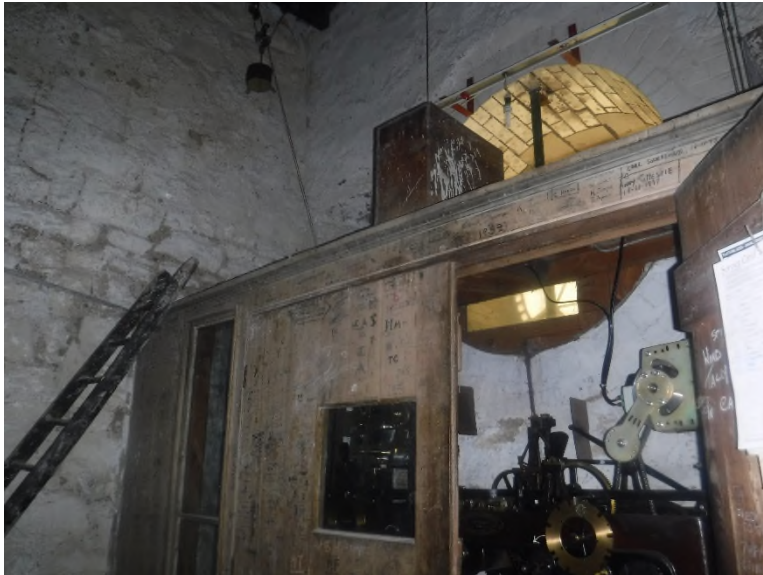
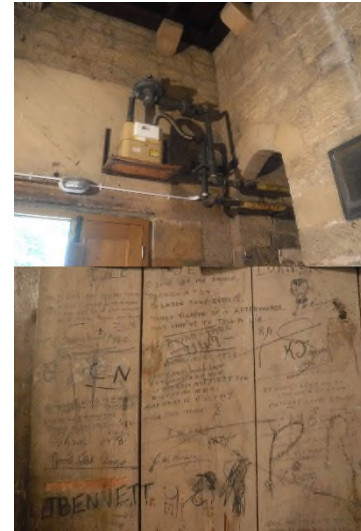
**Clock Room:**

**Ceiling** – Open boarded and looks ok, though there is some white marking from water penetration whether that is recent is not clear. Sweeping up the floor above will help.

**Walls** – Lime washed, generally ok, looks to be losing its limewash on its stair side that is the S, one big arch in it with white glazed tiles in it for the window dial for light it looks ok.

**Recommendation:** sweep out the room

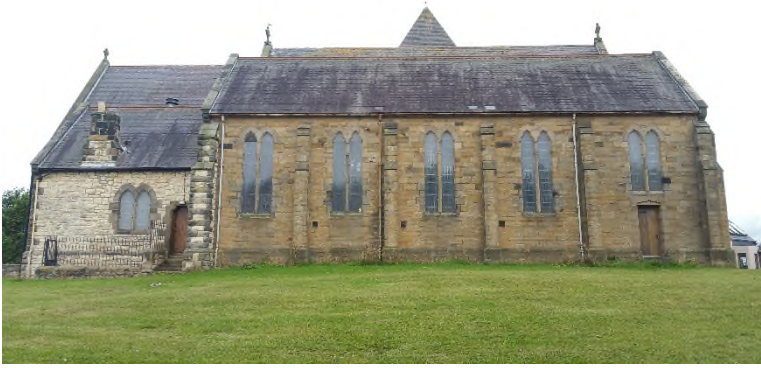
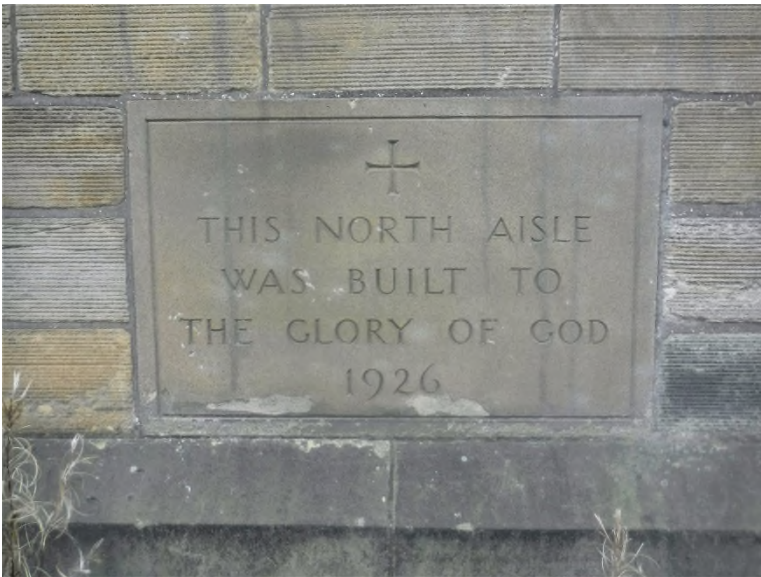
- **North Aisle:**

**West** – Original watertables fine tooling generally good, three light window within it ok and some loss of crust on the buttresses.

**North** – Generally sound though it is losing its crust a bit. Windows are alternate lancet and trefoil head and shortened above the N door, surrounds look alright, mullions look ok, polycarbonate coming away from the eastern most at high level, door varnish is breaking down and the steps giving away a bit and could do with pointing up.

**East** – Original watertable some slight open joints into the gutter, walling is generally sound as is the buttress apart from some open joints at upper level.

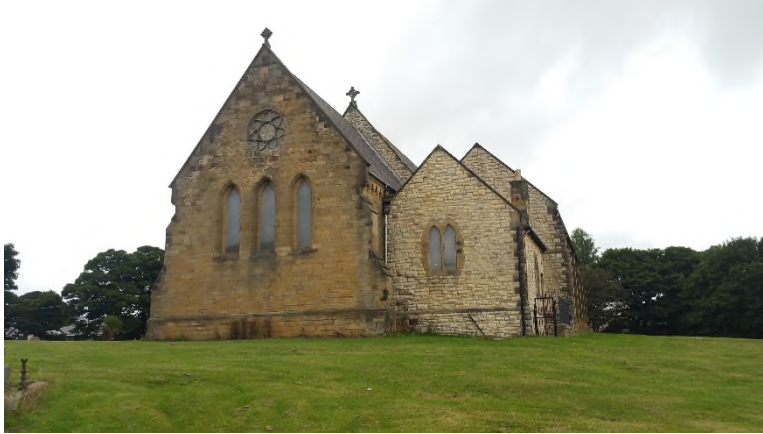
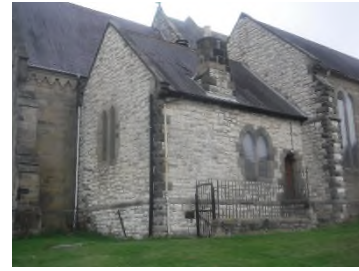
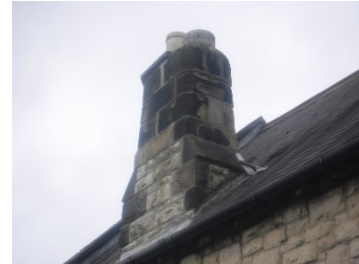
- **Vestry:**

**South** – Heavily cement pointed underneath the chimney which itself is tilting slightly and is a bit of a botch. Has a twin light lancet like the north aisle ok. Caernarfon arch to the doorway and varnished door looks ok as do the steps. Iron work railings to the boiler steps look a bit poor.

**East** – Original watertables on the gable, some water marking on the kneeler on the N, walling itself is ok, few open joints at the top but nothing too bad. Twin lancet light slight loss of crust of the ashlar surround.

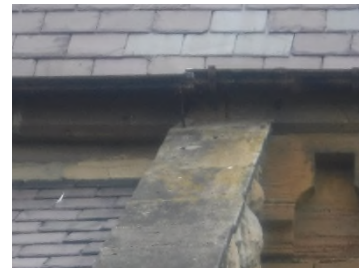
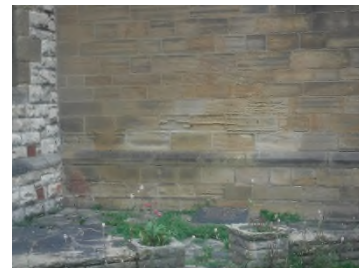
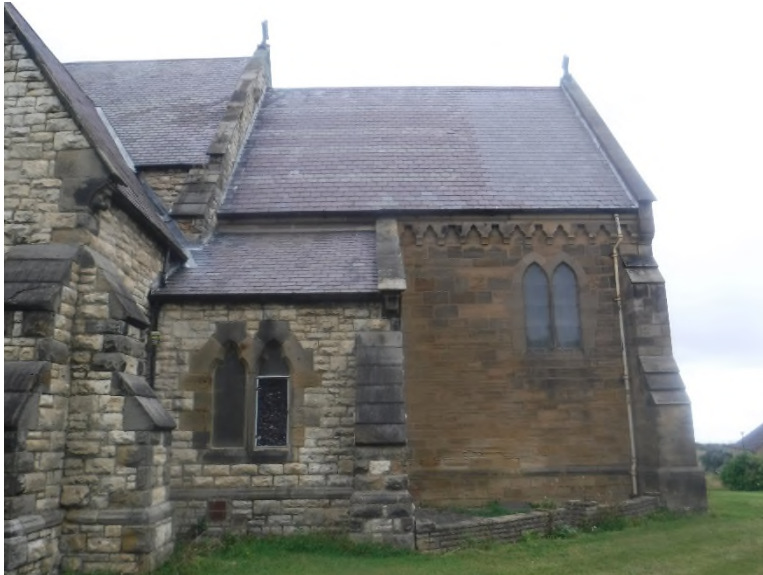
**North** – Lombardy corbelled frieze ok, the wall is green from the box gutter to the vestry, buttress ok.

**East** – Original watertable, some open joints, loss of crust to the walling, it is the same facing as the 1920's N big buttress. Circular window cill is eroding slightly but ok, three individual trefoil light windows same as on the N side they look alright, open joint at the cill, some eroding to stonework at plinth.

**South** – Part of the eaves goes over the organ it has been patched a bit with cement in the past, Lombardy frieze got some open joints, walling below ok apart from just above the plinth where there is some erosion to the stone, has been repaired in cement so it is going to erode even further, below the plinth is ok and buttress is ok.

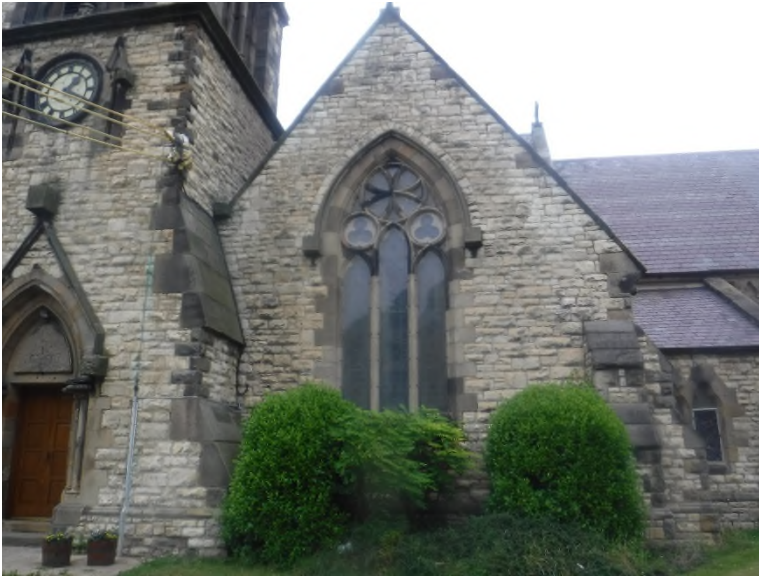
- **Transept:**

**East** – OK.

**South** – Original watertable some open joints slightly open jointed at the built-in mid length kneelers, walling is generally ok, it has had this pebbly mortar pointing in the past which drops out, quite a few bushes so it is hard to see what is below the plinth but I suspect open joints, has a three light three circle window, ashlar jambs that is all ok.

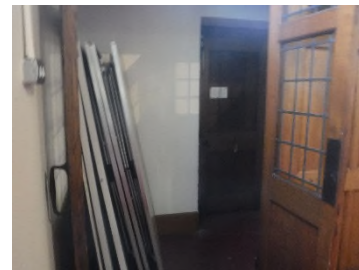
**North Aisle lobby doors:**

Pair of half glazed doors catching in the frame and stiff operation.

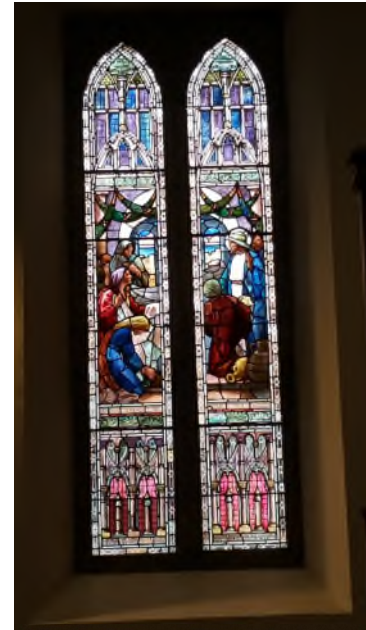
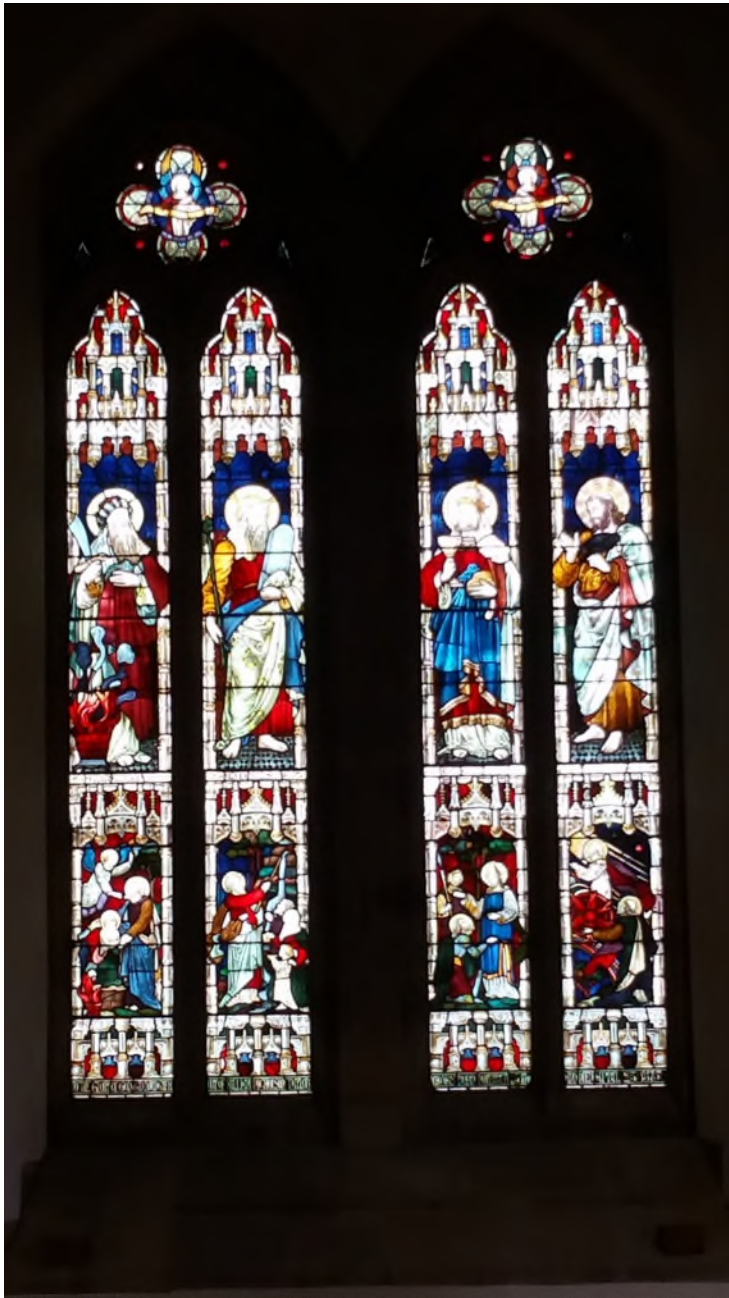
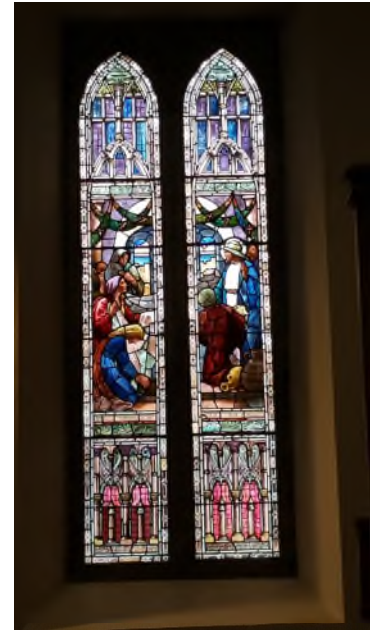
**Chancel:**

**East** – Stone beginning to spall on the southernmost lowest saddle bar and does this have a cobweb or a crack?

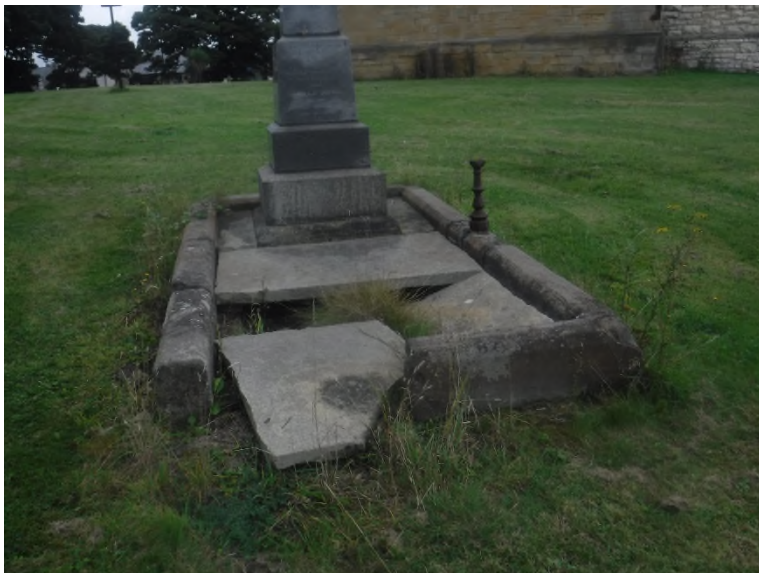
**D** It is a closed churchyard and there is very little above ground evident now, just a few memorials in poor condition.

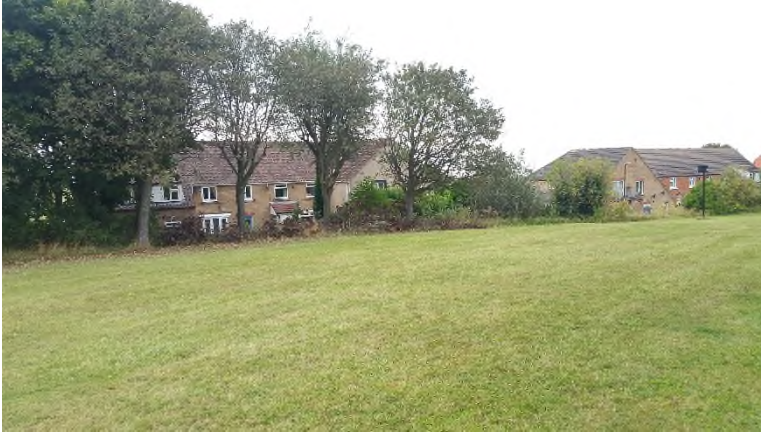
**West**

Brick and stone onto houses. Small copse of well-kept trees on this boundary, mixed trees.

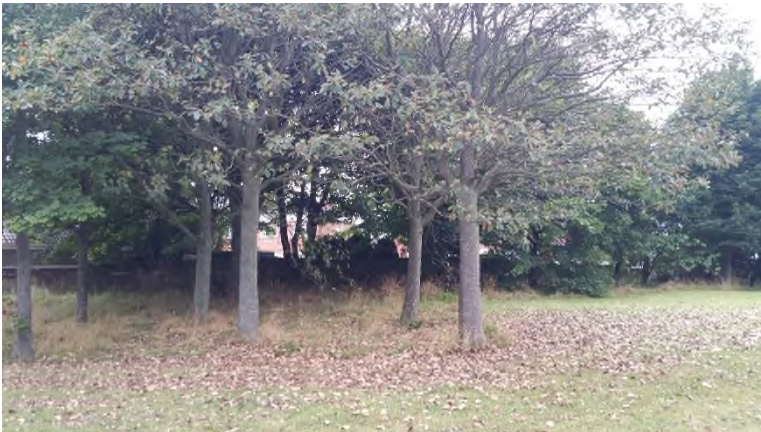
**North**

– It is not a defined boundary, that leads onto dwellings, it is all mixed shrubs with a few trees, all the trees have been trimmed and the branches left on the ground and there is also a ladder here.

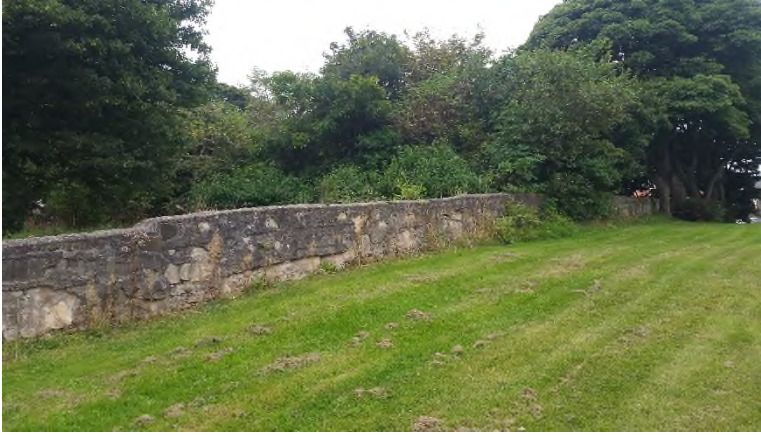
**East**

Masonry wall has had some cement facing to it in areas seems generally ok.

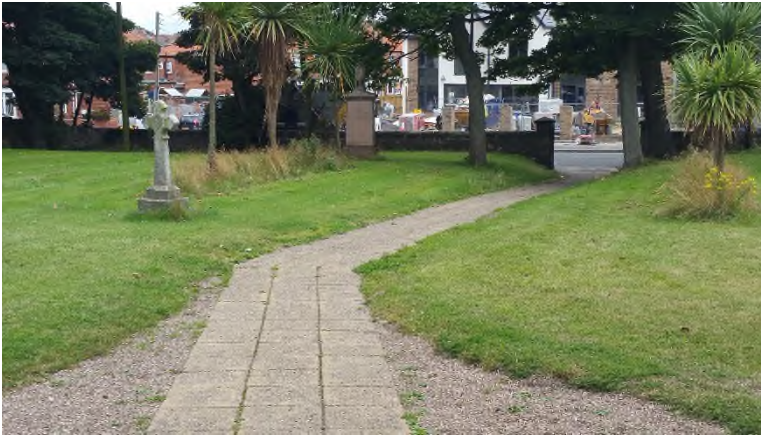
Whole of the site is grassed apart from the circulation which is modern concrete pavers and an area of gravel getting a bit mossy by the entrance porch now. The road side of this wall needs repointing (it is a fine example of concretionary limestone walling).

Signboard: timber decoration breaking down

**Recommendation:** repoint south boundary wall, repair broken memorials, repaint sign board

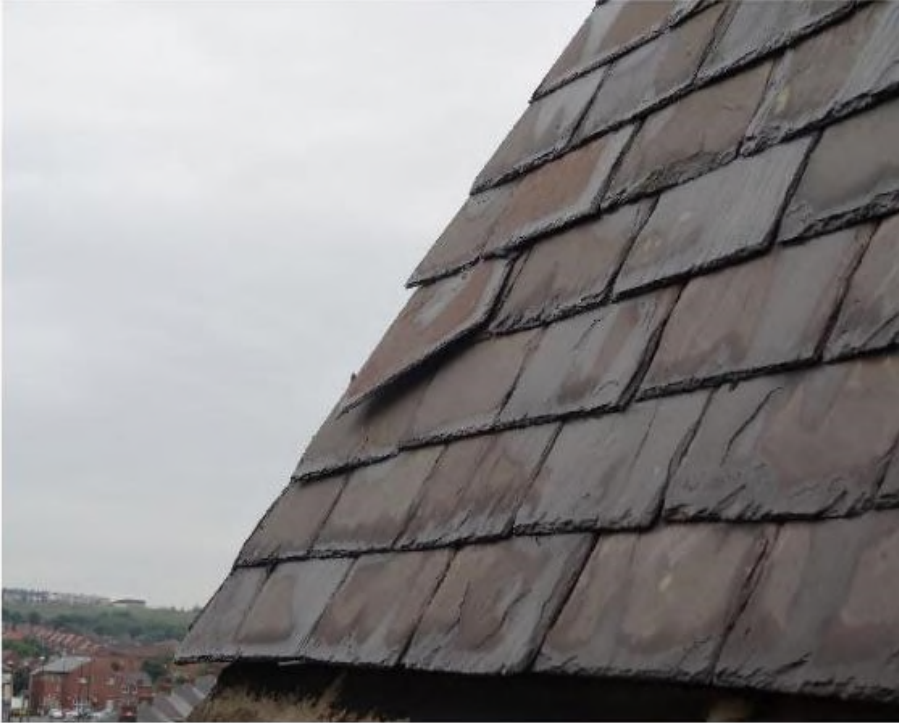
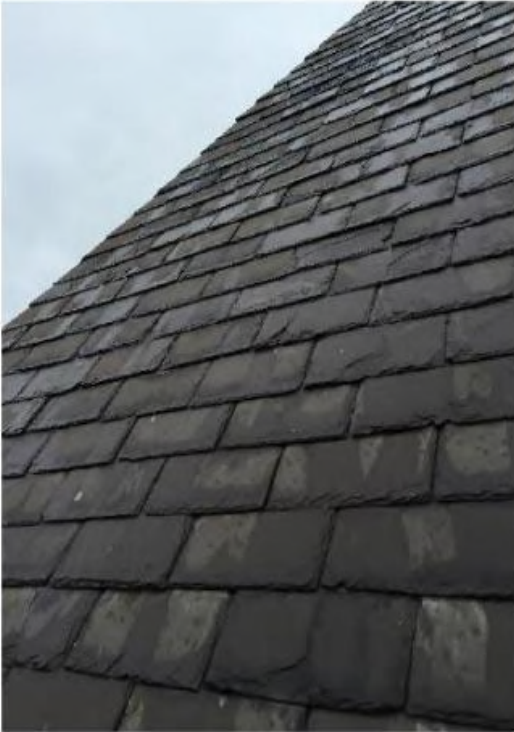
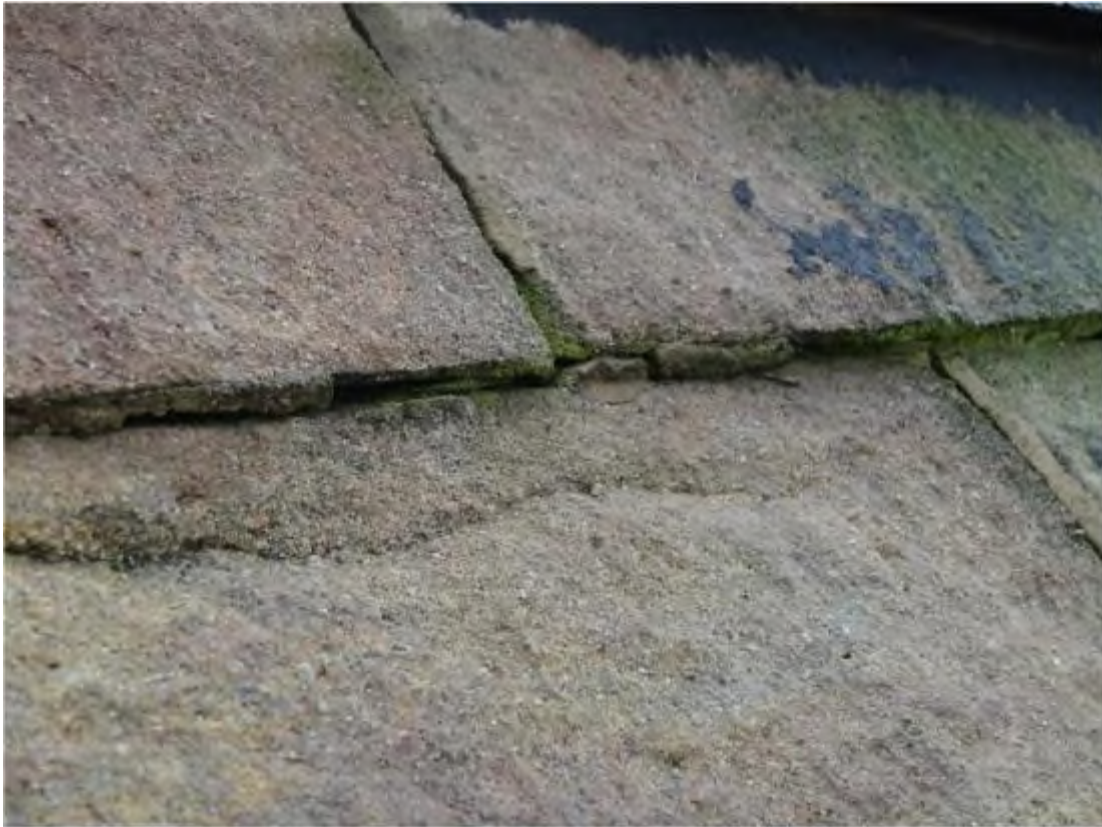
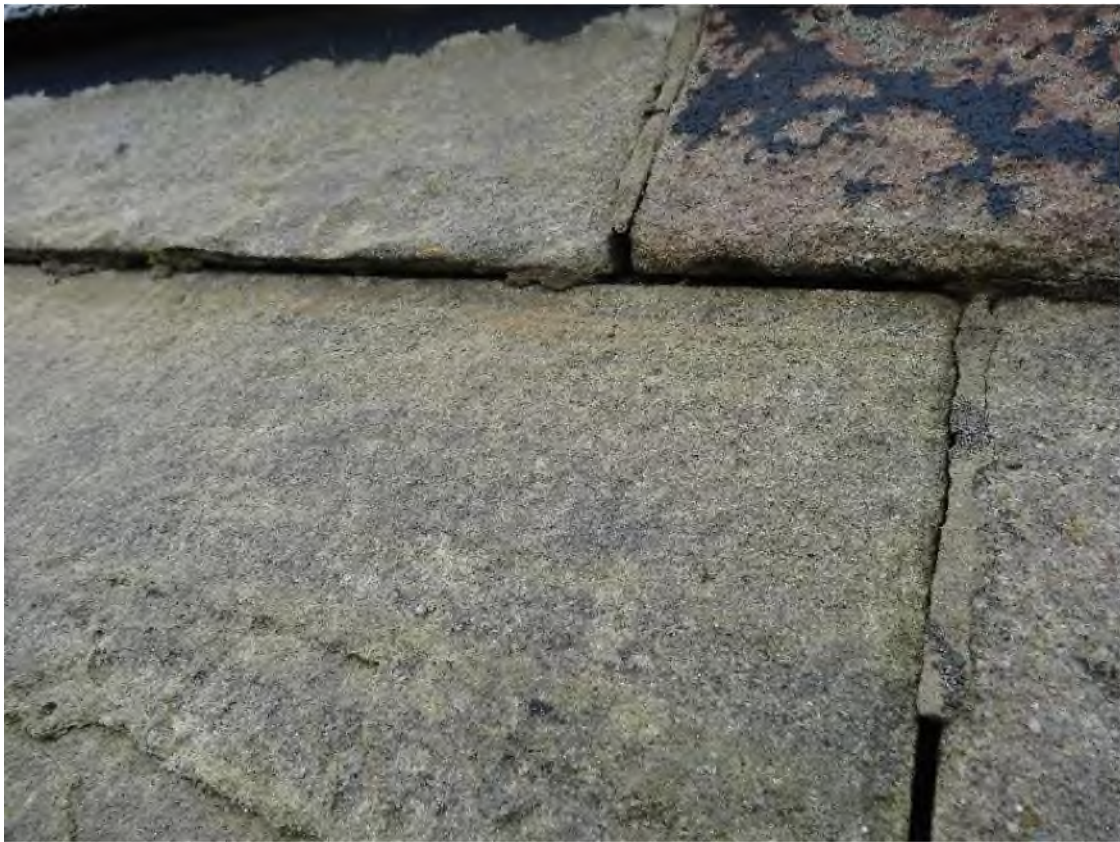
Examples of section A.

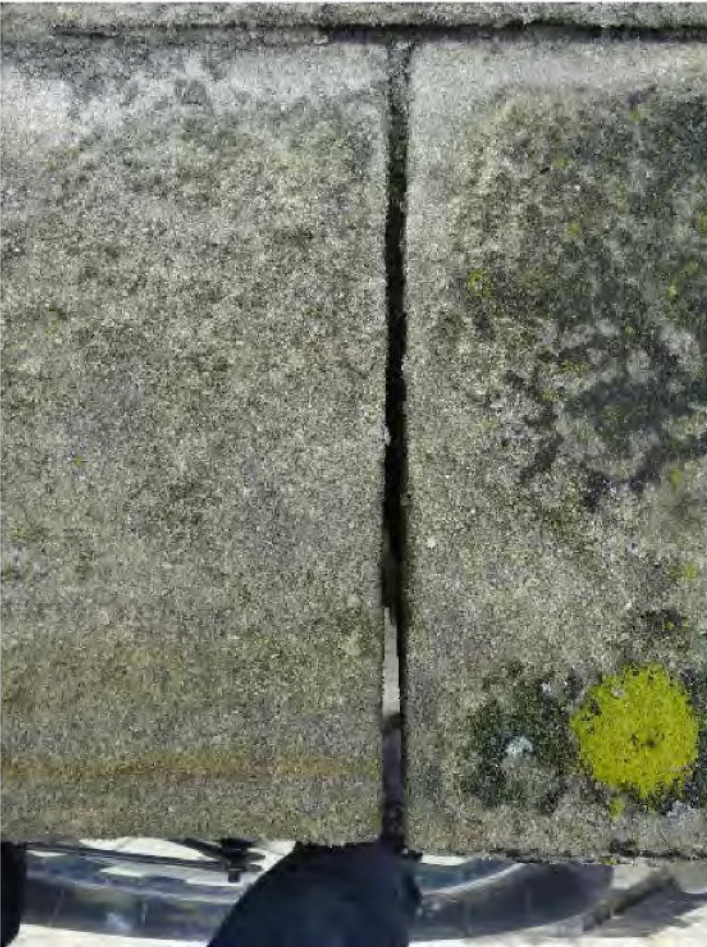
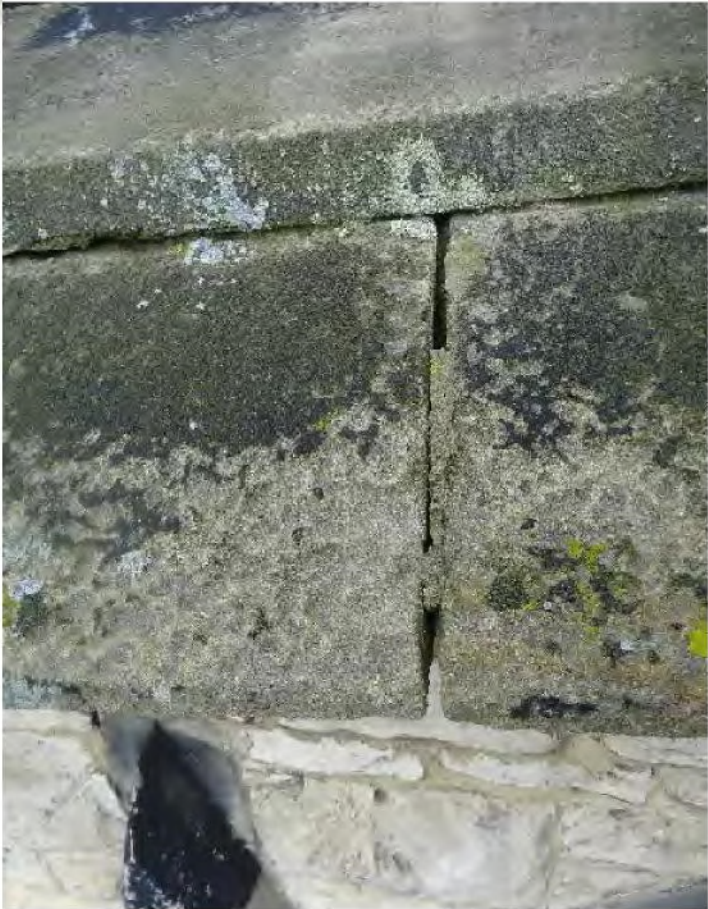
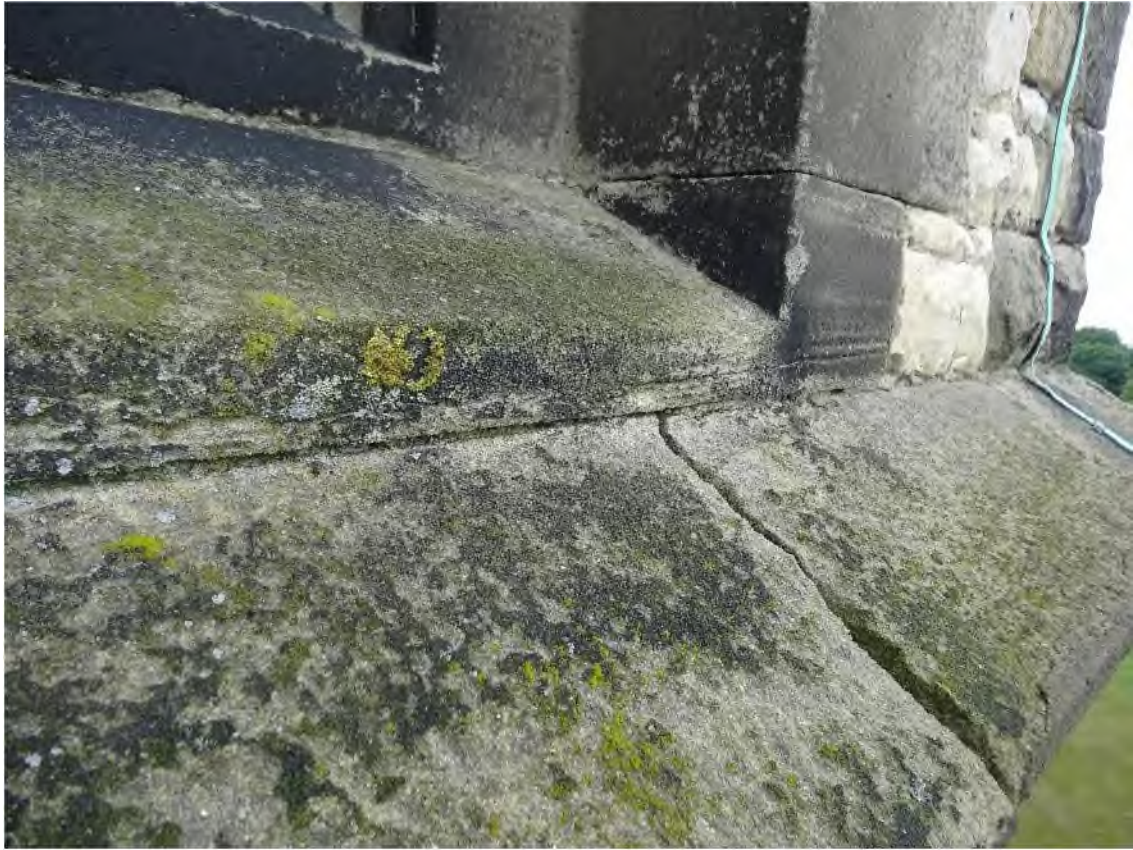
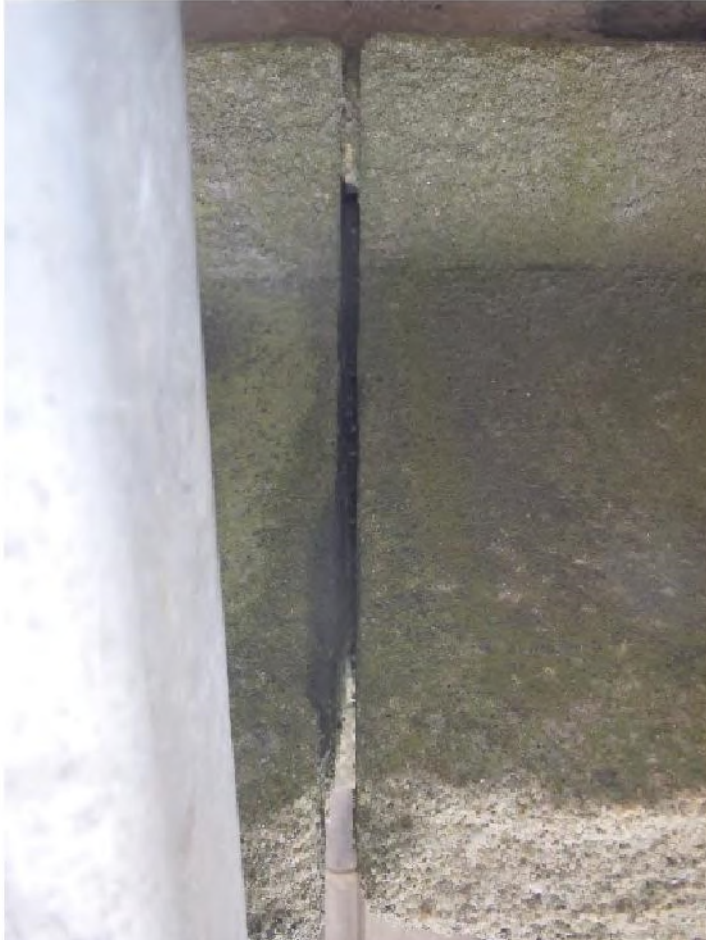
Examples of section C.

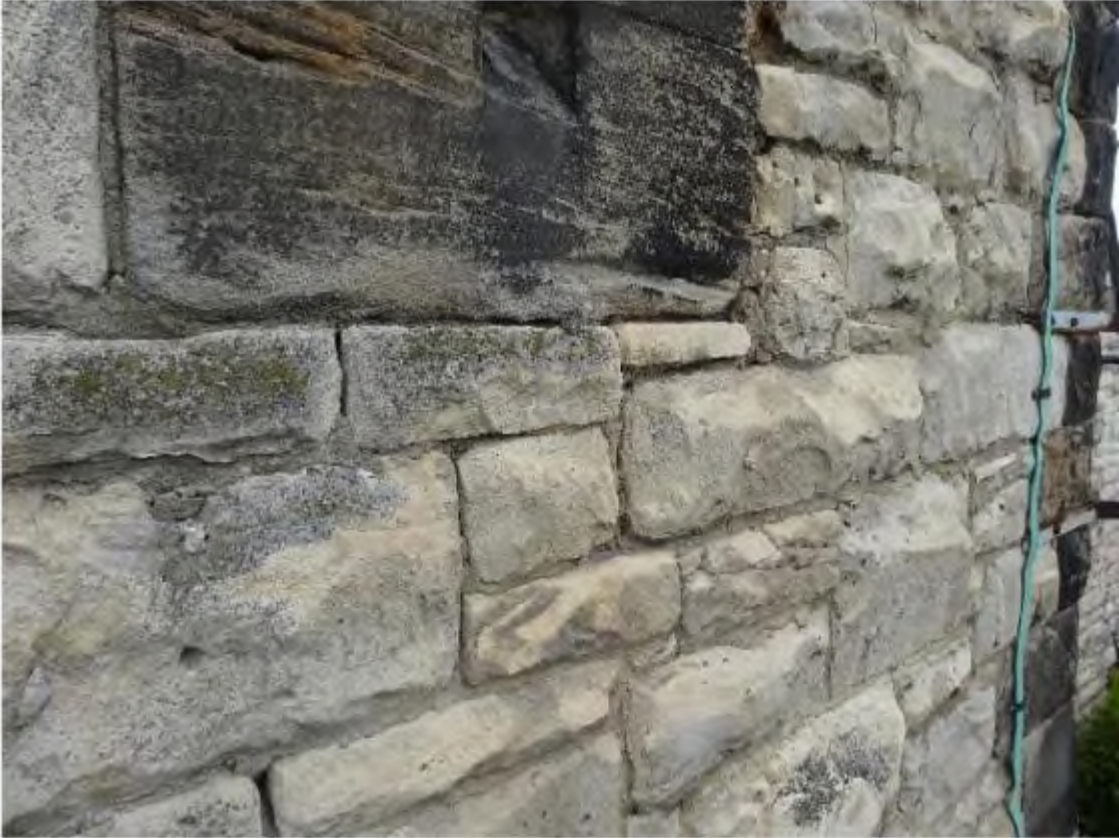
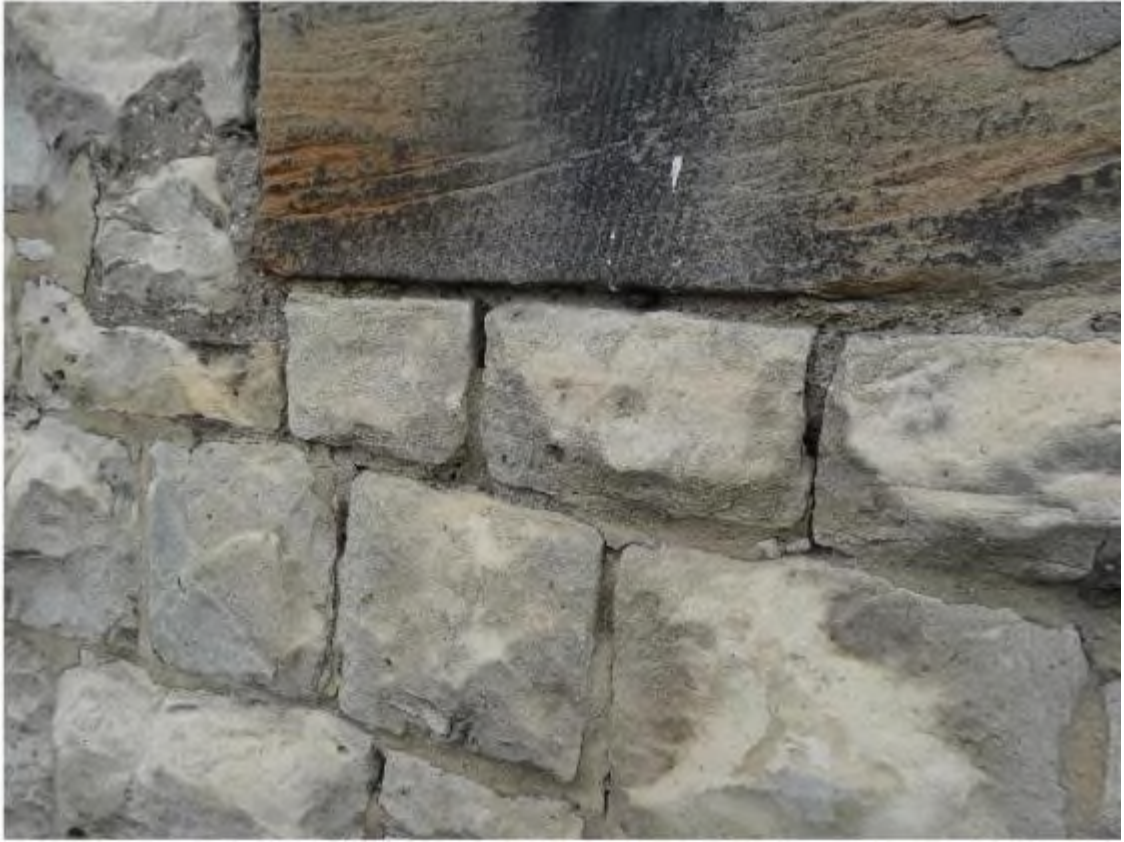
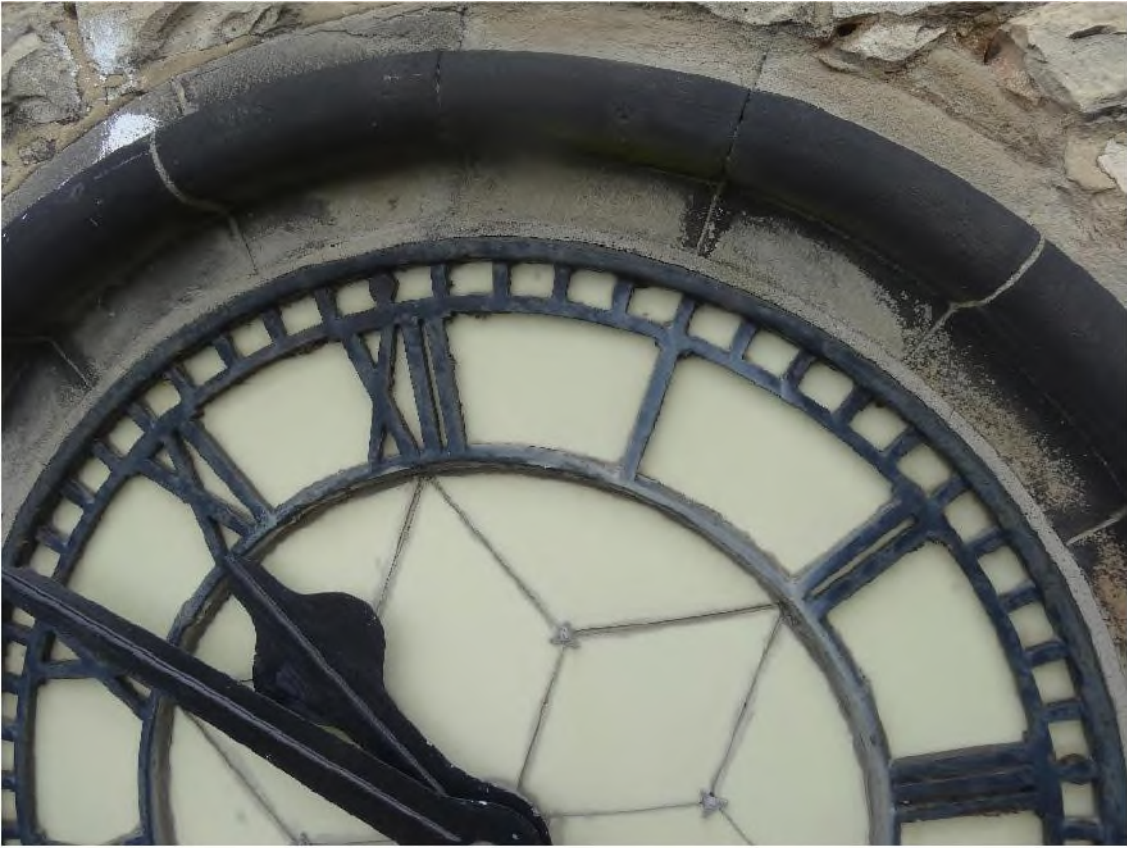
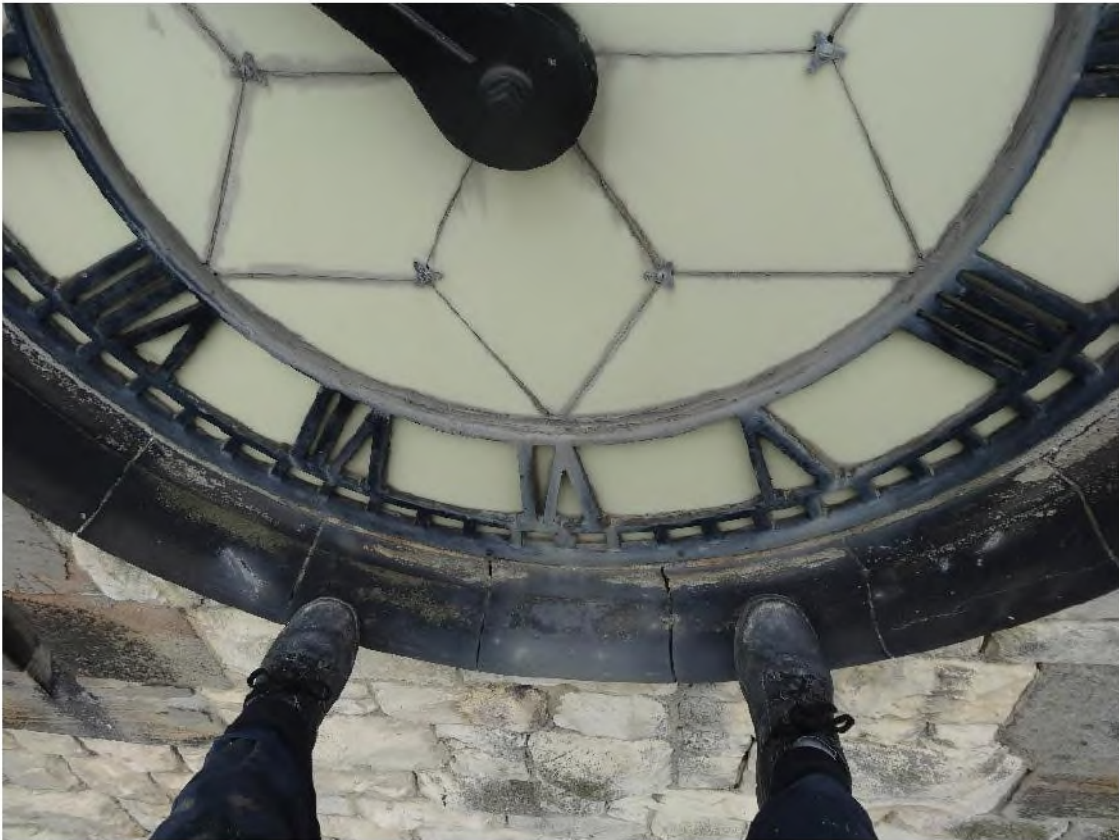
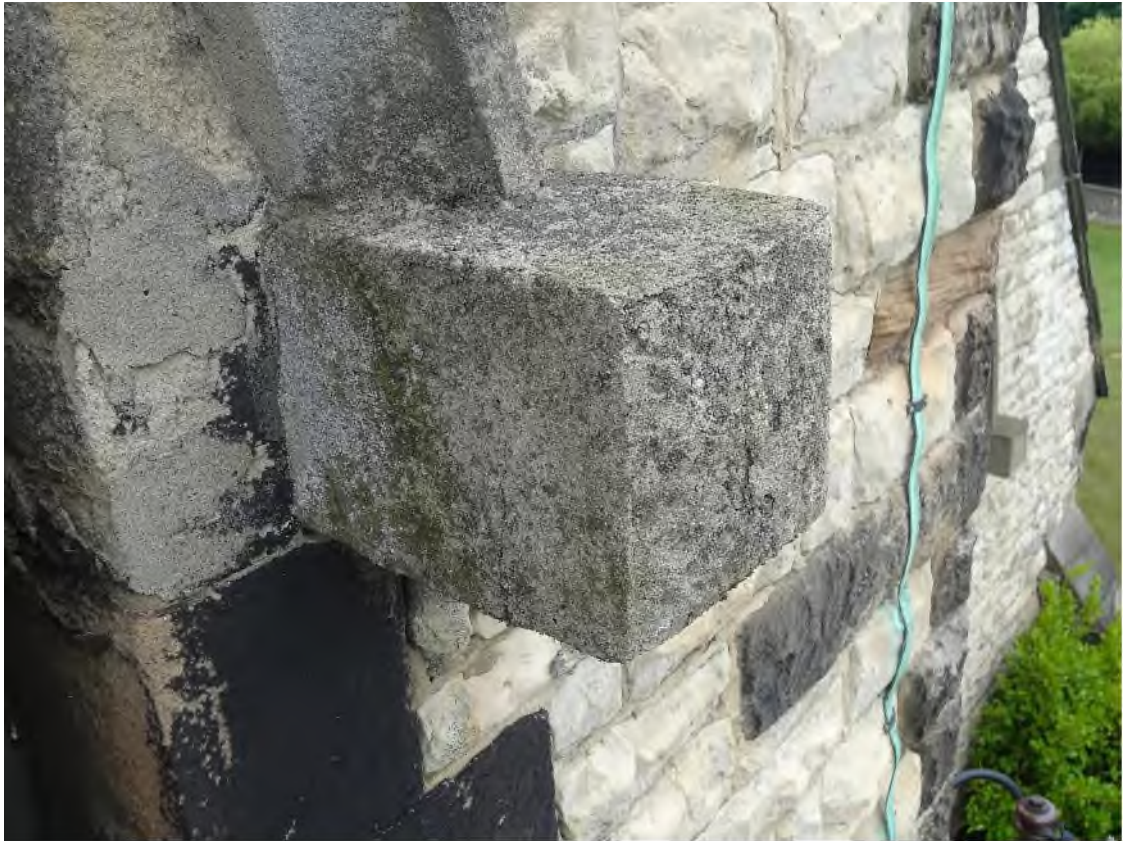
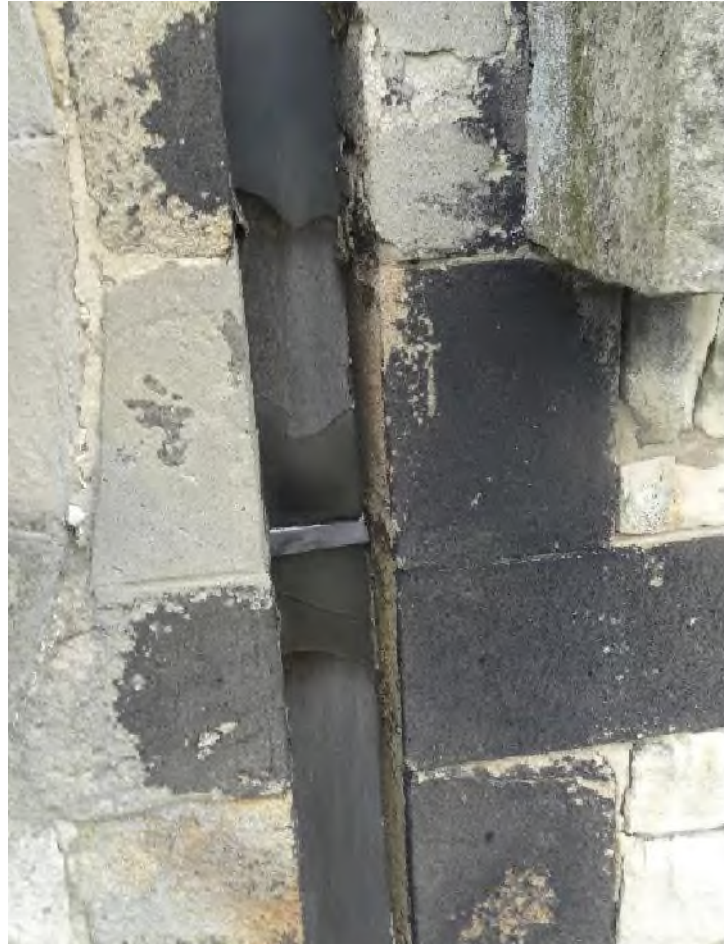
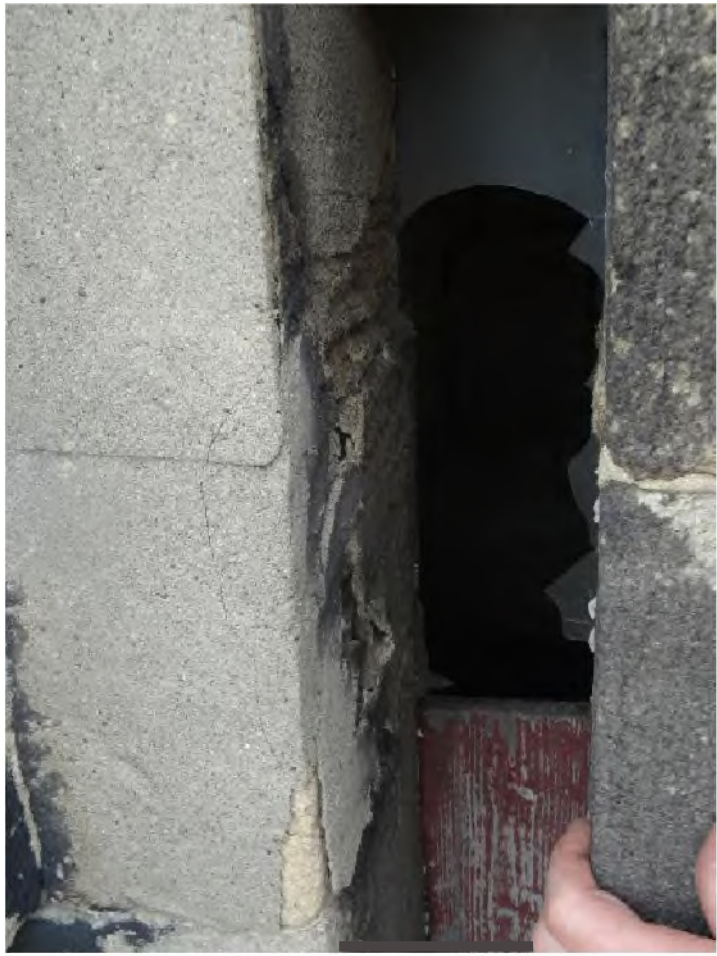
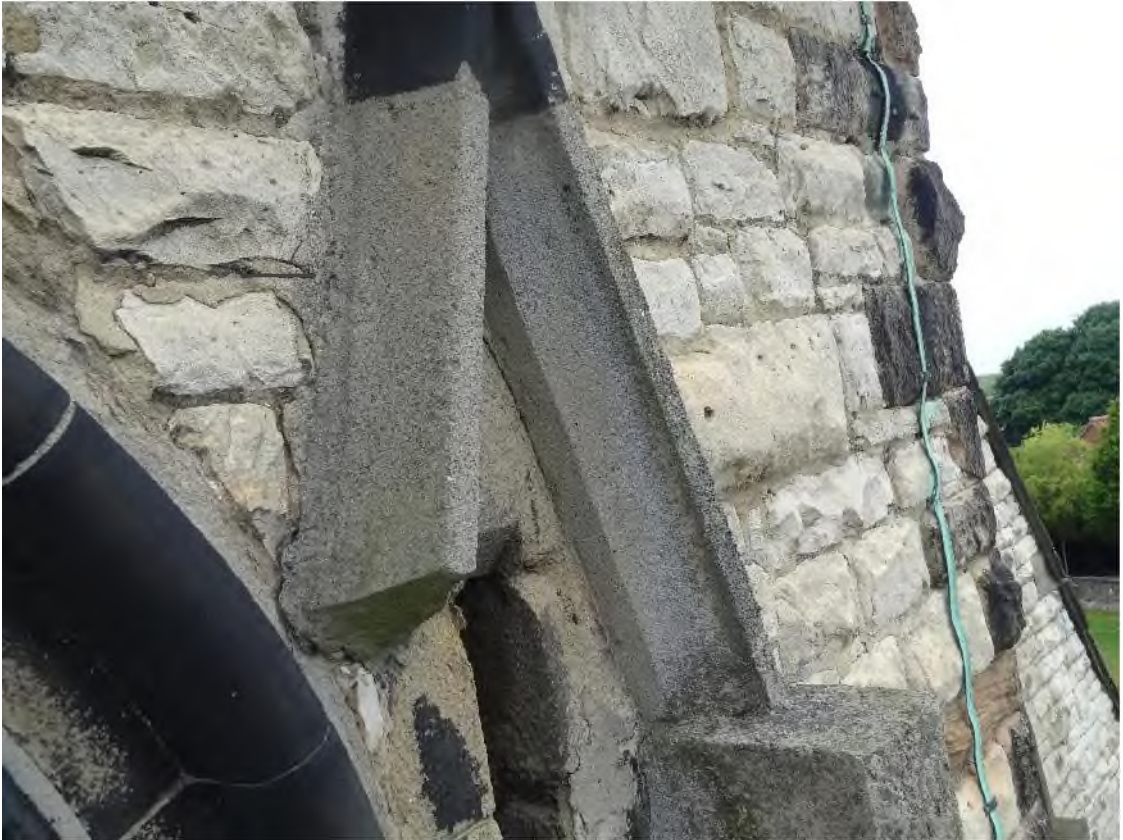
Examples of West face stair turret.
