# **ALL SAINTS    SOUTH SHIELDS**

**Boldon Lane West Harton  
(111)**

## **QUINQUENNIAL REPORT**

**25 July 2025**

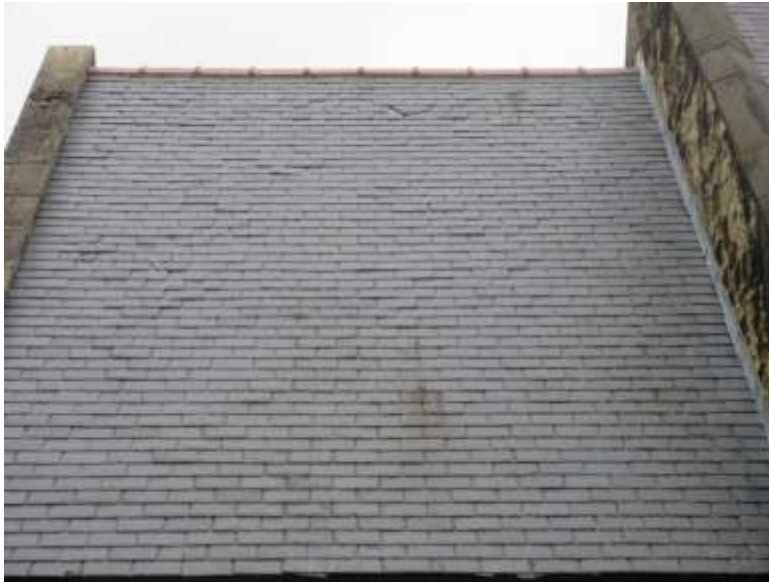
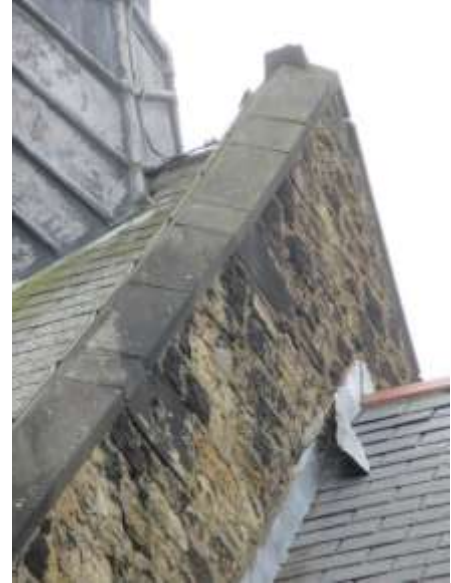
W side of Organ Chamber – lead flashings pulled apart show the gable has moved away from the slate roof

16. An inaccessible short lead tapered gutter between the Organ chamber and Nave gable. Over organ so trouble inside caused by blockage would be hard to see. Cleaning say every two years would be a wise precaution.
17. Lead flashings at the low N Porch roof
18. Two slates at the Vestry top course are held in lead clips under a painted lead flashing.
19. Extension covered in natural welsh slate said to be on Cellotex insulation as sarking to suit the sloping ceilings, requiring no ventilation. Clay ridge and lead abutment flashings. Sound except two S slates near top middle are slipping and part of the N flashing against the church hangs loose.

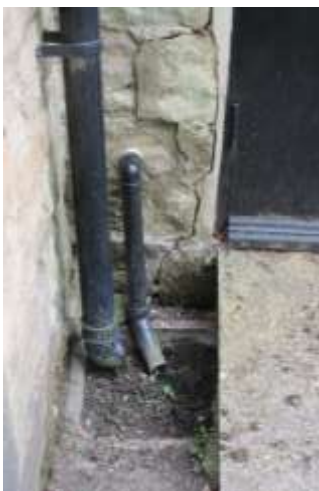
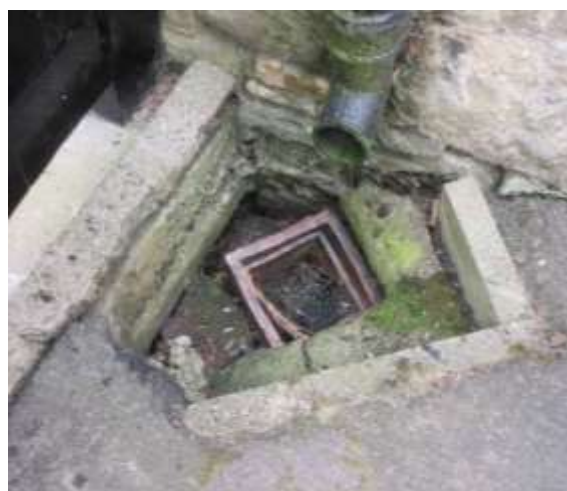
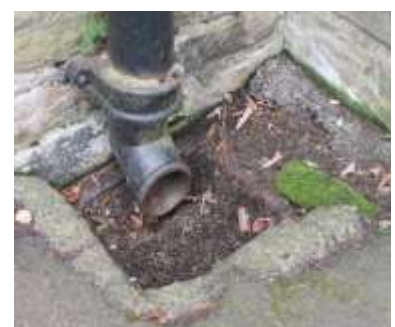
21. Church half round cast iron gutters on brackets with round pipes. Paint generally sound but rust at several joints.
22. The S Nave and S Chancel gutters show some rust but appear sound.
23. At N Nave some rust at joints, one mid joint open and leaking.
24. The Organ E gutter is rusting. Under the W gutter green streaked stone suggests a leak. The N Porch plastic gutter appears sound.
25. At W extension ogee gutters and square aluminium downpipes. The S gutter W end stop is missing. Moss on the buttress below shows spillage. Plastic downpipes from the W Porch.
26. All church gullies are choked.  
Annual cleaning of gutters and gullies and flushing of drains is needed.
27. The extension gullies and 100mm foul drains combine with earlier drains from the church gullies and connect to public sewer.

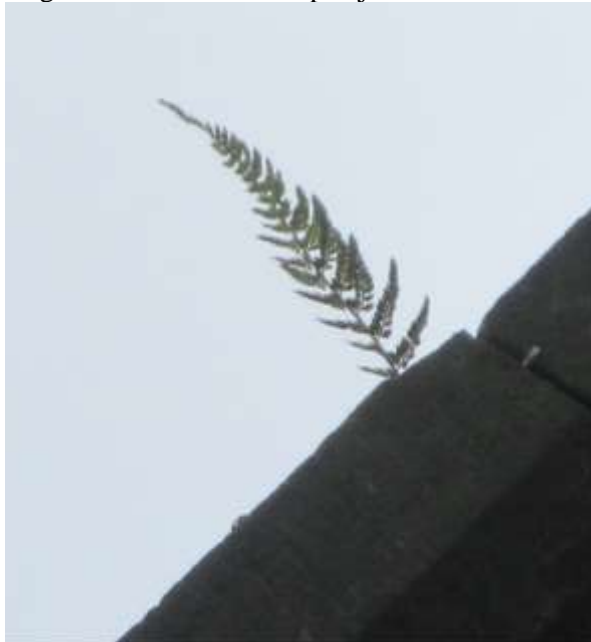
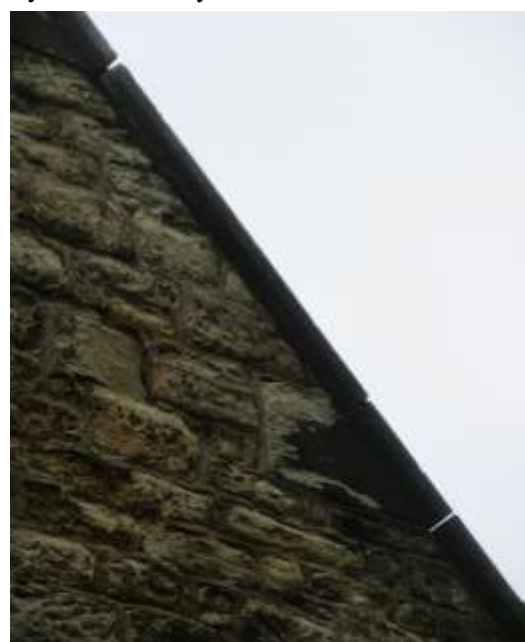
36. Under the chimney a patch of deeply weathered open joints and decayed stones in the top of the gable are beyond repointing and need stone replacements to keep out the weather and the chimney stable.
37. Organ gable watertable joints open (one with fern growing) and one watertable out of alignment, perhaps due to the movement. General walling fair but some open joints especially at the old diagonal structural crack full height of the gable. Pointing the watertables and open joints would slow decay and show any further movement.

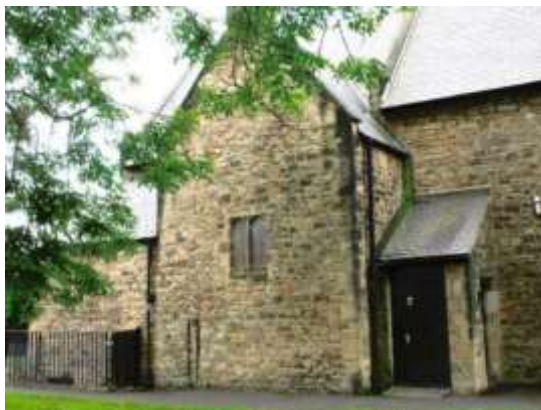
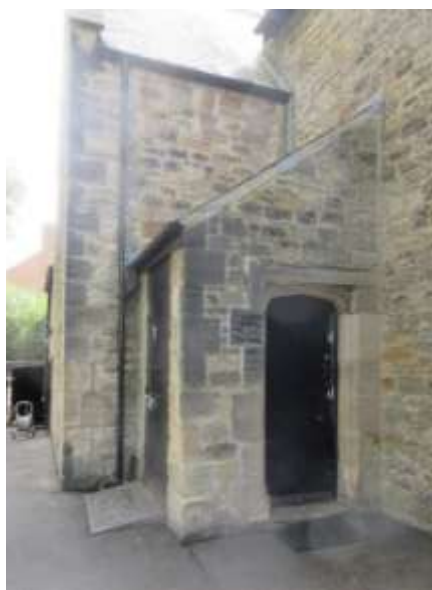
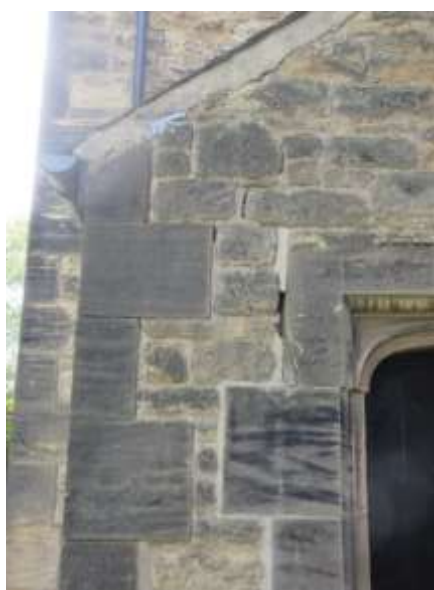
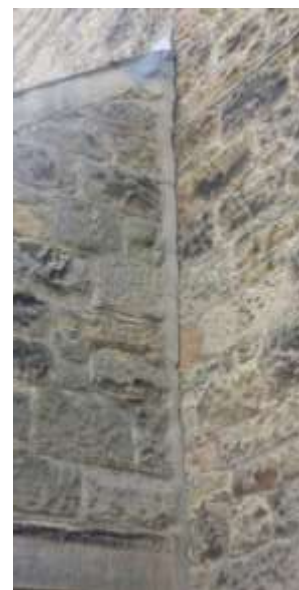
38. Wide diagonal cracks remain in the Organ W wall and N gable (see paras 8 - 10 for history). Both have been pointed in cement mortar and seem stable.
39. Movement of the small N Porch continues. It lacks any bond to the Nave where a wide cement mortar vertical joint is again cracked away from the Nave wall, widest at top. Further crack at the recent filling of a wide joint at the N end of the door lintel. Together with plaster cracks these show that the Porch continues slow rotation away from the Nave and Organ Chamber, suggesting both poor foundation and lack of bond to the building. The Porch is so small that the most economic answer would be to take it down and rebuild it on proper founds. If preferred an alternative would be a larger Porch with more inside (wc etc?) similar to my drawing 111/2 July 2004 in the church archive.

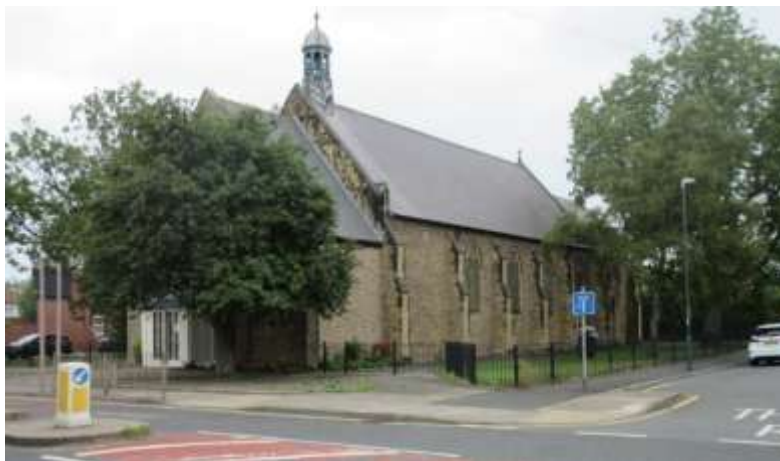
41. The 1994 west extension is buff/grey artificial stone. The original drawings show cavity walls of artificial stone, cavity part filled with insulation and ties to concrete inner blocks. Reinforced concrete strip founds. Slight settlement away from the Nave shows as vertical cracks in the butt joint pointing both sides, about 20mm wide at top. The cracks show the edges of vertical damp proof courses. With plaster cracks inside this confirms the 1994 drawings in church which show no structural anchors tying the extension walls to the church stonework.

Cracked joint at S side

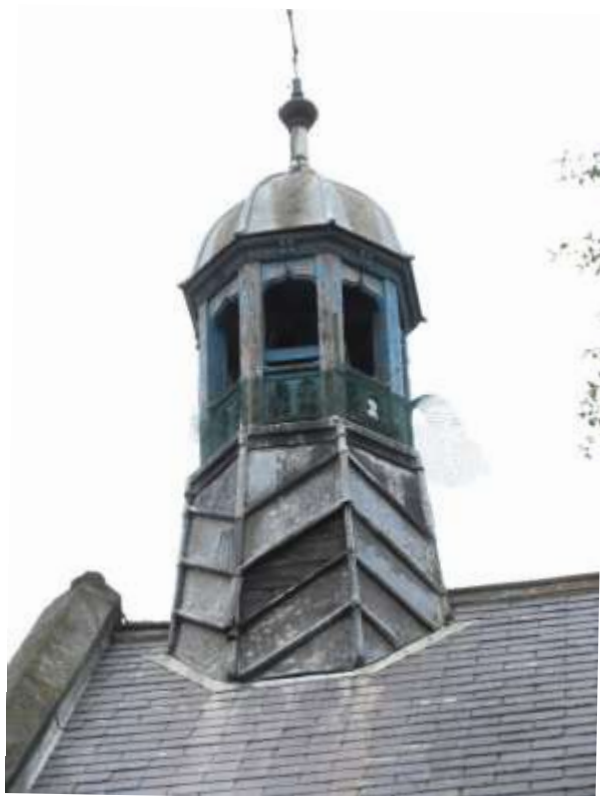
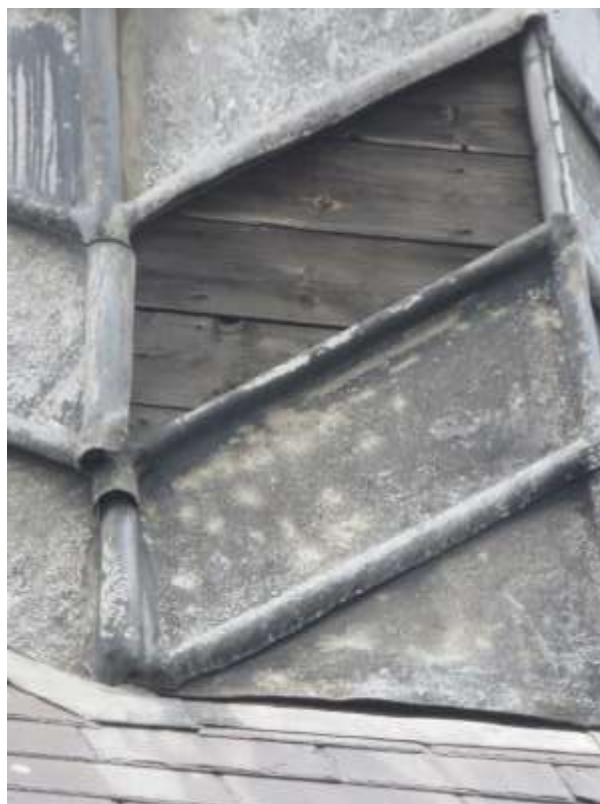
43. A graceful small octagonal turret near the W end of the Nave ridge is timber framed with lead clad dome and base and external plastic bird mesh over traceried timber openings.  
About half of the mesh is missing or loose.  
One S lead panel is missing, exposing timber diagonal rolls and boards.  
The remaining exposed timber parts need paint.  
Otherwise appears sound though no close access. The exposed timber will decay if left unprotected and the time comes for general repair and painting from scaffold.

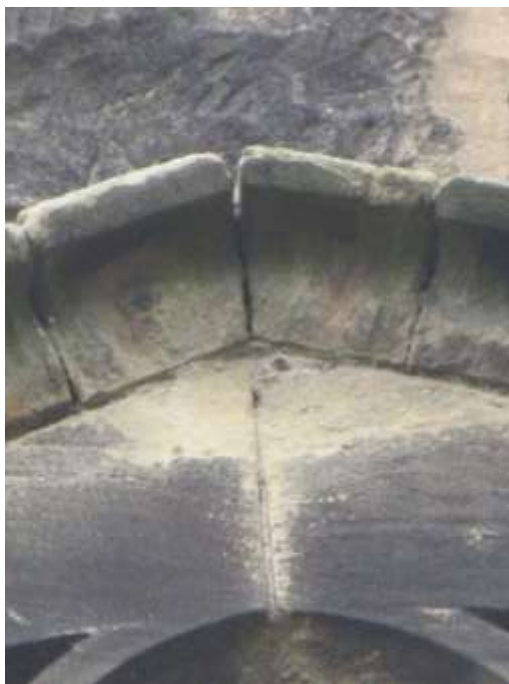
45. E window plate tracery is braced by its own buttress.

Some open joints and minor decay at bottom of two mullions. Open joints and very minor decay in top of hood mould and parts of the two moulded string courses need pointing.

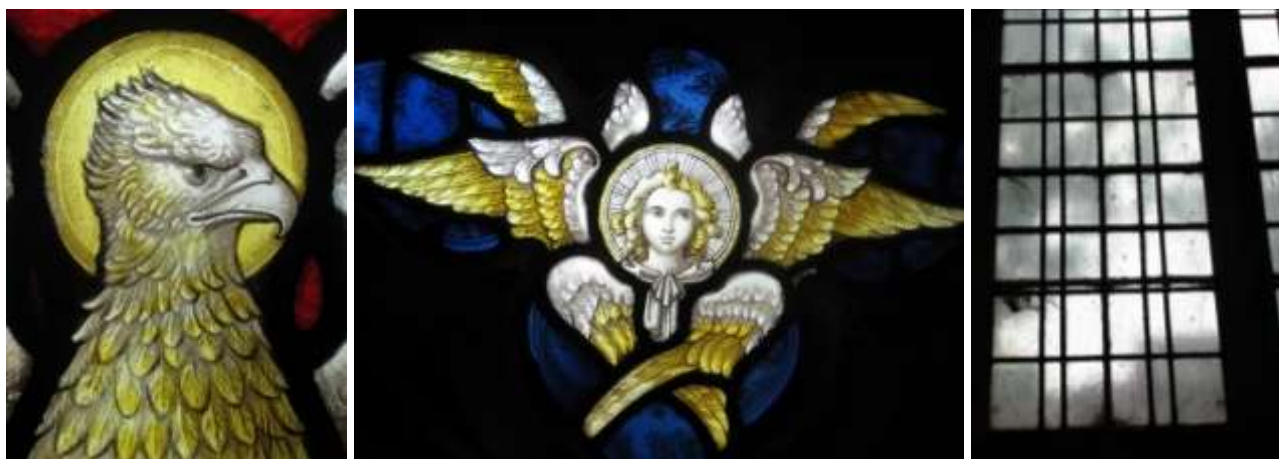
77. E – six light Christ the King and Servant with evangelists in roundel over, Philpott memorial 1888, good condition.

S Chancel and Nave except one S side – reamy glass good but dirty outside especially at N between glass and protection

S Nave stained – Peace and Hope, 1<sup>st</sup> war memorial good painted glass in good condition

W window (moved into extension) - reamy white glass in good condition but some dirt

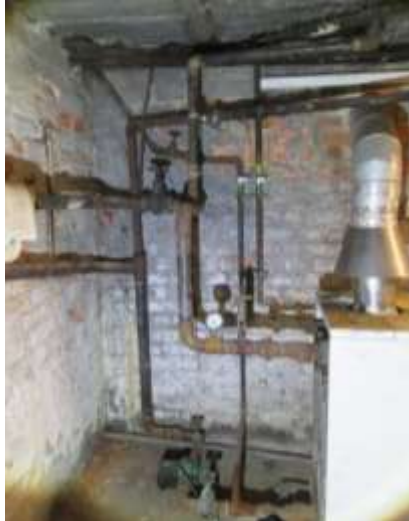
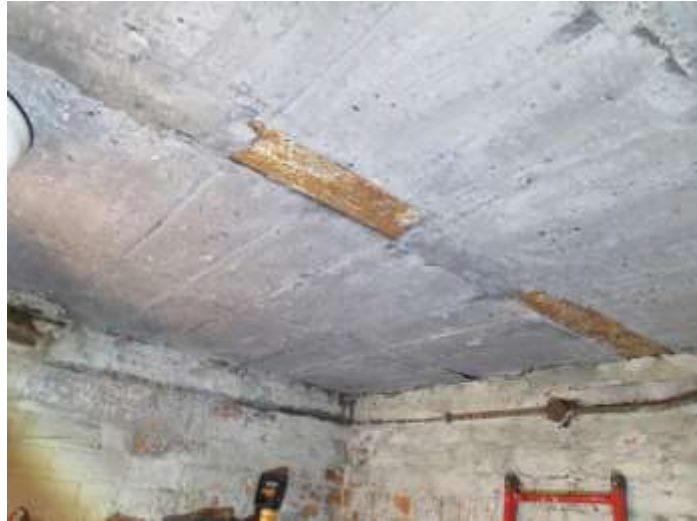
96. Church boiler Ideal Concord 41,500 btus, converted from oil in 1979 so now well over 40 years old. Open flue to sectional metal pipe whose joints are taped over to seal, to a flexible liner in the wall thickness, rising to a metal terminal on one of the stone chimneys. Froststat by boiler, 7 day timer in Vestry. The boiler room is well ventilated but gets very warm due to lack of lagging on the steel circulation pipes which pass into the walls at head height. So fuel economy poor due to inefficient aged boiler and bare pipes in boiler room.

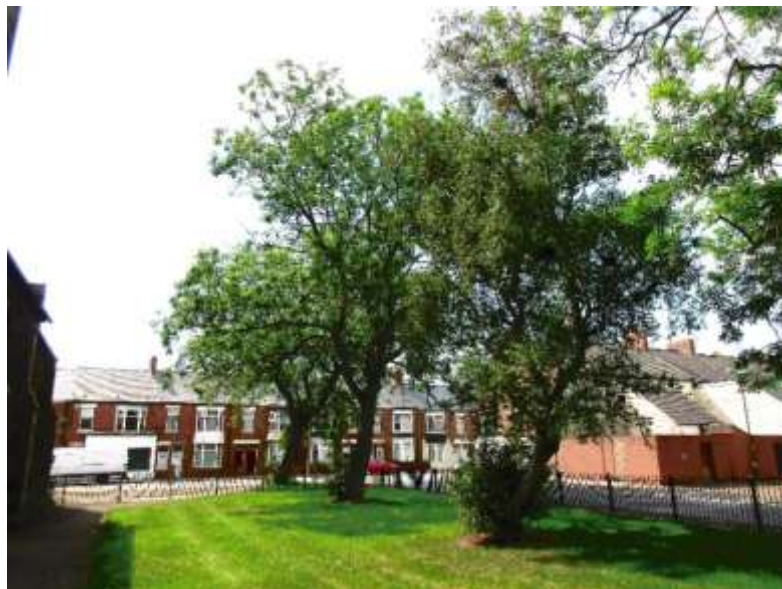
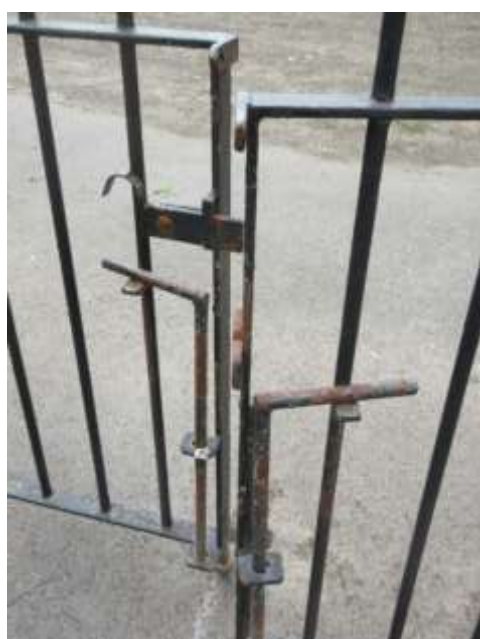
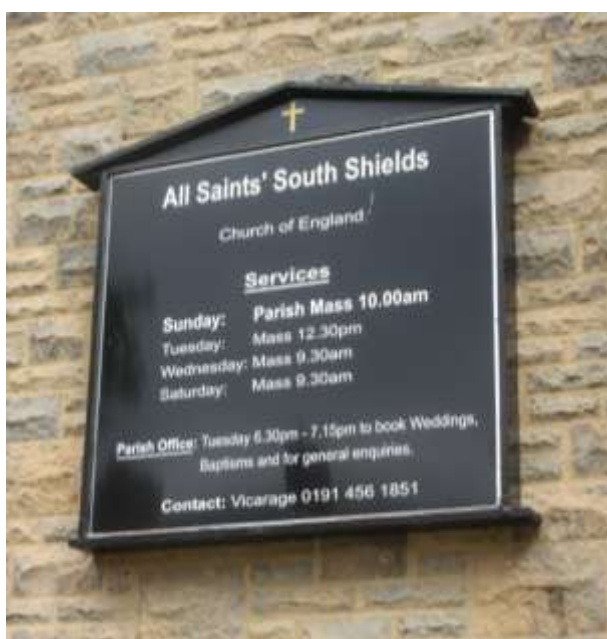
117. Small flat grounds maintained by the local authority. The remaining mature ash trees (three at N, one at S with single silver birches each side) are important in the townscape. The grassed site has steel railings and rusting gates.

Planting beds outside the railings at W are mainly bare. Tarmac paths in mixed condition.
