## Church of St Anne, Bishop Aukland

### Quinquennial Report

**24<sup>th</sup> July 2022**

Date of report – August 2025

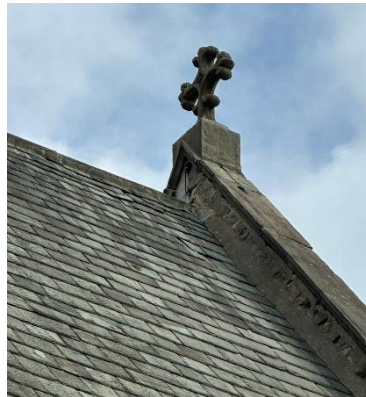
*Figure 5- E Nave finial*

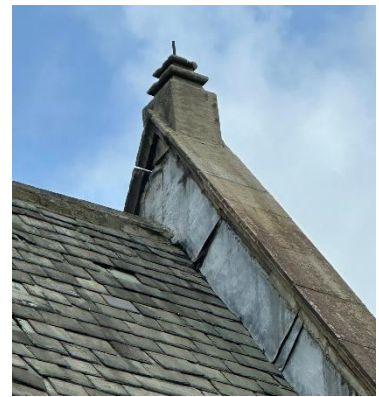
*Figure 6 - E Chancel Finial*

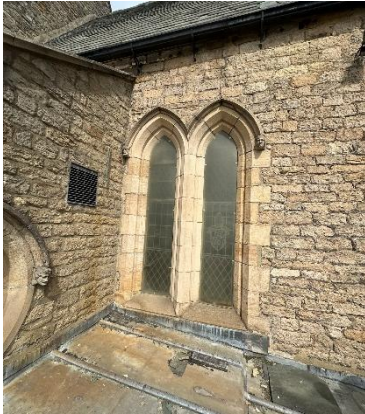
Figure 22 – S Chancel

8.9.1 **South** - Above the eastern part of the South Aisle roof there is a short section of rubble walling, only three courses high, which is in fair condition. One or two open joints are visible and require repointing. The eastern half of the Chancel wall is of similar rubble stonework, also in reasonable condition. There may be an open joint at high level, though this could not be definitively confirmed from ground level. An external spotlight is fixed to this elevation; its electric cable is loose and requires securing.

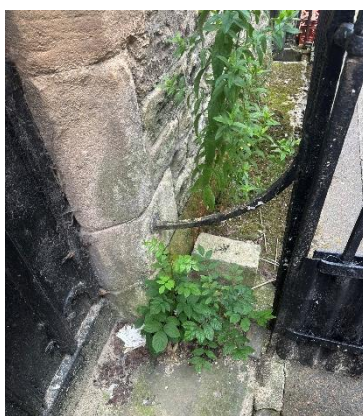
Figure 25 – vegetation nr door

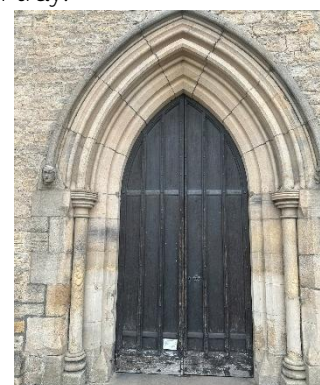
Figure 27 – West doors

9.4 The main **west entrance doors** are made of oak, boarded and battened. The decorative finish is deteriorating, most noticeably at the base where weathering has exposed bare timber, and at hand-height where repeated contact has caused surface wear. One board is split at the bottom, and areas of exposed timber are now vulnerable to decay if left untreated<sup>35</sup>. The doors are no longer in regular use and remain closed.

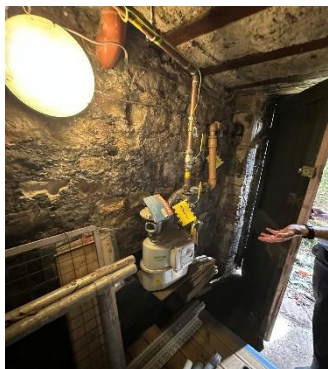
Figure 30 – boiler room

10.1 **Roof** - The roof structure comprises steel beams with in-situ reinforced concrete infill, likely reinforced (concrete type is unknown and unchecked – further advice should be taken by the PCC)<sup>40</sup>. The beams themselves are rusty and require brushing down and repainting.

10.2 **Walls** - The walls are of brick and rubble stone and are generally fair for their situation, though there are many open joints, disturbed areas, holes, and a noticeable degree of efflorescence.

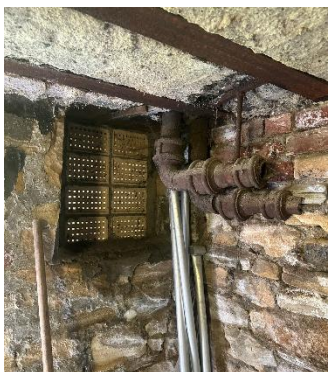
Figure 31 – ceiling and former window

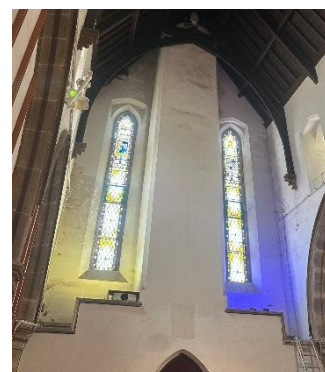
Figure 35 – W Nave

12.2.5 A full-height fracture in the plaster at the southwest corner requires investigation<sup>43</sup>; the previous inspector reports that this may relate to similar historic movement previously repaired at the northwest corner, though no records of this are available to cross reference.

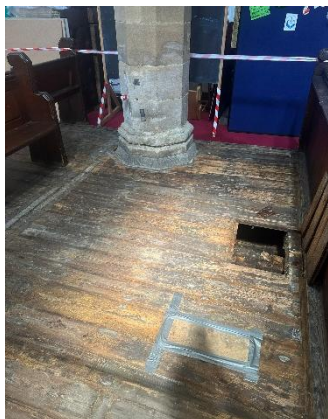
Figure 36 – W Nave floor

12.4 **Floors** - The nave floor is largely carpeted to the aisles, limiting inspection of the stone slabs beneath. Pews have been removed from the west end, exposing a large area where timber joists and boards were found to be rotten, in some cases to full depth. The joists sit on sleeper walls, and moisture transfer from these appears to be the cause. This floor needs to be fully replaced<sup>44</sup>, there may be an opportunity to level the floor here, as I believe is the PCC's desire. This area has been cordoned off and should remain so until the issues are resolved.

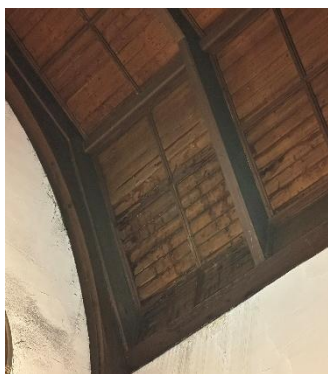
Figure 37 – Chancel South roof

13.1 **Roof Structure & Ceilings** - The roof is of similar construction to the Nave, with arched trusses, but here they support a mansard or wagon-shaped ceiling rather than a simple double pitch. The spaces between purlins, trusses, and principals are divided by timber mouldings.

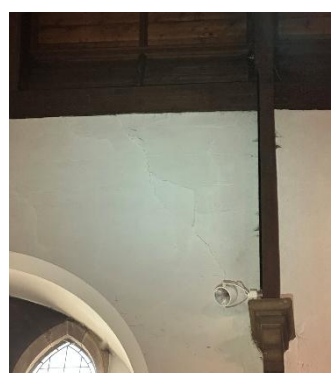
*Figure 50 – easing to S*

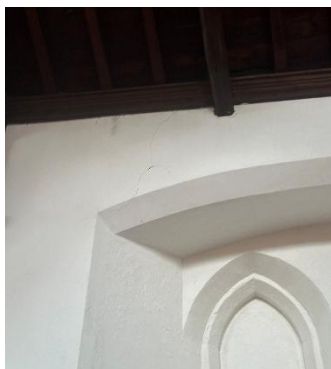
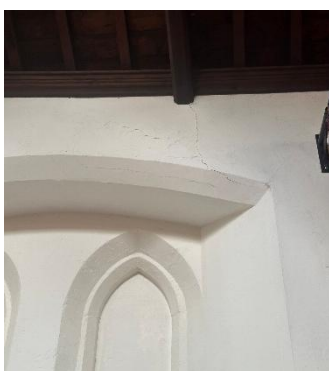
Figure 53 – N 2<sup>nd</sup> from E LHS

Figure 54 – N 2<sup>nd</sup> from E RHS

14.2 **Walls** - The aisle walls are plastered and generally remain in fair condition following patch repairs in 2015. Several blocked window openings are present on the north elevation, including two twin lancet recesses. The associated stonework is in reasonable condition, though slight fractures are visible above the second recess from the east, which should be monitored.

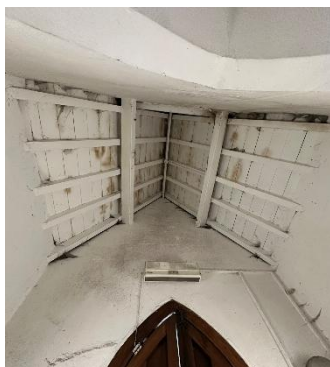
17.1 **Roof Structure and Ceilings** - The porch roof is formed with painted pine purlins, ridge, rafters, and boarding, all generally in good condition. The rafters are stained, and external roof repairs should be carried out before any internal redecoration is undertaken.

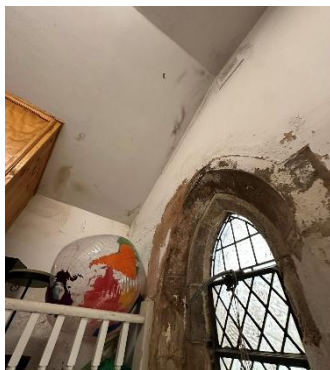
Figure 62 – Vestry ceiling and E

18.1 **Roof Structure and Ceilings** - The Vestry has been altered to form an additional upper storeroom accessed by a timber staircase dating from the 1990s. At this level, the walls are plastered and generally in fair condition, although damp is evident on the north wall.

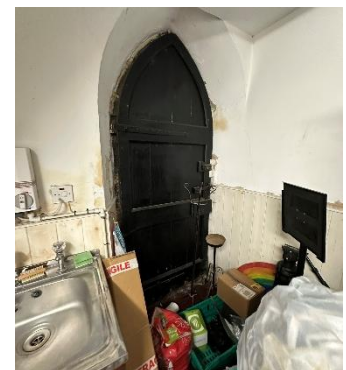
Figure 64 – Vestry door

18.3.2 The internal entrance doorway from the area adjacent to the organ chamber is set beneath a shouldered arch. The softwood boarded door is in reasonable condition, but the threshold and base of the external east door show signs of water ingress.

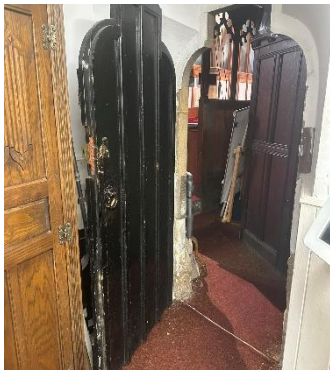
*Figure 65 – area of organ accessed*

19.1 Roof and Chimney – A clear visual inspection of the roof was not possible from the accessible areas, and the presence of asbestos made closer inspection inadvisable. It was reported that a chimney had previously been removed from this location.

19.3 Floor - The floor is suspended and has a noticeable degree of deflection underfoot. This may indicate weakness in the supporting structure, possibly linked to damp-affected joists. Further investigation is recommended to confirm the condition beneath and identify any necessary remedial work.

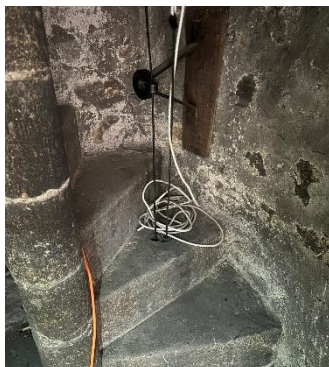
*Figure 66 – staircase wires*

the aesthetics. The floor of this area (which is also the ceiling of the west entrance/store) is rotten in places and not currently safe to stand on; this needs to be repaired or replaced. An irregular narrow stone spiral stair then leads up to the bell turret. The stair has no external windows, and lighting should be introduced as the current arrangement of exposed cables running up the centre, with some hanging from the side, is unsatisfactory. A more formal power supply should be installed, and a central rope handrail would improve safety.

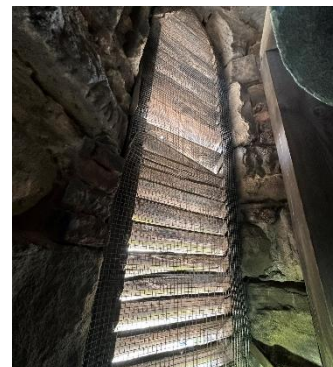
*Figure 68 – louvres*

20.4.1 The timber louvres to all sides are defective, with several missing or dislodged and at risk of falling. They were originally slotted into the masonry, but many are now loose. Bird mesh has been installed and reportedly repaired, yet gaps remain and the risk of bird ingress persists.

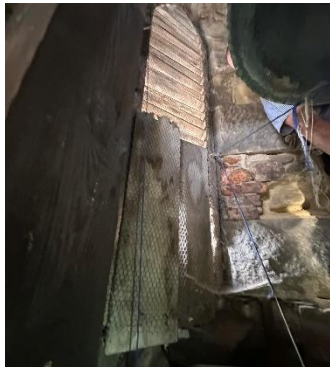
Figure 69 – bell chamber

20.3 Access Hatch - The timber access hatch to the chamber is completely rotten and unsafe. At the time of inspection, it was propped by a temporary timber support, which was removed as it was loose. The hatch itself has a hole through it, rendering it largely redundant. A new, safe hatch should be constructed as soon as possible.

20.4 Bell Chamber - The bell chamber contains two bells hung above one another and is partly visible from the semi-safe access areas, though confined and difficult to assess, particularly with two people present (which was deemed necessary for safety). Externally of stone, the internal structure comprises four angled stone and brick piers supporting a brick ring at the base of the spire. This ring is capped with large sandstone slabs spanning inward, forming the transition between the tower walls and the spire above. The brickwork appears weathered, and some mortar bedding has been lost over time, making the construction worthy of closer inspection, as it does not appear to have been safely inspected in recent years. This is required to assess the stability of both the brickwork and the stone capping at the spire base, alongside the supporting structure of the bells themselves.

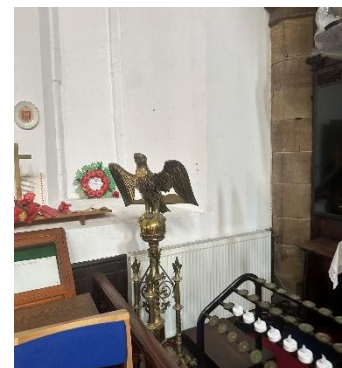
Figure 71 – brass lectern

21.4 **North Aisle** - The pews are pine and in fair condition, consistent with the wainscot. At the west end stands the font, dating from 1892, of limestone and marble with a carved oak bracket cover. It remains in good condition, although at the time of inspection it was partly obscured by stored items. There is a brass lectern amongst other storage at the east end.

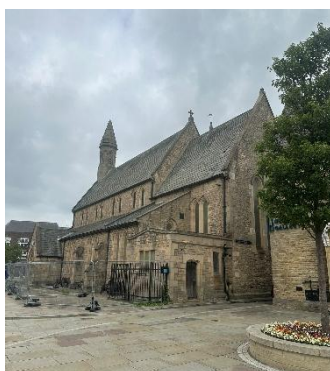
*Figure 38 – new fence and gravel*

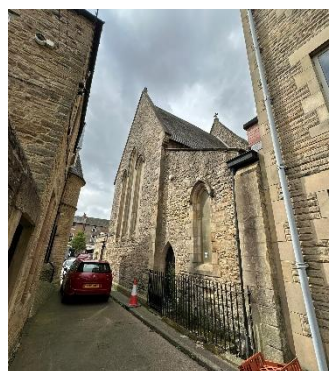
*Figure 39 – raised areas*
