Stanley S Andrew

St ANDREW STANLEY

QUINQUENNIAL REPORT

19 October 2021

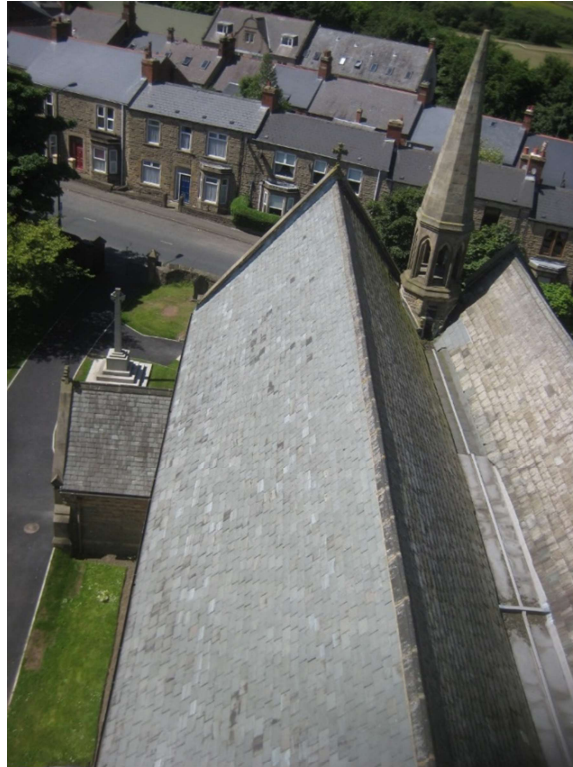
11. All green westmorland on modern breather felt.
At inner slopes large slates fair except on Nave one very large fixed on two lead clips.
12. *At the Aisle roof next to the turret a change of bond between new green and older slates is flashed with a piece of stainless steel.*
13. The cover flashings at Tower and gable upstands are felt or other substitute.
Felt dressings and back gutter around the N side of the bell turret.
14. The outer slopes at Nave and Aisle are good green westmorland with lead soakers and cover flashings.
Porch same but mortar fillets under the gable water tables.
At Aisle E end chimney a flashing is slightly lifted but looks secure.
15. *Main valley long bay stainless steel with capped centre roll except W bay bitumen felted each side of a stainless steel roll so that bay may be felt over stainless, perhaps after a leak. Not accessible 2021.*

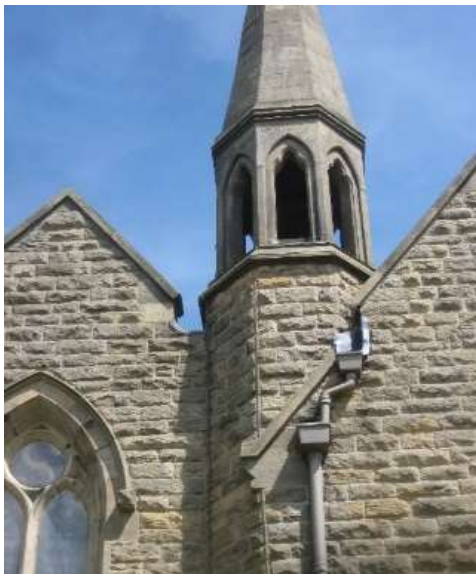
25. At the Choir Vestry W eave an ordinary ogee cast iron gutter takes half the flow from both main valley and Vestry. A cast iron pipe and gully.
At its E eave a short plastic gutter is part broken. Cast iron pipe sound.
At the boiler house side outlet a hopper and pipe sound but paint needed where rust spots begin.
26. At wc E of the Clergy Vestry a sound cast iron rainwater hopper and pipe, gully shared with plastic wastes.
A plastic wc waste into a cast iron soil pipe with added fixings. All need paint.
27. At least some of the S gullies join an earthenware drain through manholes at S and E which appear to lead under graves, northwards down the bank into the grounds of St Andrew's Nursing Home. No known defect but some history of blockage reported.

Repair broken slates both sides of Clergy Vestry, clear its gutter against Aisle end, renew its E plastic gutter	17, 18, 25
Check clock time, adjust if needed	41

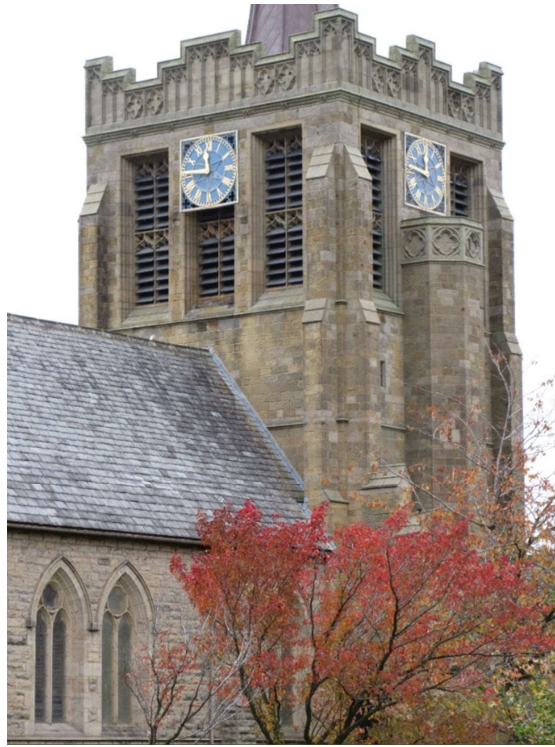
36. No safe access to the Tower roof so I repeat observations from 2016:

A loose extending aluminium ladder to the copper covered roof hatch which remains awkward to use.

Tower roof asphalt with lead cover flashings over the upstand. Large outlet with cage in NE corner and pipe through concrete roof and masonry to external downpipe.

Stair roof flat lead on concrete with shallow step and dressed into top of low edge upstand

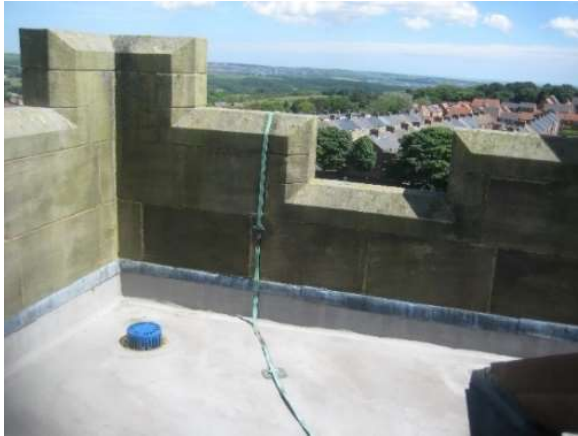
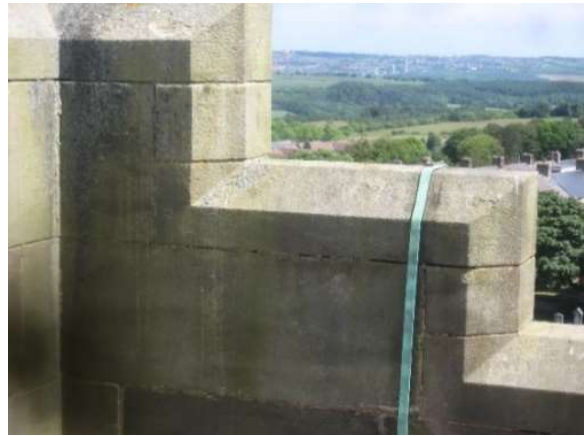
37. About half the joints inside the parapets are open. Carved outsides of parapets good.

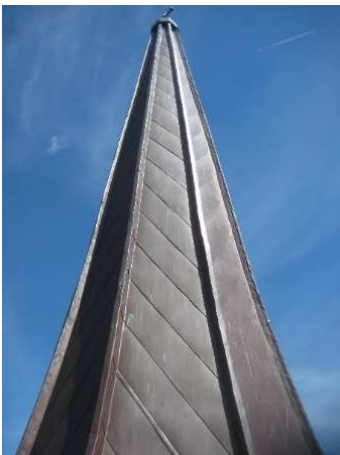
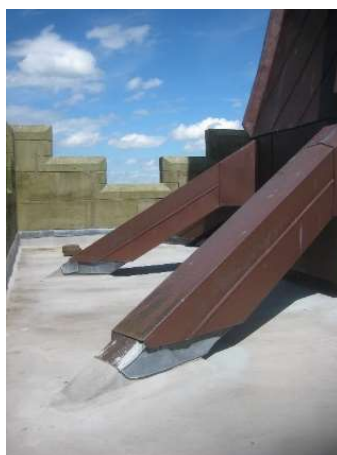
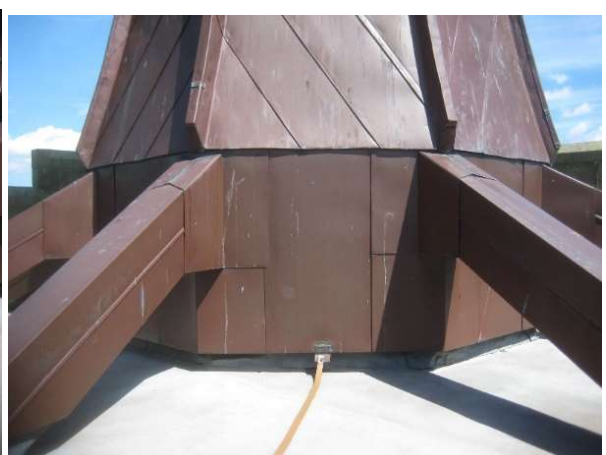
38. Belfry roof reinforced concrete with downstand beams and ring beam at bottom of octagonal needle. An interlaced steel cage (now beginning to rust) was added to strengthen at least the base of the needle. Ceiling concrete patched at former spalls and crack and appears sound. Brick inner walls sound. Slate louvres with good mesh inside.

104. Special effort will be needed soon at the rusting Tower steels.
Other minor maintenance work is needed over the next few years.

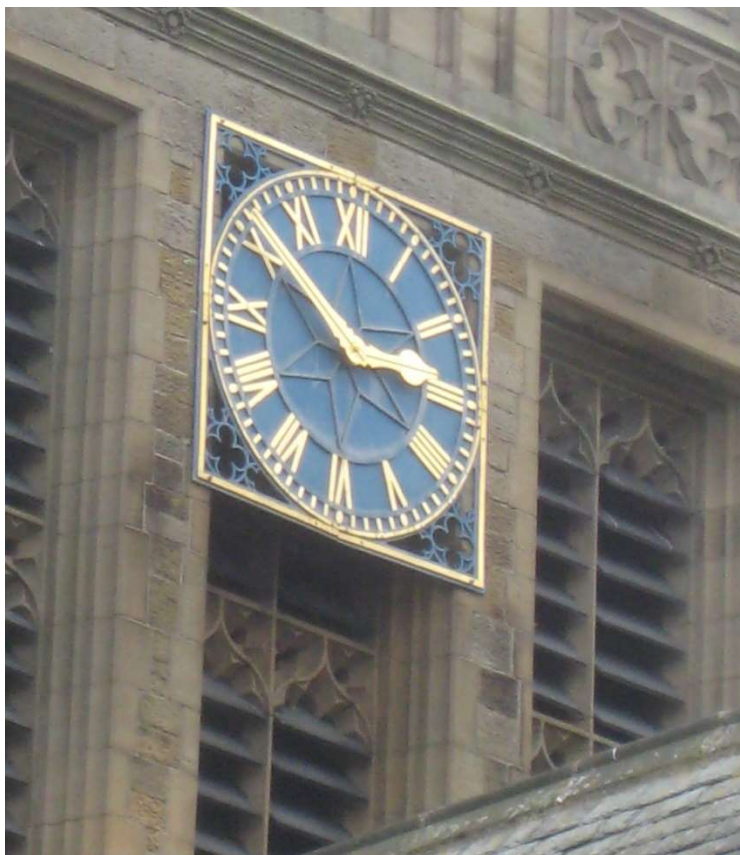
42. Tower external masonry :
W good except open joints in the buttresses and under the louvres with some minor stone edge decay.
N, E and S sides fair. Scattered minor surface decay and open joints, especially in buttresses and at E and S under the bell louvres and over the E window.

An ash tree sapling against the E side of the Tower must be dug out.

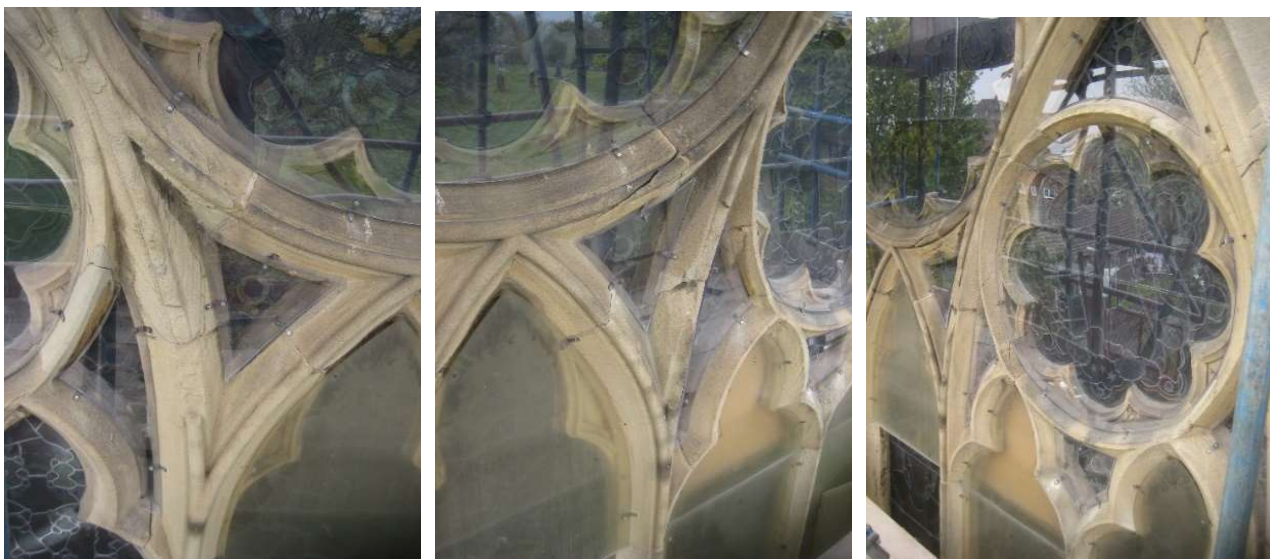
43. E large 5 light with three cusped roses in tracery, fair, minor opening of joints and loss of mould above tops of both mid mullions. Empty canopied niche over.

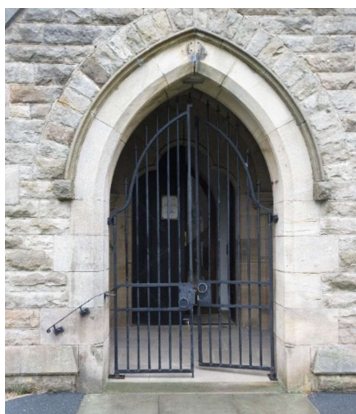
54. Choir Vestry and Boiler doors framed batten mainly good.
At Boiler door one batten lost and generally dilapidated, stain poor.
Steel handrail outside the Choir Vestry door needs preparation and paint
55. Clergy Vestry disused door weathered but sound except one cover lath bottom damaged.
Painted iron rail at steps minor rust and detached from bottom post.

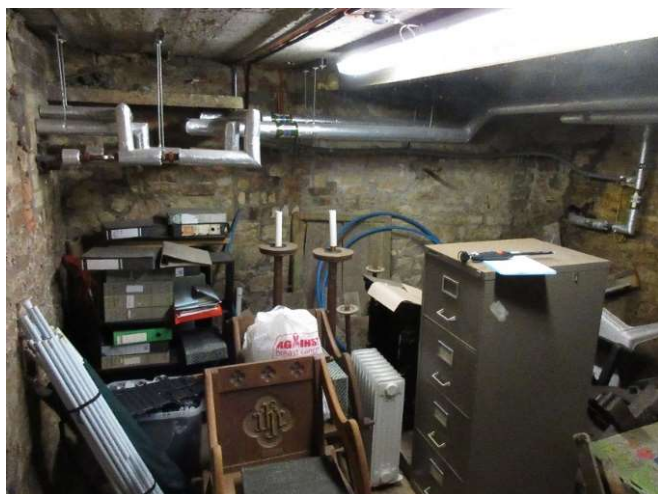
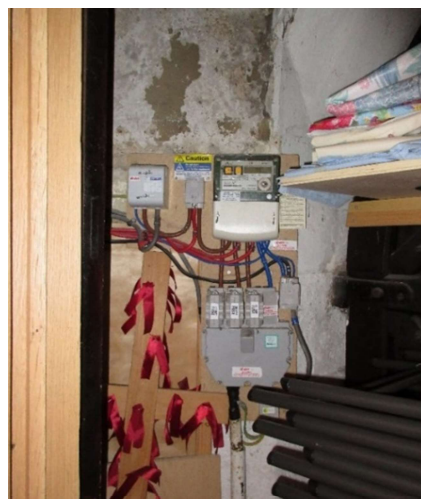
80. A slightly rusting steel supports the concrete ceiling of Blower chamber. In Boiler room concrete casing around another apparent steel under ceiling is cracked.

81. A build up of storage and archive risks damp despite good ventilation and should be limited.

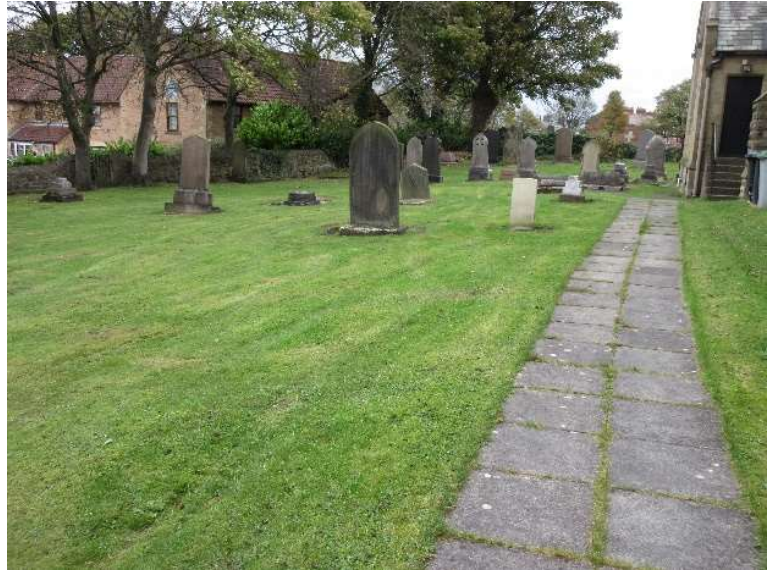
100. Stones generally sound, some with minor lean.

The Reed stone S of the Nave has a severe lean and appears unstable but was not tested.
