# **QUINQUENNIAL INSPECTION REPORT**

## **STOCKTON PARISH CHURCH**

**QUINQUENNIAL INSPECTION AND REPORT  
February 2022**

**David Beaumont BA (Hons) Grad Dip, RIBA, AABC**

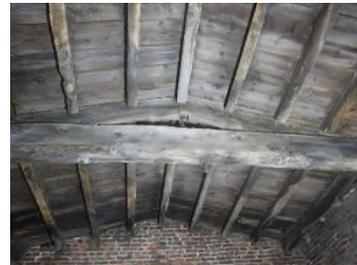
*The walls are in brickwork and these seem to be in good condition. Mortar pointed and sand cement works in the past but generally holding up okay. The windows have glass fibre louvres to them and these are beginning to wear and there are holes to the stone framework around them. These look as if they could do with remedial stonework around the frames. There are sound deadening boards to the windows so it is not possible to see condition here. These are in hardboard, just about okay.*

**Recommendation:** *remove deadening boards, inspect louvres and guarding to omit birds, formulate repair needs to window frame stonework, sweep up stairs and landing, repair bell hatch trap door.*

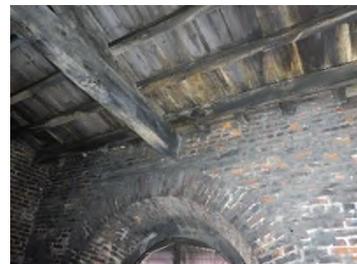
*Half landing at the foot of the stairs is covered in dust and needs sweeping up. This area looks down onto the bells and it can be seen that they are in a good painted frame in reasonably good condition. Lumber sat on top of the steel frame could be removed.*

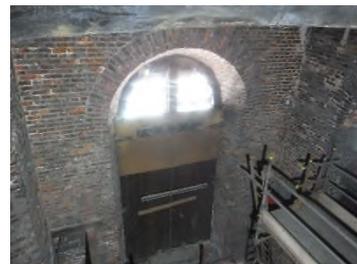
*I can see the timber beam is supported across the top. This has been cut out. Steel frame bearing looks okay. There is some other lumber around here and some evidence of pigeon nesting and eggs on the ground, probably accessed from the deadening boards.*

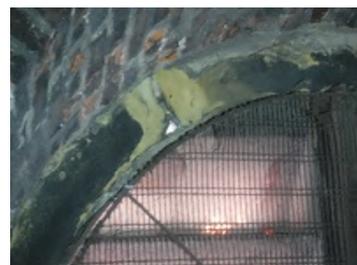
*Descending to the bottom level. Intermediate stage floor. Loose spare pipework in the corner of the room. Bell hatch part made out of plywood sheeting and broken down.*

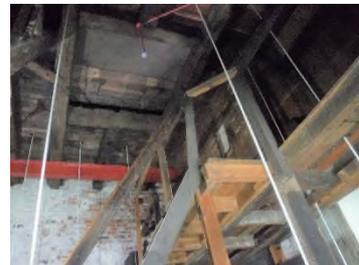
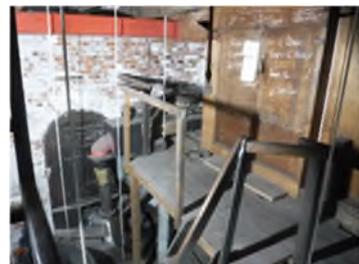
The floor is now supported off steel beams. Walls are brick with lime wash that is dusting off a bit now and the floors have got a bit of dust on them, but they are generally alright.

On a mezzanine is the clock and that all looks ok, some lumber around the room which could do with clearing out.

**Recommendation:** *sweep up*

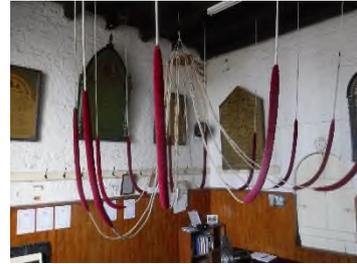
**C** **Ringling Chamber:** *Ceiling cuts across the springing line of the West window. The arch looks in good shape. Ceiling has some woodworm activity, although I think this is probably historic. Walls are brickwork and painted. Some loss of paint in minor areas. Below that a dado level of timber boarding which looks okay. Carpeted floor which is fine. Clock weight mechanism cupboard contains bits of lumber and weights*

and could do with being cleared out. There is also a cupboard on the East side containing various old pieces of things, tools I think and old pamphlets. There is a bay window seat at the big West window which has got various bits and pieces on it and could do with clearing up. The window is in obscure glass apart from the ventilator which is partially in clear. The window has been curtained with clear plastic sheeting and this is ripped. The room contains a distribution board, two fluorescents, one twin tube, and a couple of plug in heaters and fire extinguisher.

**Recommendation:** check if woodworm is active, sweep up, repair sheeting to window

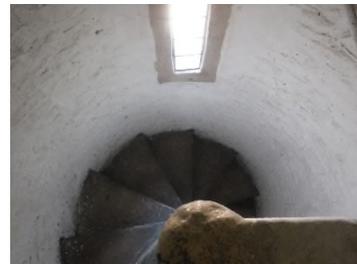
**D** **Spiral Stair:** This is wholly cement pointed but now painted out white. The stairs are slightly worn with some concrete toppings but these are okay. The door to the ringing chamber does not latch and it is being held by a piece of cardboard. The knob itself is loose as well. Single glazed lights to the wall, which are in good condition. They have little lead covered sills which are quite nice. Some salting to the lower walling at the base of the steps on the Western side, and one of the newels which connects to the central newel is eroding slightly.

**Recommendation:** fix door latch and knob,

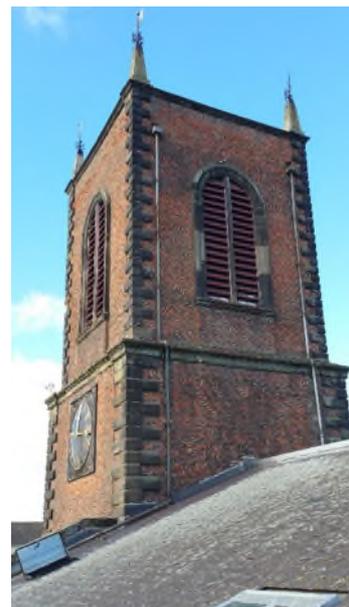
**North Elevation:**

NW quoins- vertical crack but perhaps a joint to the uppermost. The quoins themselves, as you come down the wall, look okay from this elevation. I haven't seen the return yet.

Looks to be some water staining off the parapet coping. The walling has been cement pointed at high level and there is obviously some loss of brick material there. Looks to a change of colour of brick at that point above the top of the arch. Discoloured panel of brickwork below the window cill, probably a wash off the former metal guards to the belfry window. The window frame has been patched but looks okay. Timber face to the middle mullion has been decorated and has got some bolting through to hold the louvre.

**Recommendation:** carry out repairs to tower

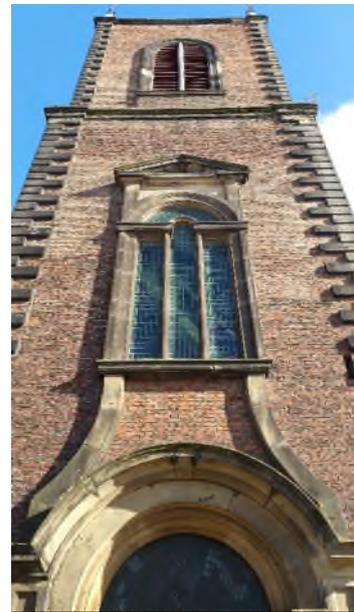
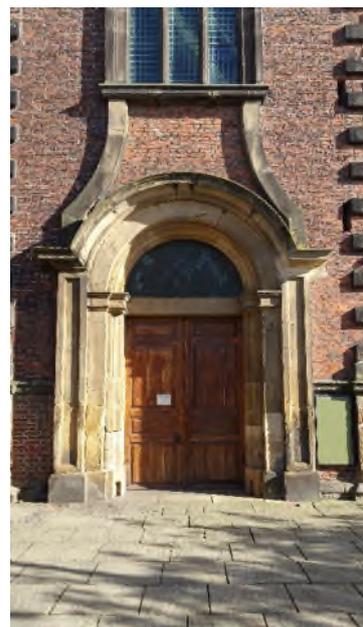
**Middle stage** - Unlike the other sides, this stage goes down to the ground and it features the pedimented central window and entrance doors below. Horizontal string course has some open joints. There is a shrub growing on the Southern side. The NW quoins have been cement patched. There is an open joint to the side of the brickwork a quarter of the way down. The SW quoins at the top are eroded. A small piece has come out of the third one down at the corner. This looks to have been previously repaired with cement. About an eighth of the way up, there has been some cement shouldering to the top of the quoin and this looks to be breaking down and is itself breaking the edges of the stone now. The rest appear okay.

The central brick panel has been repointed but the upper section above the pedimented window hasn't and this is showing up differently to the rest. The pediment itself has water penetration and perching birds. The glass looks okay. Erosion to the left-hand shoulder as it joins the top of the pilaster. The arch surround is okay, although it could do with a lead shelter on the top because there is some water penetration, particularly on the Northern side. The Southern has been replaced in the past. At low level the dressings are eroding, although they will do for now.

**Dado stage** -Below the lowest string course, the stonework itself is eroding and looks like it could do with deshaling and seeing how far that deshaling goes. On the South side, there have been some stones replaced here.

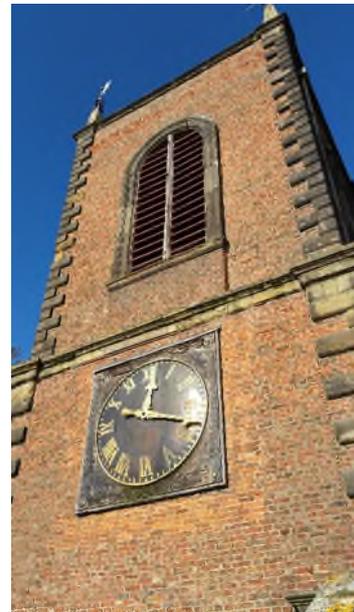
**Middle stage** - The string course is broken in the middle. It has had a replacement here in the past. The Western quoin top looks more heavily eroded but I think is sound. The rest of the quoins look okay. The SE quoins look okay. The brick panel is generally alright. There appears to be a lighter coloured square of it just bigger than the current clock surround. There also looks to be some vertical joints. This is possibly just poor build. It looks like a bigger opening has been infilled in the past because the bricks don't seem to line through properly.

**Bottom stage** - String course looks okay. The SW quoins have been cement topped like all the others. They look okay and the bottom part has had some replacement. On the Western side, some suggestion of parting in two places and some cement repair to them. The gaps aren't anything to worry about but are an interesting construction joint. One of the quoins above the plinth has been badly cemented up and the ones below the plinth are in fair condition. This elevation has lightning conductor wire coming down it. The brickwork panel has been badly repointed just under the string course. Below that, the general panelling brickwork is fair, although there is some erosion to the lime pointing. The oval window has some water damage over the top of it and looks as if it is spalling at the crown.

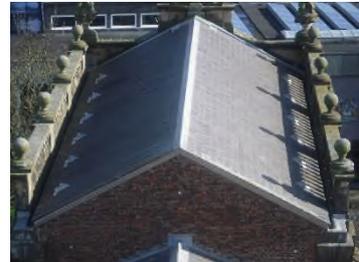
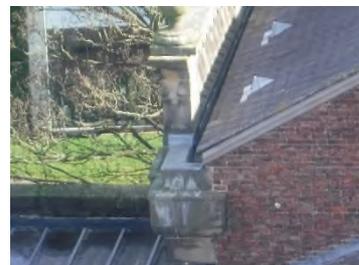
- D** **Chancel roof** – The rear of the decorative panel holding the cross has open joints, a S corner stone is eroded. Open joints to the rear of the water table forming the gable capping. The ornamental balustrade looks to have open joints. The box gutter lead flashing has horizontal surfaces that appear not to have been pointed in adequately. The overthrow of the slates has projected too much into the box gutter and so it is impossible to inspect it properly. This looks to needs to be completely remade however, it is an almighty task to do this. Where the slating abuts the gable there is a lead secret gutter and there looks to be damp beyond that on the horizontal raking surface of the water table. This may explain the damp on the inside. The flashing also wraps around the foot of the gable and this might be a weak point. The bargeboard facing W is undecorated.

**Recommendation:** redecorate bargeboard

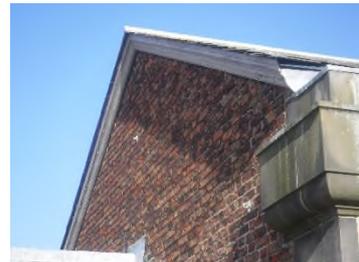
The chancel W facing wall in brickwork with lime pointing, is okay. However, the flashing to the nave roof is in cement. It looks like the returns of the cornice have open joints as they abut the brickwork.

Since last QI the balusters have been repointed, and chancel gutter widened and reflashed. Paint is still wanted on the W bargeboard.

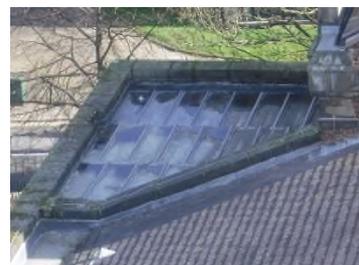
- **Vestry roof:** three bays of leadwork with flat topped coping. This all looks okay.

**Recommendation:** none

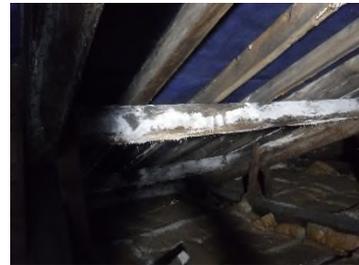
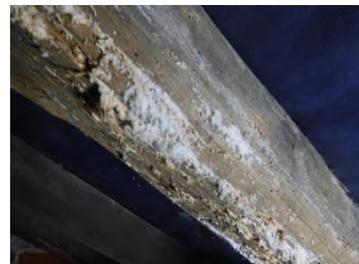
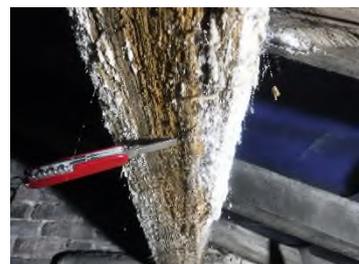
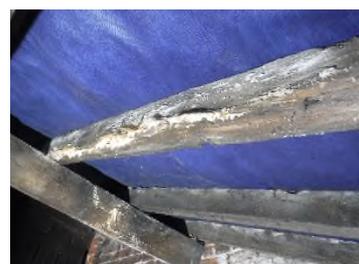
**C** **Nave roof void:**

Salting showing on the rafters, particularly on the Northern side. Also, significantly at a collar across truss number 2 from the doorway, plus number 3 equally is salting and there looks to be some rot to the purlin as well. The condition of the rafters looks dramatic but is a cause of drying out? The third rafter in from the doorway has rot to its underside. This looks like it should be looked at in the future. An assessment is needed of all of the structure here. There is some woodworm to the base of the kingpost trusses, and it is not known whether that is still active (no mention of this in the 2010 QI). The aisles have had insulation placed over them, as have the nave, approximately 200mm thick. The West wall of the tower can be seen here and this has salting to it. The purlins do not go in very much and are bedded on timber in once instance

*and that is crushing slightly. The rafters look to have been packed up in the past and there has been a repair on the S side which looks a bit ham-fisted. There is also a plaster line that shows that this roof has been raised and also the old purlin sockets. The roof has been re-felted with a blue underlay. Ladders to the roof lights give access to the box gutter.*

*There is such a lot of salting of purlins and rafters so it is difficult to understand if these are old leaks just drying out, (which is probably the case). The last QI says that the rafters were cleaned up during the 2008 repairs so this salting is probably the wetness drying out.*

**Recommendation:** procure specialist investigation report on timber condition, check records to see if woodworm treatment has been carried out, repair rotten rafter

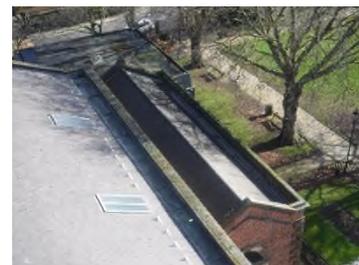
**B** **Lady Chapel:** *The slating seems okay. That leads into lead lined box gutter that on the nave side has a split fall both W and E. The S side, also split fall drains into chutes and hoppers on the S elevation. The copings look okay although there seems to be an open joint on the W facing water table.*

**Recommendation:** repair loose and broken slates

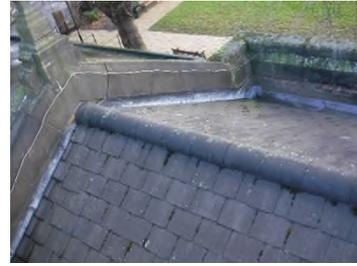
Half round ridge tiles, their joints are ok, the S slope has some damaged slates from when somebody climbed up in the box gutter so there is a few cracked ones, the leadwork looks generally all ok. The abutment flashing to the E is cockling slightly and cracked but of no consequence really, it just looks like it needs some running slate repairs rather than anything else.

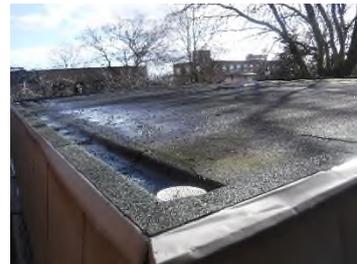
**M Parish Hall:** The flat roof material is coming the end of its life and has been repaired and has about 5 years left.

**Recommendation:** monitor

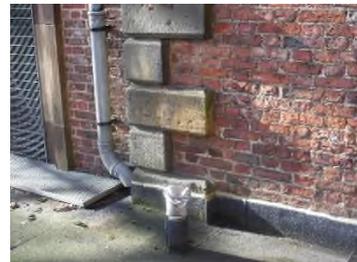
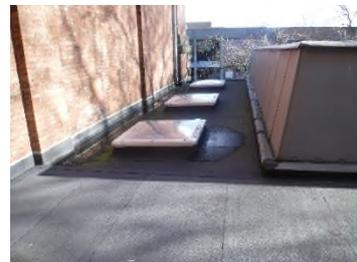
**C Parish Hall Link:** The condition of the lower roof (which is the roof above the hall corridor) was in very poor condition. It was inspected insitu in January 2015. The felt covering had been patched over the years and was failing. Water ingress has caused decay to the boards support the felt. Some were collapsing under foot- particularly at the eastern end. The roof lights were also in poor condition.

The hall extension encloses the SE corner of the church and by doing so, has enclosed a former external nave and aisle walls and the lower part of their pictorial glazing. This has created damp problems within the church. See also Rainwater Goods section for comment on rainwater goods at this location.

The slot space is guarded from leaves by chicken wire screens which did not excluding all leaves.

The flat roof was renewed in 2017 and new rooflights installed. The guarding to the slot space was also improved. Cows have been broken

**Recommendation:** repair cowls

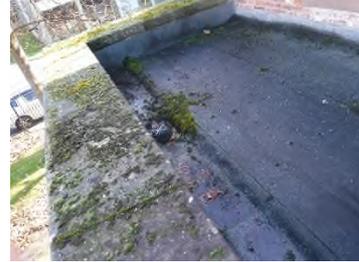
Boiler room: felt roof with blocked parapet gutter causing staining inside. blockage cleared at inspection.

**Recommendation:** keep up routine maintenance. Consider a balloon wire guard to keep away balls and bottles.

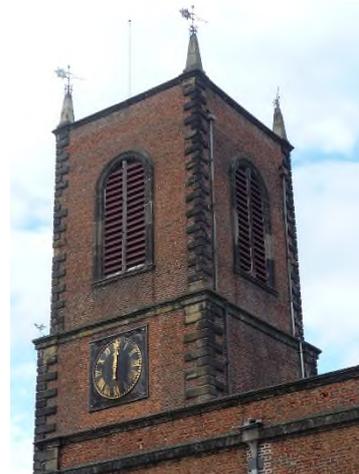
**C** **Tower:** There are two rainwater pipes on the east elevation taking the roof water. Material? Looks like cast iron, the N has a crack at collar at the third length down. S has rust stains at the collar of the hopper, as it does to the downpipe itself in the middle section.

**Recommendation:** redecorate

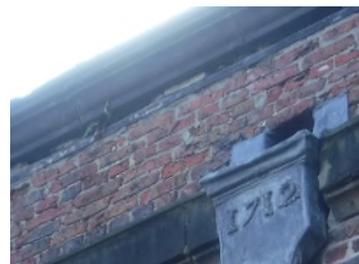
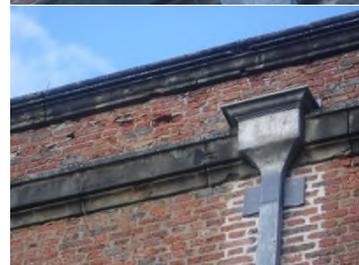
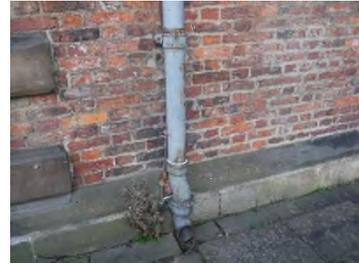
**B** **North aisle:** Both N and S downpipes replaced in cast iron in 2008 leaving the lead hoppers in place. The lead pipe spigots buckled and partially blocked them but were released soon after. The shoes discharge above ground now so that the downpipes can be easily seen if blocked when raining.

The east end downpipe appears ok but its exit on to the Vestry roof couldn't be checked.

**Recommendation:** check E downpipe exit

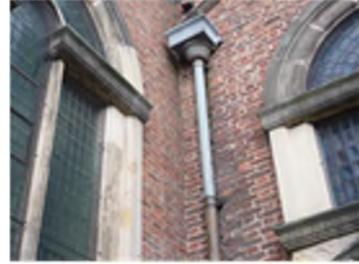
- B** *Lady Chapel: west elevation- Roof discharge is high for the hopper. The downpipe looks to have some staining on it, suggesting the collar is leaking below the hopper, although it is running okay. It could do with being repainted.*

*South elevation- The W downpipe is blocked at the hopper. The pipe itself is rusty. The E end downpipe is working but the collar joints are poor.*

**Recommendation:** *check in rain that the chute discharges into the hopper, repaint downpipe. Unblock downpipe.*

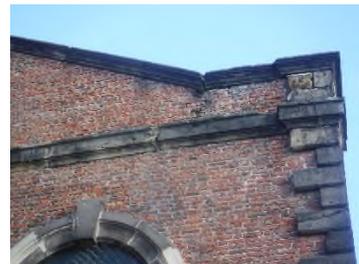
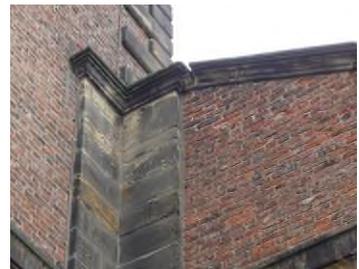
- C** *South Aisle: Open joints at the raking water table and there is a crack at the bottom of the slope, open joints in the brickwork and cracking to the string course. The arch has been repaired and there are still signs of the previous cracking there and the open joints need to be pointed up.*

*The junction between the wall and the window surround has cement mortar coming away on the S. The quoins to the SW corner generally are okay but there are open joints at the very top of the return that needs remaking. There are open joints to the string course as well. Walling is reasonably fair. The window leading looks okay.*

**Recommendation:** *repoint watertable, window frame and repair quoin*

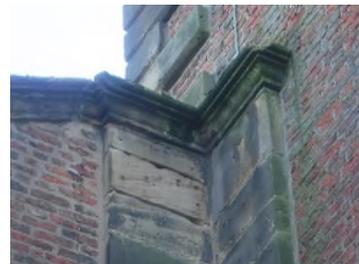
- C** *North Aisle: Open joints on the raking coping. Its foot has been rebuilt. The returning cornice has cracked in the past. Against the tower, the large ashlar block at the top has quite deeply eroded joints. The smaller one below it has eroded significantly.*

*Where a lightning conductor tape has been in the past, it has been pointed badly around and that needs remaking.*

*The upper part of the wall is heavily cemented.*

*There are some areas of erosion to the stonework. Below this, the string course has some open joints. The quoins to*

*the N are eroded at high level. There is some deep erosion to the top part. Those below are okay but as they abut the brickwork there are some gaps to them. The plinth is okay. The S quoins have been commented on at the tower section. There has been a diagonal crack above the window arch, repointed badly in cement. There is also some slight suggestion of brickwork movement to the left of the arch. Part of this brickwork is a penny struck joint, although that is not typical of the whole building as repointing has been carried out and lost the original.*

*The window surrounds against the brickwork are slightly open, and that is bound to be the case at the heads as well. The mullions are eroding at the foot where it joins the cill.*

**Recommendation:** repoint water table, window surrounds, consider stonework repair

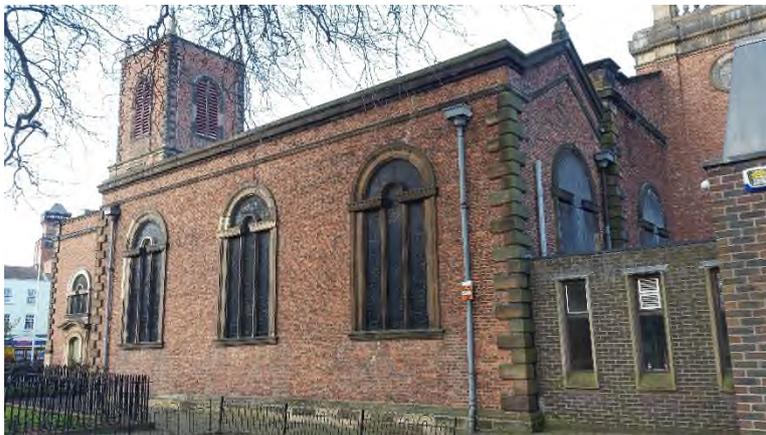
**NORTH ELEVATION**

**C** *Aisle: The cornice has open joints. It is bedded on a lead course and its bedding is coming away in many places. Open joints and some probable movement above the upper brick band more at the W. The string course has open joints. These are perhaps more at the Eastern end. Below the string course, the quoins appear okay apart from some holes in them.*

*The walls generally are in reasonably condition and repointed where the downpipes are in a very hard lime mortar and the contrast is remarkable when the remainder of the walling is looked at. There is some localised brick loss at window surrounds. At low level there is a stone plinth which is generally okay.*

**Recommendation:** repoint open joints, inspect crowns of windows, repoint window surrounds, repair broken glass,

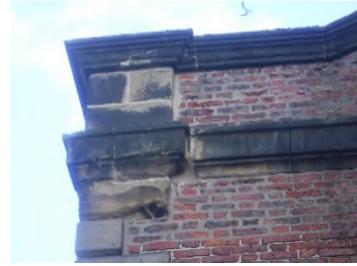
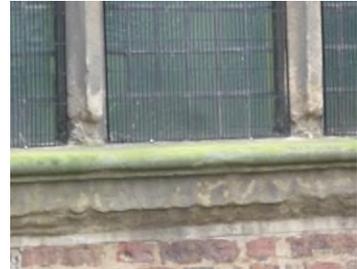
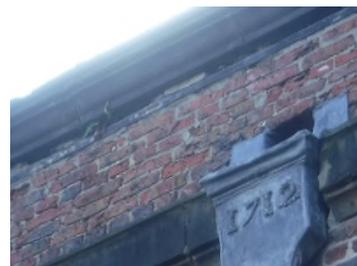
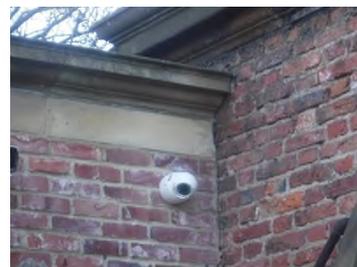
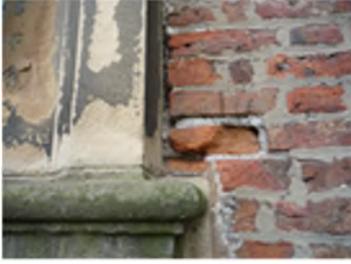
The window surrounds, where they join the brickwork, have loss of pointing revealing gaps at least 6 inches deep and this must be contributing to the damp showing on the inside. The crown of the window surrounds need inspecting for water penetration.

Above the middle arch there is suggestions of cracking, particularly windows 3 and 5.

There is a crack running down above the penultimate W window.

Above the outer lobby, there are three strip lights made up of single glazing with rusty horizontal support bars. The middle has broken glass in it.

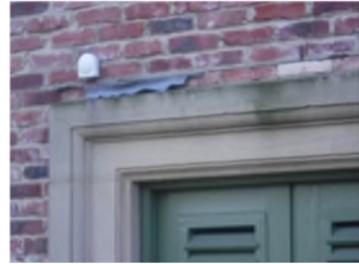
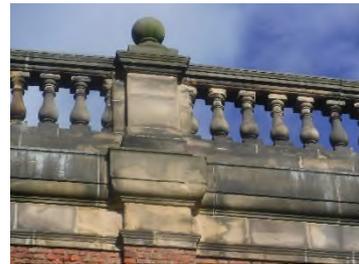
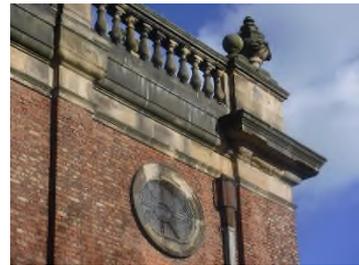
**C** **Chancel:** The balustrade that sits on the wall head has open joints to its coping. There is some erosion to the balusters, noticeably where there are joints. This is leading to them wasting away. The massive pilaster at the NE corner looks sound, although there are some slight open joints above the hopper. The frieze has open joints. A lot of green algae of the surface of the frieze. It is likely that the decay in pointing and material failure is leading to water ingress into the wall head.

The brickwork has been repointed over time. The lower panels are more eroded. It has three clerestory windows, two of which are visible, and these have damp showing on the inside although there is no clear evidence of that on the outside, albeit that there is a diagonal crack in the brickwork, leading down from the hopper. The glass close to the first hopper is broken in four panes. Also, the second has some broken at lower panes.

Balustrade repairs were carried out in 2017.

**Recommendation:** repair oval window stonework, repair glass,

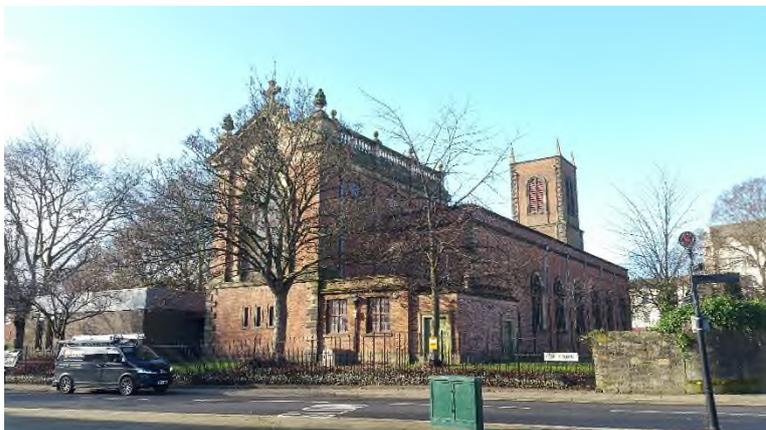
## **EAST ELEVATION**

**C** **North aisle:** *The coping and string course has open joints. The brickwork below appears okay. The NE corner has a horizontal crack in the joint of the two frieze corner quoins suggesting slight structural movement- see cracked brick close by.*

**Recommendation:** *repoint and monitor crack*

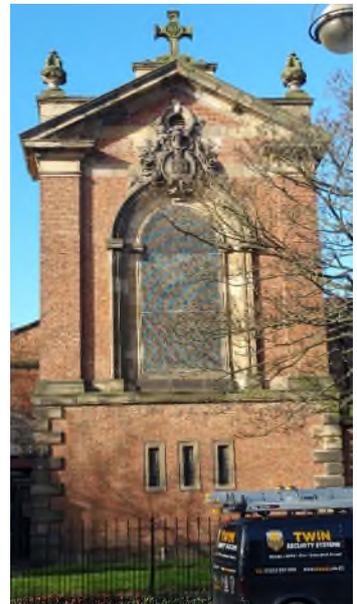
**C** **Chancel:** *Heavily ornamental façade. Formed of a broken pediment with brick pilasters. Above the pilasters are two urns. On their platforms are, open joints where there is water washing through, eroding the moulding underneath it. There are open joints to the raking pediment and a plant growing in a joint. There is also erosion to the bases of the pediment as they sit on top of the pilaster on both sides. To the right of the S pilaster, there is efflorescence on the brickwork and the joints are rather dark so I think that there is probably water ingress there - perhaps gutter flashing failure. This was repaired 2017*

Same as before, there is still some vegetation growing in the apex and that is probably because the joints of the

pediment are leaking, cartouche looks alright as do the window surround and guarding over it.

**Recommendation:** repoint open joints

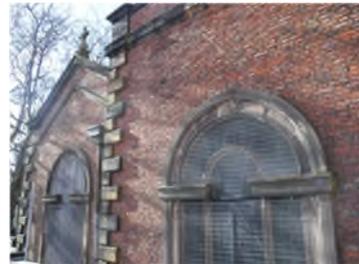
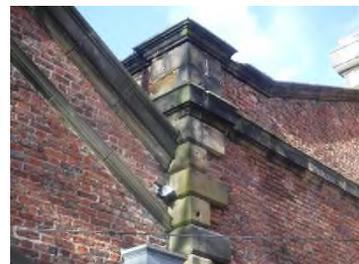
- C** **South aisle:** This elevation is partially obscured by the parish hall. The gable has a raking coping. The water table and brickwork below appears okay. The string course has open joints and a chip out of it. The window surround has open joints on the arch.

**Recommendation:** repoint open joints

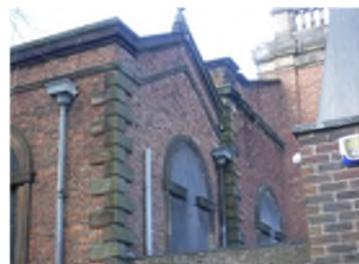
- C** **Lady Chapel:** Raking verge formed from a cornice moulding. There are open joints to it. At its foot, it returns to a corner pilaster. This has open joints and the moulding where the string course is looks as if it has a couple of big open joints in it. The brick panel above the string course, whilst eroded, looks okay. The string course has open joints and these are washing through. The brickwork joints below it are deeply eroded. The arch window looks okay, although there is a sense of a vertical crack above the arch, although it doesn't look structural. There is a cracked brick about three courses up.

Raking parapet ok as is the masonry below it, this is the junction between the aisles, which is the route for intruders who get a step up by standing on the gas vent terminal.

**Recommendation:** repoint open joints, anti climb paint needed

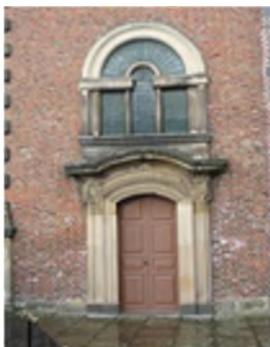
Looks ok. Plant above the segmental head doorway.

**Recommendation:** repoint open joints, remove plant

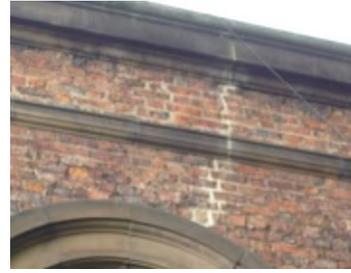
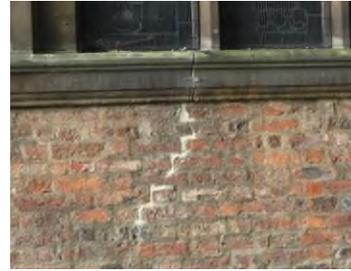
- C** **Lady Chapel (South elevation):** Open joint to the coping. Brickwork panel underneath that okay. Brickwork walling looks alright. There has been some settlement at the Easternmost window, repointed, seems okay. The windows themselves look okay apart from some wasting at the bottom of the mullions and there has been some replacement to them.

The crack that is on the last E window, is running all the way up through the window and the joint can be seen at high level. The open joint at the cill was not repointed.

All ok apart from W window arch slipped slightly.

**Recommendation:** repoint open joint

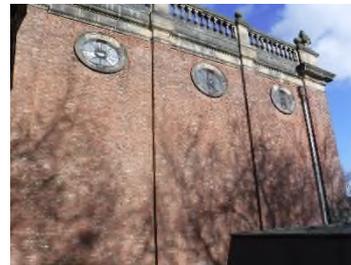
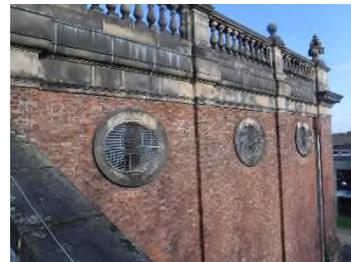
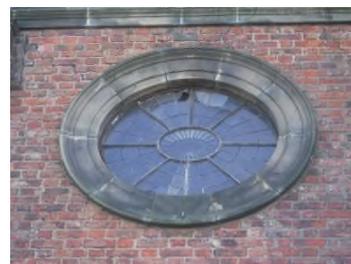
- C** **Chancel:** The balustrade is suffering the same defect as the N side. However, the major worry is the whole of the SE corner at high level at the frieze where there are some open joints just by the hopper. The whole construction is so massive, there might have been some differential settlement at the Eastern end. The stonework frieze has some shaling at the middle pilasters.

The brick panel below it is eroded. The pointing is eroded to the underside of the cornice, although generally it looks sound. The decay in pointing and material failure are leading to suggest a risk of water ingress into the wall head. The balustrade was repaired in 2017.

The three clerestory windows have shaling stonework to their crowns, no doubt because there wasn't any water protection over the top of them. Their guarding is rusty in the centre section. The Easternmost looks most in need, as is the Westernmost, the middle could probably survive.

Some soffit erosion to the returning pediment coming round the corner and the tops of the pilasters, this is also where there was one open vertical joint.

**Recommendation:** repair clerestory window surrounds and glass, replace rusting guarding

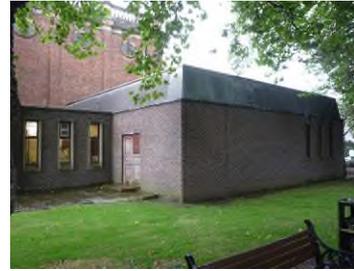
- **Parish Hall – South Elevation**  
**Kitchen:** The brickwork looks okay. It has slot windows in and they seem alright. The lead flashings are intact.

**Recommendation:** none

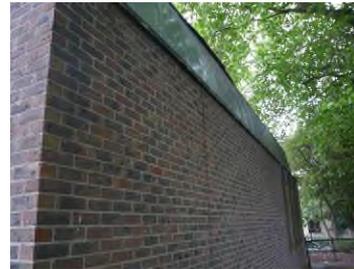
- D **Parish Hall: South Elevation** – some slight uplift to the metal side of the roof – perhaps this is an attempted theft? The walling itself is okay, as are the windows, although they are losing their paint at the cills.

**Recommendation:** redecorate windows

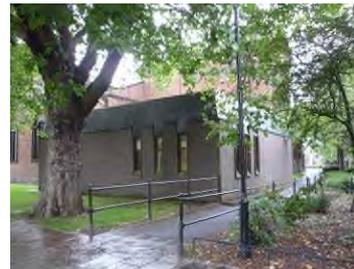
- **Parish Hall: West Elevation** – there are no gutters to this building so it drips off the eaves and runs down the wall, although there is no real problem to that. The area in front of it is a soil area and that is unplanted and not up to much.

**Recommendation:** none

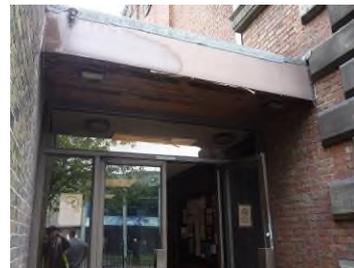
- **Parish Hall: North Elevation** – looking a bit green on the brickwork, generally alright. The entrance elevation has been updated as part of the 2017 works.

**Recommendation:** none

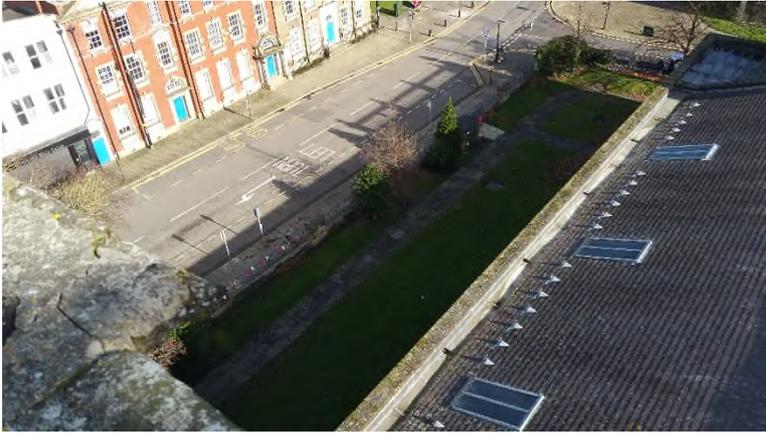
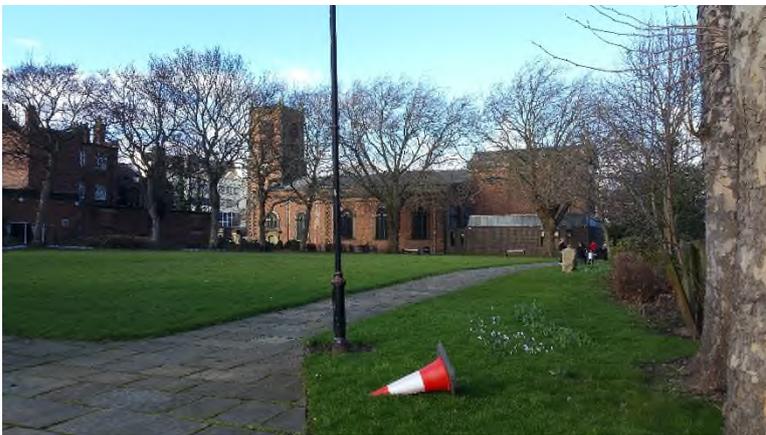
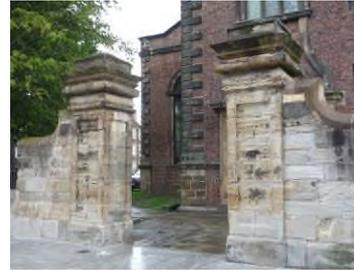
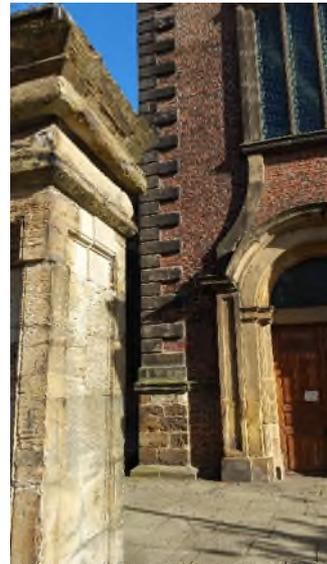
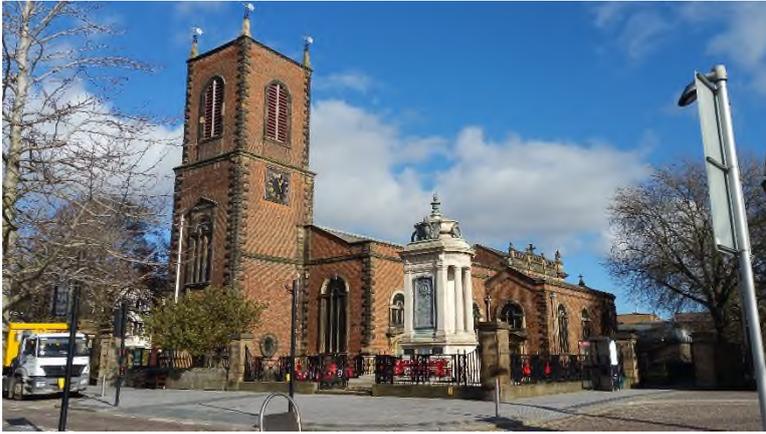
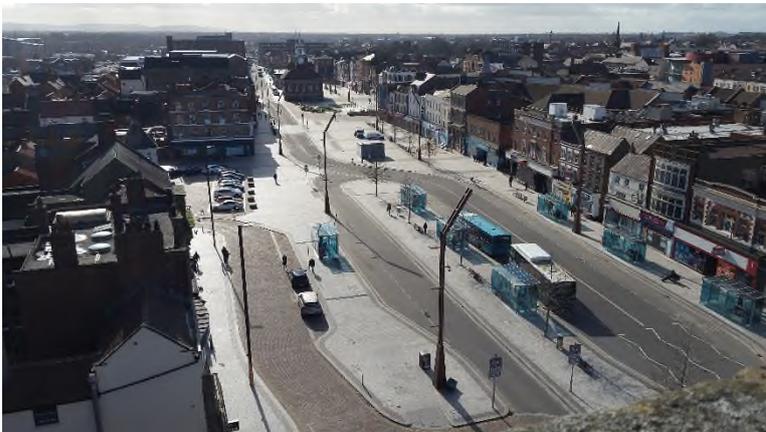
**M** *Externals:* It is a closed churchyard in the care of the Local Authority. There are few memorials left on the site and those that remain are in fair condition.

*There are mature trees to the W, E and S and these are understood to be reasonably regularly maintained, although the E are now beginning to scrape the side of the walls. Those that are at the S are close to the Parish Hall and could be affecting the stability of the corner, although there is no real evidence of that externally only the plaster cracking inside. The site has flagstone paving which undulates rather on the E side and has open joints. To the S of the site, there are gravestones that are stacked and this probably forms a small area of focus. It would be worth knowing if these are stable. Some are leaning.*

*The remaining areas are grass and this is kept up to date. The site is bounded by stone walls with metal railings. These are kept generally in good condition. The gate piers to the West are eroded but reasonably okay.*

**Recommendation:** monitor corner of hall, ask LA to test the leaning headstones

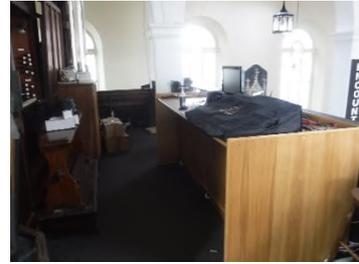
- Floor – ok
- Stair- The balustrades on the N and S are flimsy and have been retro supported in the past. One of the newels is lost its cap.
- The organ case is large and elementary, and the pipes have been covered in aluminium foil.
- AV desk has been introduced.

**Recommendation:** replace newel cap

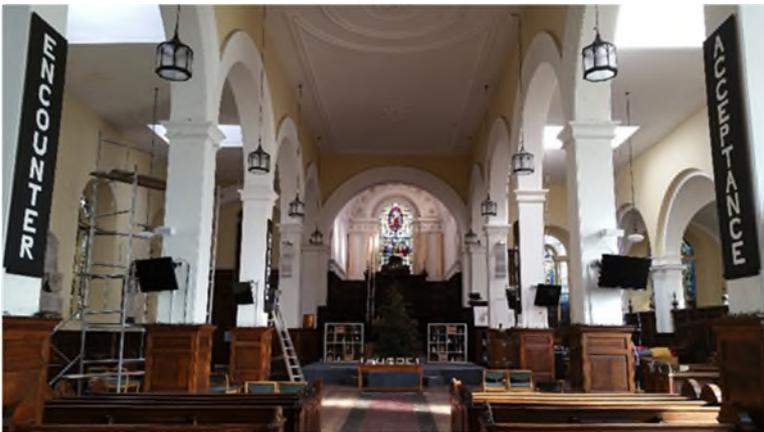
. Formed from arcades of six arches, that are structurally sound.

- Ceiling – flat, plastered and painted. Apart from a couple of small areas of missing and flaking paint, it is in very good condition. The aisle ceilings are fair, though there are some areas of loss of decoration. There is also a large water stain on the S aisle but it is not obvious from within the roof space what has caused this.

The furniture is all a bit of a jumble at the moment as they are resetting themselves, a lot of the pews are out of the middle now, these have probably found their way into the lady chapel, so the interior is a bit disjointed, it has now got a drop down screen, new speakers and repeater t.v.s. the speakers are on heavy brackets.

The flooring is ok, the occasional loose herringbone and crack to the solid circulation and some of the heating grilles are lifting slightly.

**Recommendation:** *repair loose flooring and grilles*

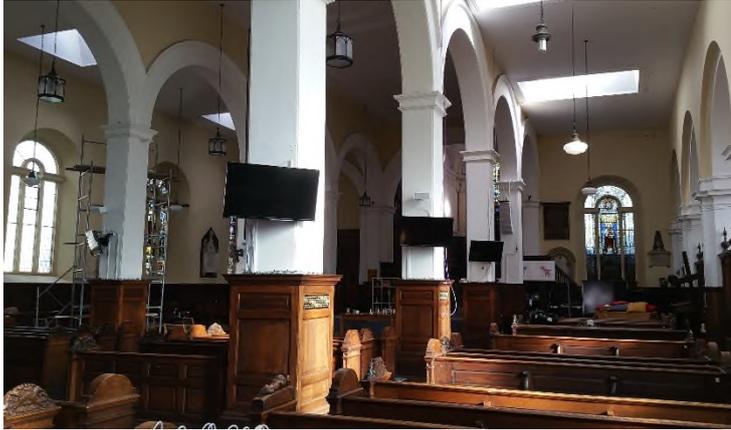
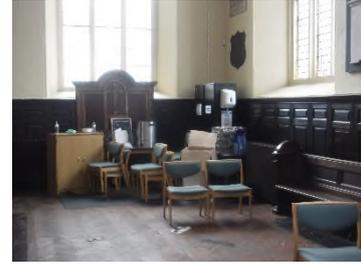
## North Aisle Walls

**North-** water ingress at the bottom of the window reveals there's no obvious clue to this internally, but externally, the pointing around the window surrounds is breaking down. They have had some patch painting over the years, with slight hairline cracking but nothing significant.

**Recommendation:** *repair damp plaster, fill in cracks to walls and redecorate, fix loose floor blocks and set heating grilles level, repair doors, restore monument pinnacle,*

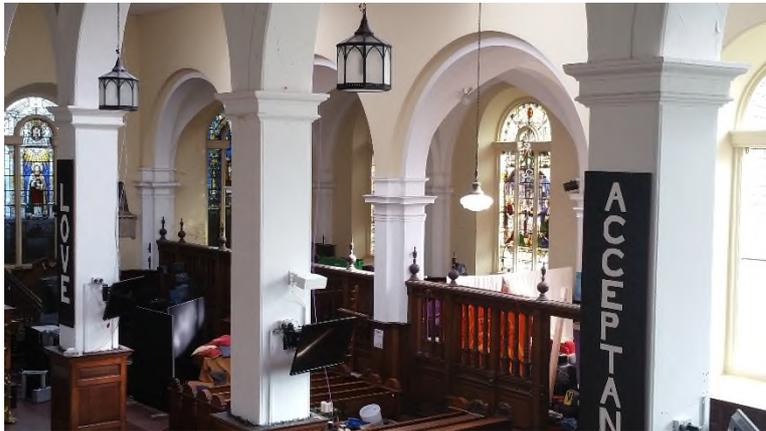
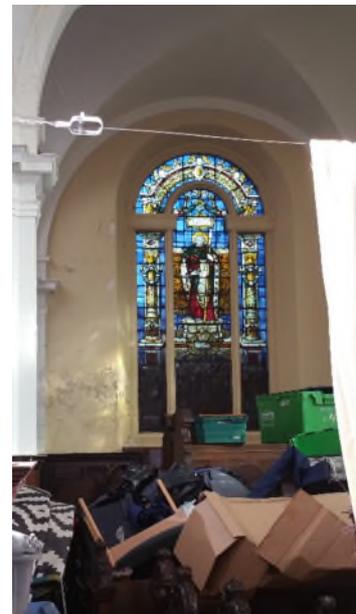
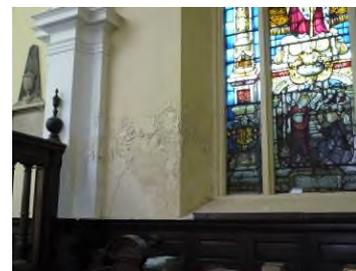
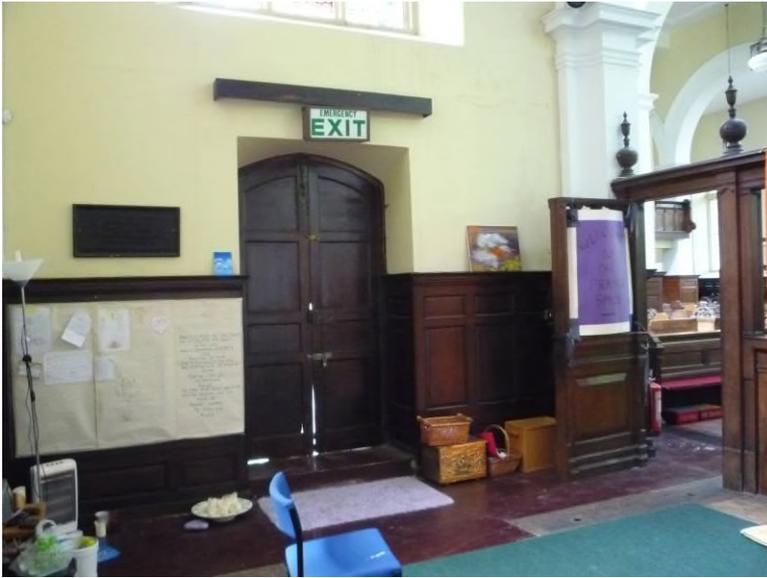
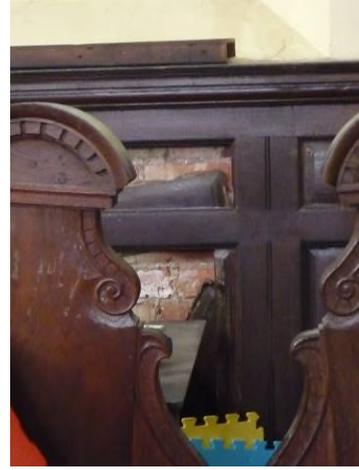
**D Lady Chapel:**

- *Ceiling – The ceiling is formed by vaulting. Okay.*
- *Walls - The walls are as the north aisle with large windows within them. There is cracking to the heads of these maybe as a consequence of the rusting support metalwork that holds the Palladian arch lintel design together. Investigate further.*
- *the east end is a major area of damp, showing at the position of the wall level, which is likely to be a historic problem of the hall corridor flat roof connection between the wcs. It is impossible to look behind the panelling, but brickwork can be seen at a broken panel. It might be more feasible to look behind the wc partitions.*
- *Floor – continuation of the nave flooring- ok*

**Recommendation:** tidy up pews and repair panelling

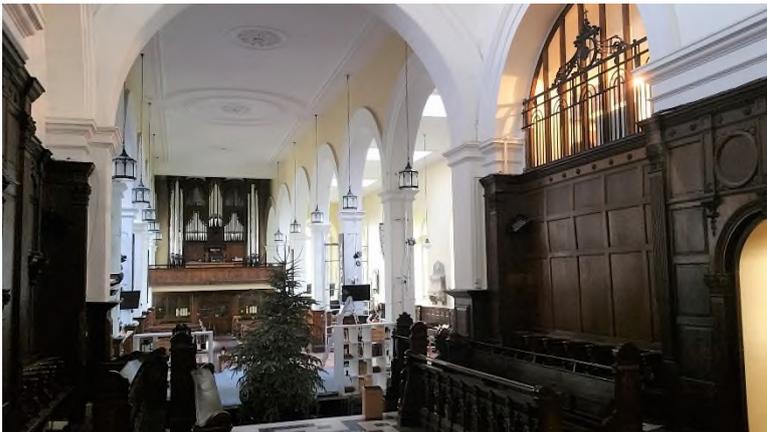
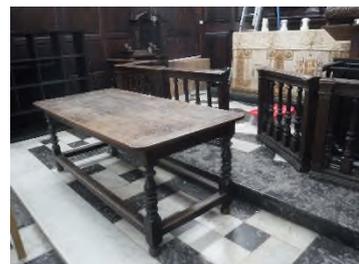
**Chancel:**

**South and East** – both suffering from high level water penetration at the top arches of the clerestory windows. Also the east wall behind the reredos and above the flower vestry passage. The reredos itself is okay though there are a couple of cracked panels behind the altar.

**North** – The lower panelled walls are in heavy Jacobean style. It is buckling at the arcade archway to the vestry room above the choir seats and is coming apart by the rear lobby doorway and there are other similar cracking panels, more on the southern side.

*cracks to it, with a chip out at the northern side. One of the floorboards missing on the South side.*

Still suffering from deterioration to the paint finish at the E end, little worse on the N. We know that the oval windows are pretty poor form the outside. There is a drop down projector screen above the arch. The room contains antique furniture, and the floor is pretty much as it was before but with the odd crack but nothing problematic. The S side elliptical windows the E most has no secondary polycarbonate and on the S side it is the E most that does have polycarbonate and there is a mixture of mesh on the S side as well, so it is a right old confusion of bits.

***Recommendation:*** *repair to the clerestory windows (described in the outside section of the report), redecorate, joinery repairs to panelling and pews*

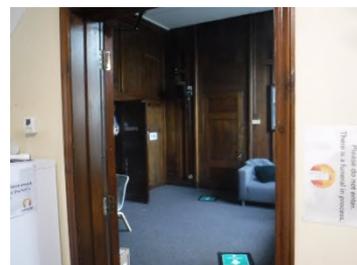
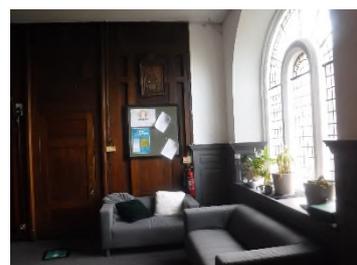
### **Vestry:**

This is fitted with cupboarding and been made into an informal sitting room space now, it was the former vestry. The door operation is a bit stiff. new lighting,all looks ok.

**Recommendation:** ease door

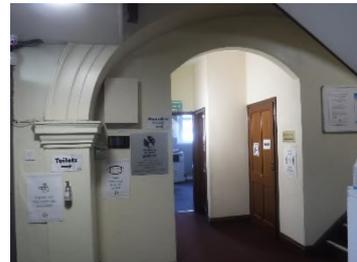
**D Outer lobby: entrance lobby**

- Ceiling – the plaster ceiling and walls decoration is good
- Walls – The timber panelling has been redecorated It also contains the fire panel and distribution board.
- The door has a magnetic lock on it and it slams into the opening.
- Floor- ok

**Recommendation:** ease door closer

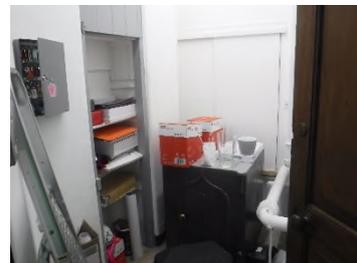
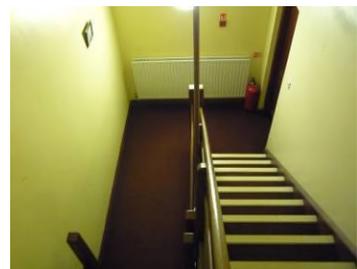
- D Youth Room:** This is a former office, now another sitting room, no ventilation here apart from a mechanical extract not sure if there is one upstairs. This room overlooks the chancel. Door has security bolts on, is that advisable? Slight creak on the stairs as you go down at the first landing.

**Recommendation:** improve ventilation,

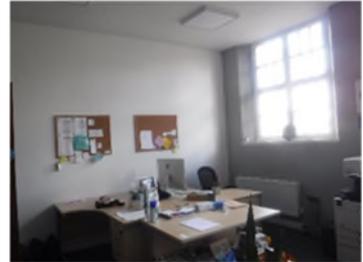
- D Office:**  
This is a former meeting room been decorated out and has four workstations all seems ok. There is no natural ventilation I think and the windows have top opening hoppers and these could do with being operable.

**Recommendation:** improve natural ventilation

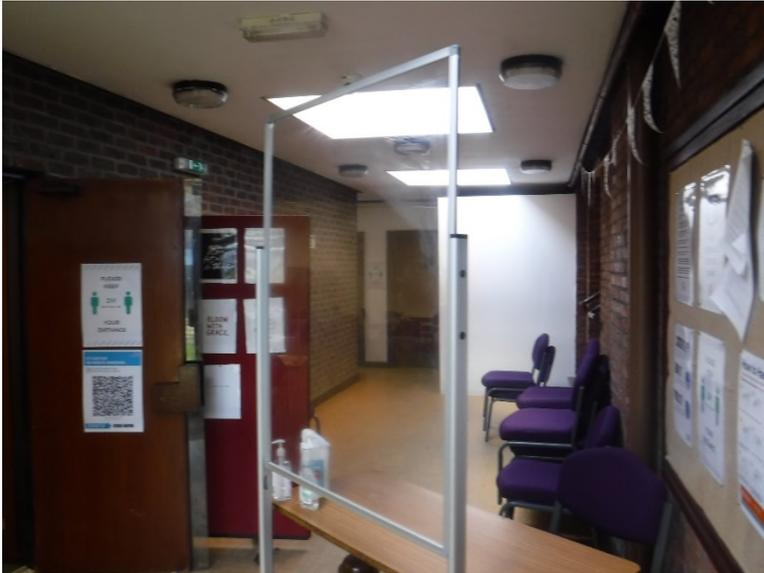
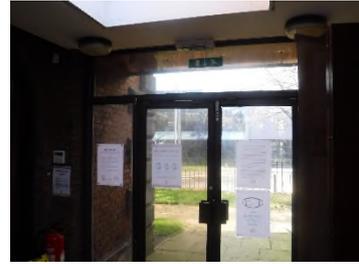
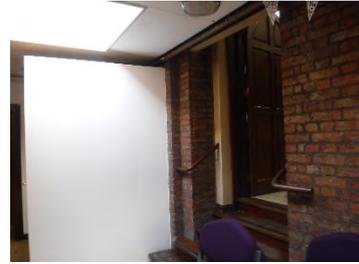
**Hall Lobby**

- Ceiling –rooftlights replaced 2017
- Walls – brickwork to the new hall, and to the church building in its original style (?) of penny struck joints, though in hard cement, repointed perhaps, when they created the hall.
- surface mount large diameter heating pipe not very neatly finished as it goes into the office.
- Floor- Floor in basket weave tiles which are cracked at reentrant corners due to screed or slab shrinkage.

**Recommendation:** repair broken floor tiles,

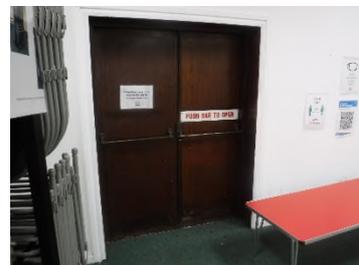
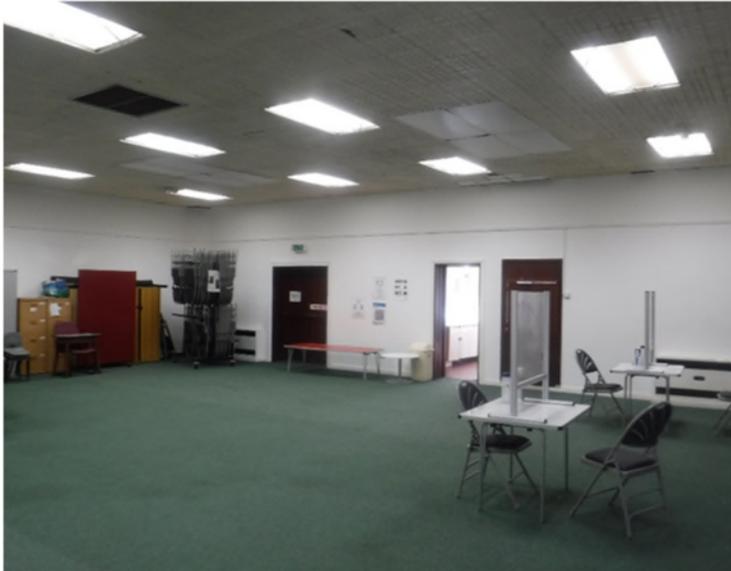
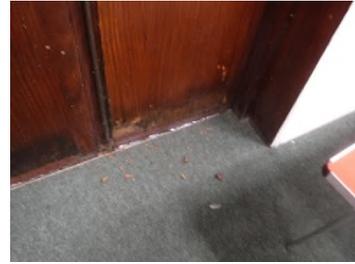
- Ceiling – suspended tile, with recessed lights.
- Walls – plaster walls with cracking to the Western side. At mostly the south-west corner with vertical cracks above the picture rail appears to be where the boarding is.
- Floor- Solid floor, carpeted some stains to it now, timber stage at the south-west corner and what looks to be a small flue or vertical space.
- windows are timber framed, single glazed with louvres above them-fairly okay
- heating by a couple of ideal standard convector rads

- *miscellaneous furniture in the room which looks dated.*

**Recommendation:** *update decorations when funds allow*

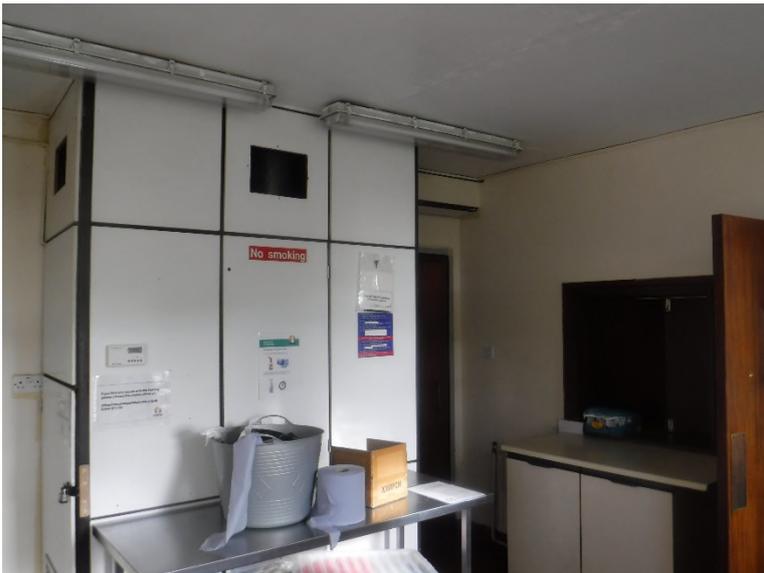
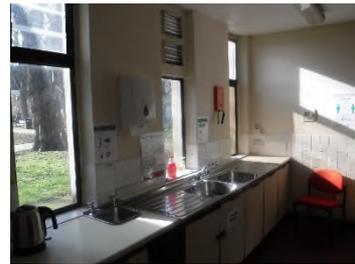
**Kitchen:** *basic fitted out kitchen*

- *Ceiling – plaster*
- *Walls – plaster*
- *Floor- quarry tiled floor with loose tiles in them. Cracking at the tiled cill doorway to the hall.*
- *There is a drainage manhole here*

**Recommendation:** *repair cracked floor tiles*

<b>D</b>	<b>Parish Hall: South Elevation</b> redecorate windows	<b>500</b>
<b>D</b>	<b>Gallery:</b> replace newel cap	<b>75</b>
<b>D</b>	<b>North Aisle Walls:</b> repair damp plaster, fill in cracks to walls and redecorate, fix loose floor blocks and set heating grilles level, repair doors, restore monument pinnacle,	<b>2,500</b>
<b>D</b>	<b>Lady Chapel:</b> tidy up pews and repair panelling	<b>2,500</b>
<b>D</b>	<b>Vestry:</b> ease door	<b>75</b>
<b>D</b>	<b>Outer lobby:</b> entrance lobby: ease door closer	<b>25</b>
<b>D</b>	<b>Upper Room:</b> improve ventilation,	<b>500</b>
<b>D</b>	<b>Youth Room:</b> improve natural ventilation	<b>250</b>
<b>D</b>	<b>WC:</b> unisex. check room for repairs	-
<b>D</b>	<b>Disabled WC:</b> ease door	-
<b>D</b>	<b>Hall:</b> update decorations when funds allow	<b>5,000</b>
<b>D</b>	<b>Kitchen:</b> repair cracked floor tiles	<b>250</b>

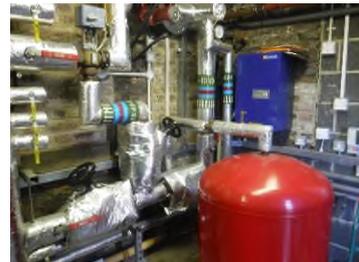
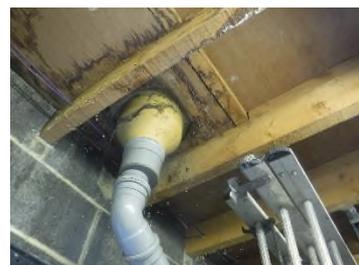
- **Boiler house:** water staining at rainwater outlet. Gully above was blocked and cleared at time of inspection. Slight movement of structure away from the church due to differential settlement. No problem presently.

**Recommendation:** none
