# **QUINQUENNIAL INSPECTION REPORT**

## **STOCKTON PARISH CHURCH**

**QUINQUENNIAL INSPECTION AND REPORT  
February 2022**

**David Beaumont BA (Hons) Grad Dip, RIBA, AABC**

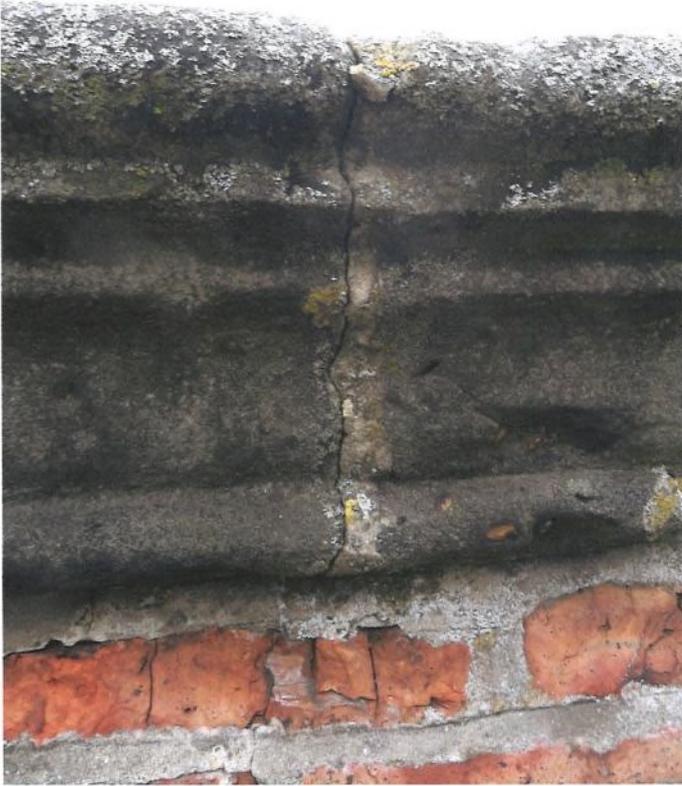
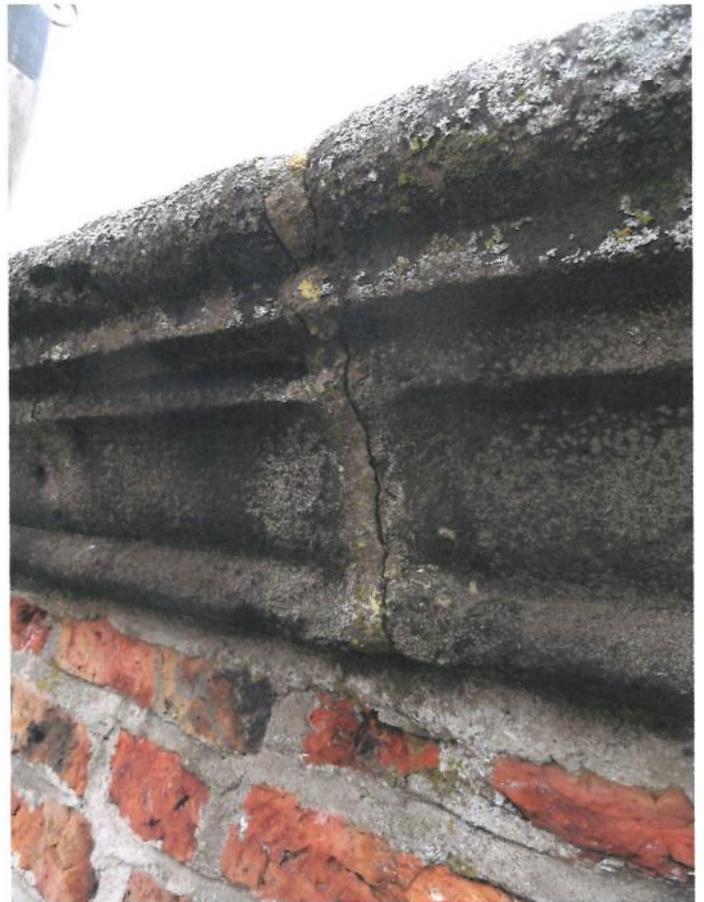
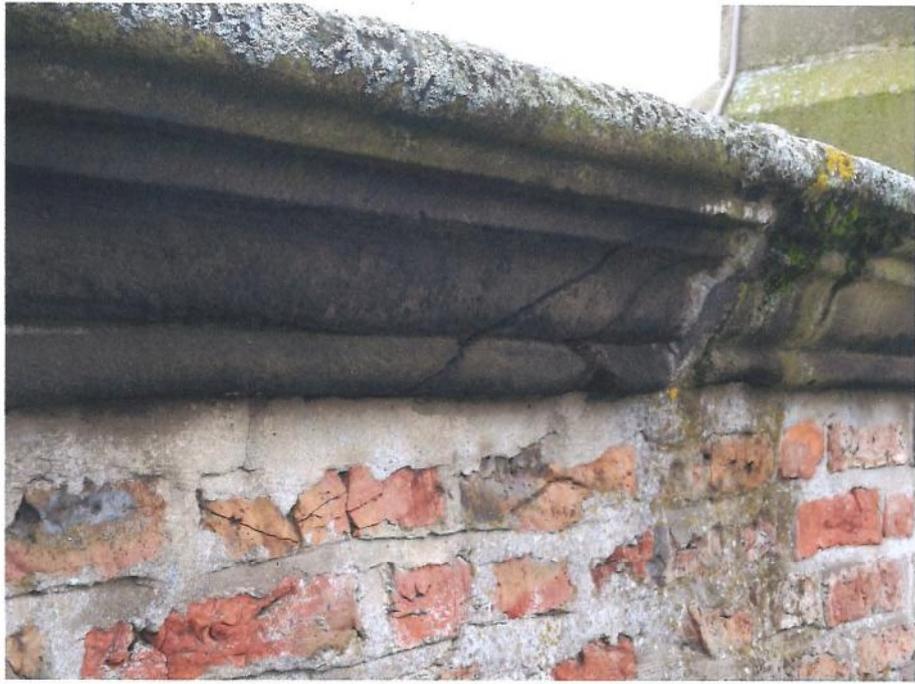
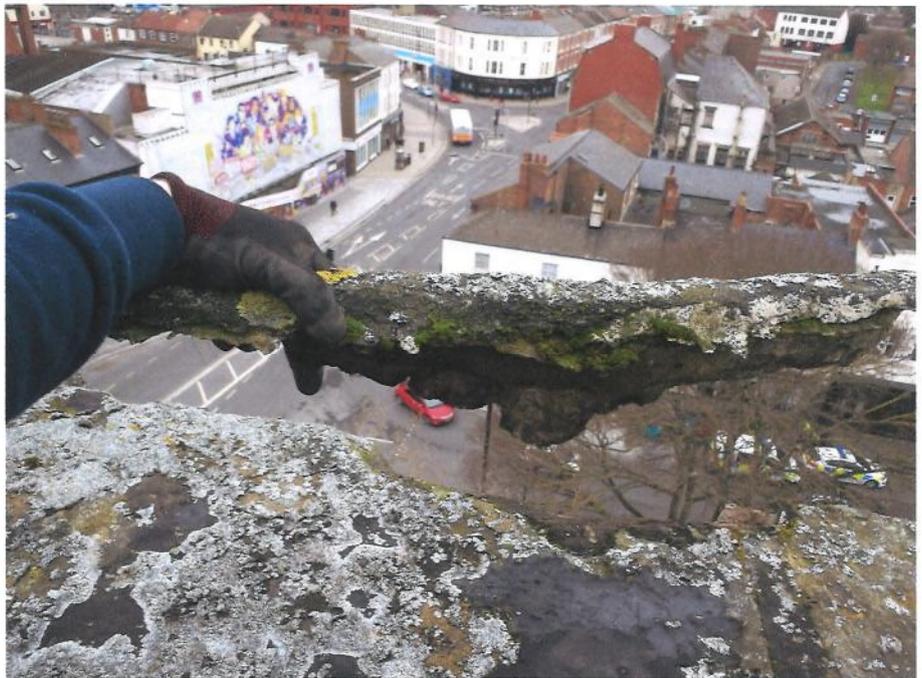
- 1.1 Top stones appear secure, however most joints are cracking. 1No stone has 2 large cracks.
- 1.2 Several corroded bricks are evident in the area between the top stones and the top of the louvre arch, the mortar in this area is also failing.

Examples of top stones of tower.

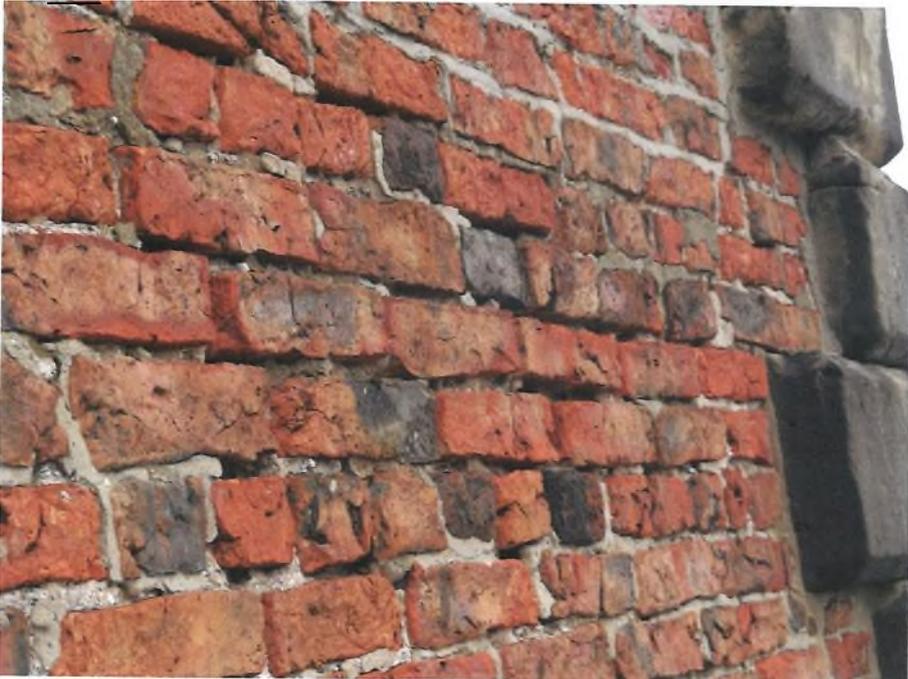
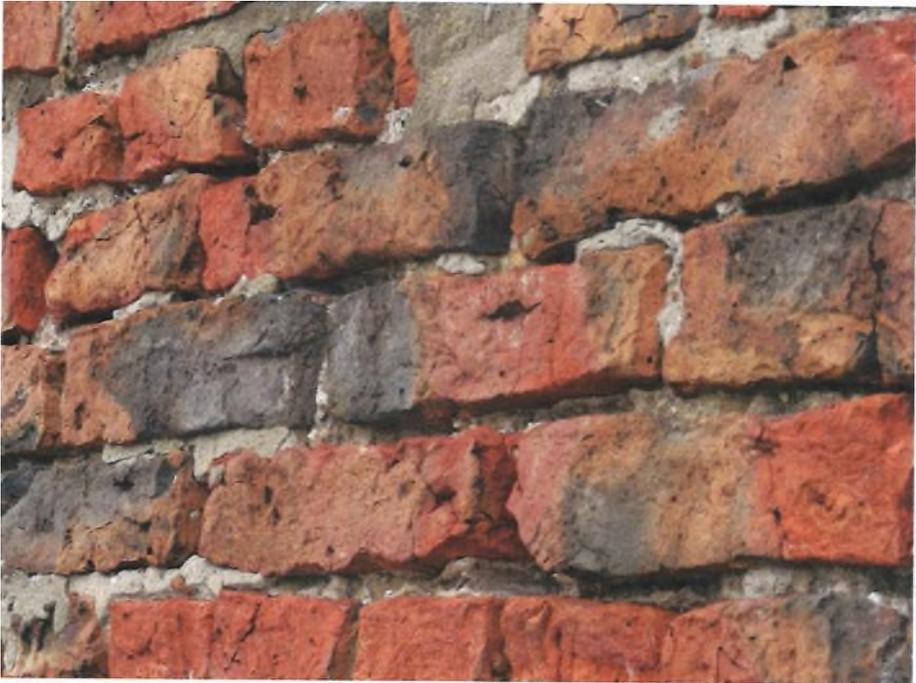
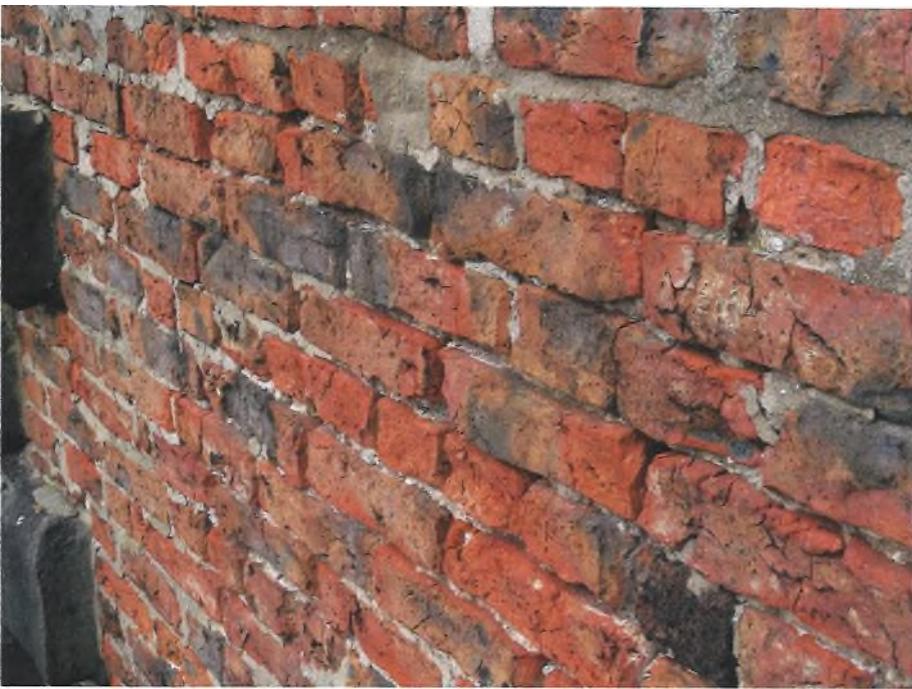
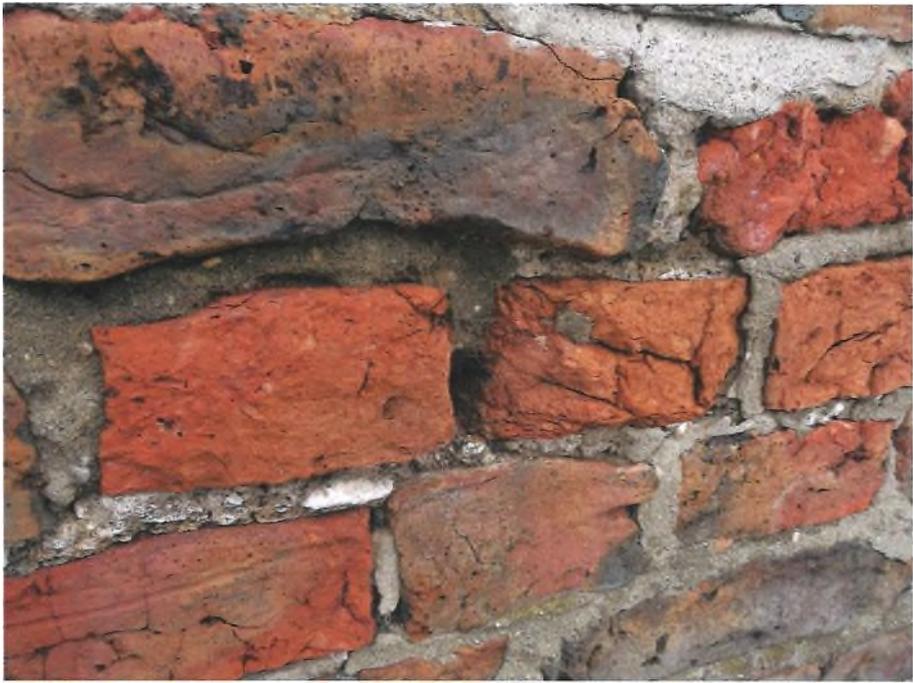
- 1.8 The brickwork around the louvres has some failed mortar joints.
- 1.9 Vegetation evident on the stringcourse and most joints are failing

Examples of brickwork.

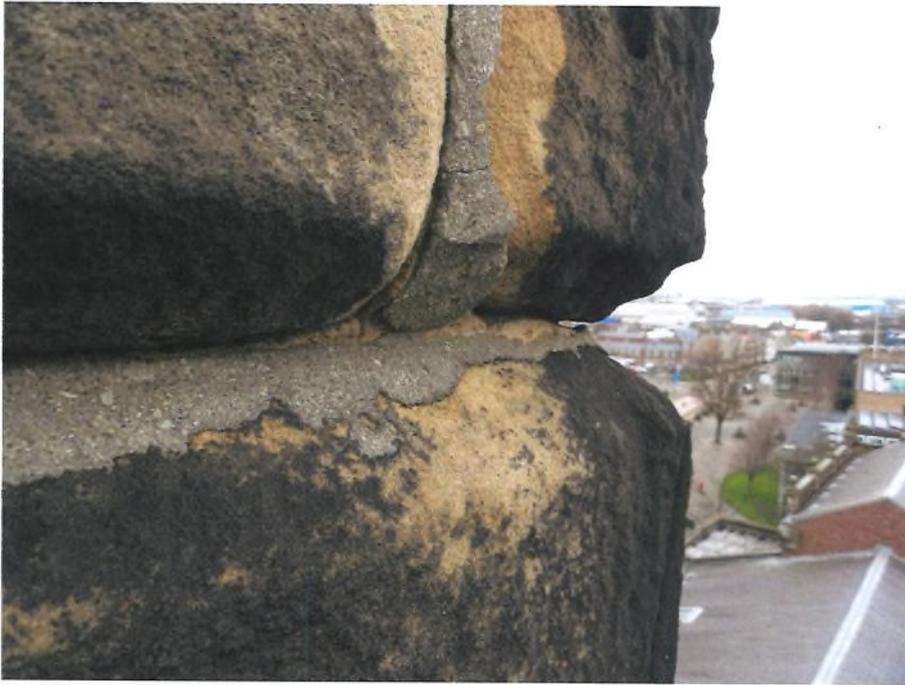
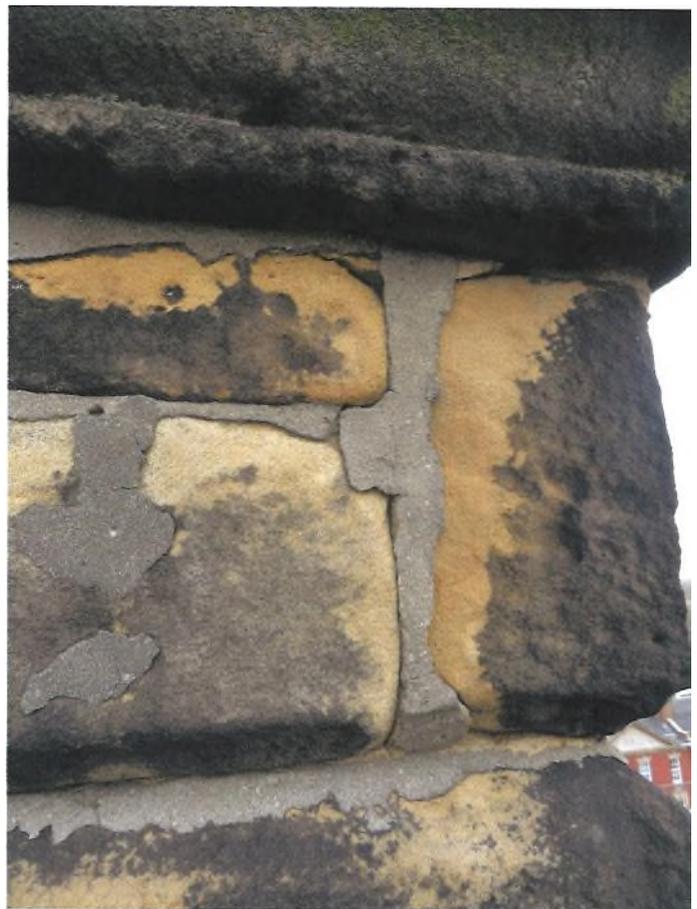
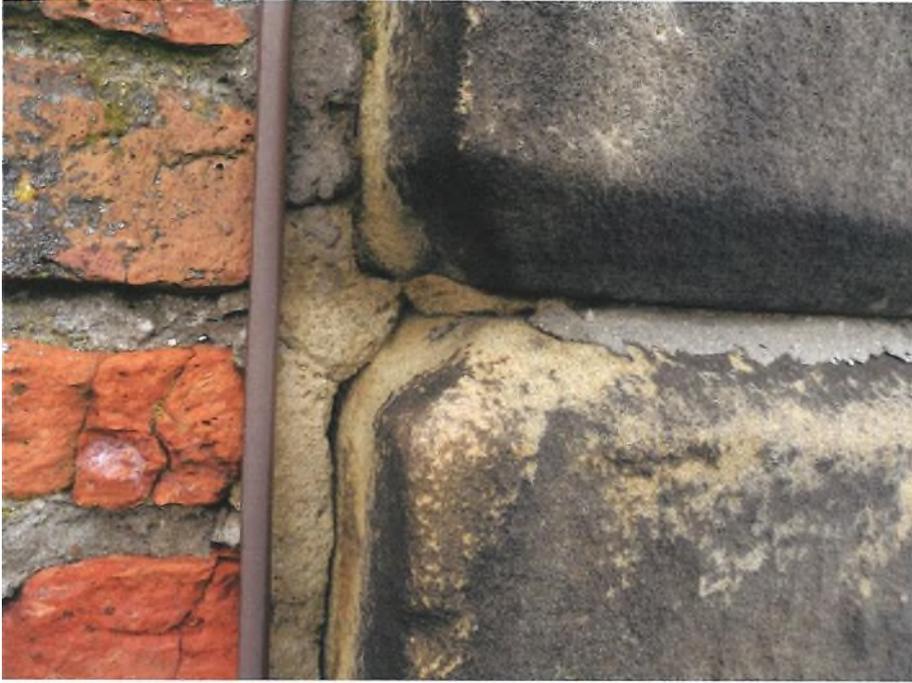
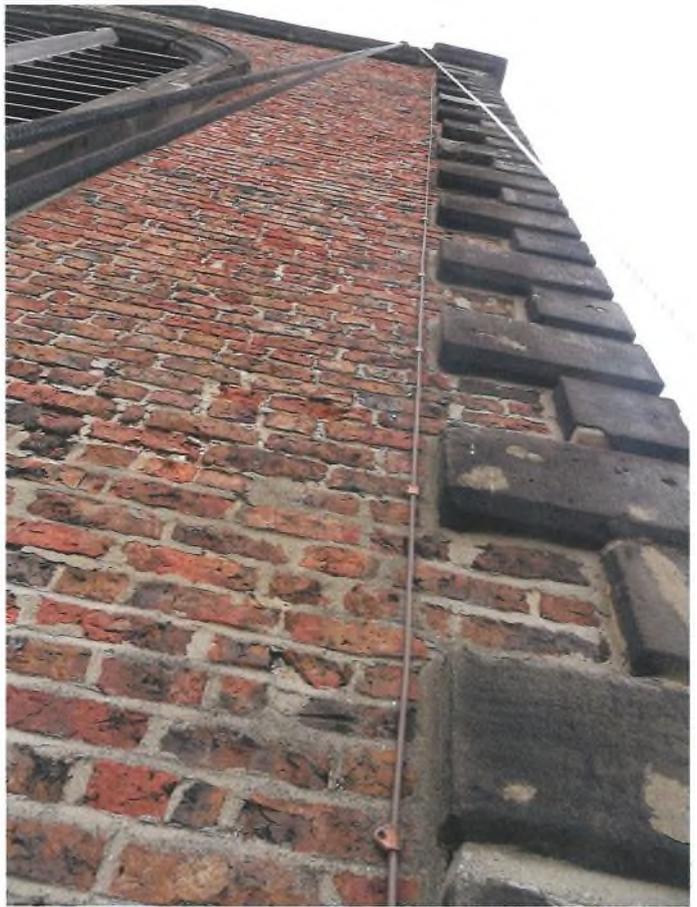
Examples of corner stonework

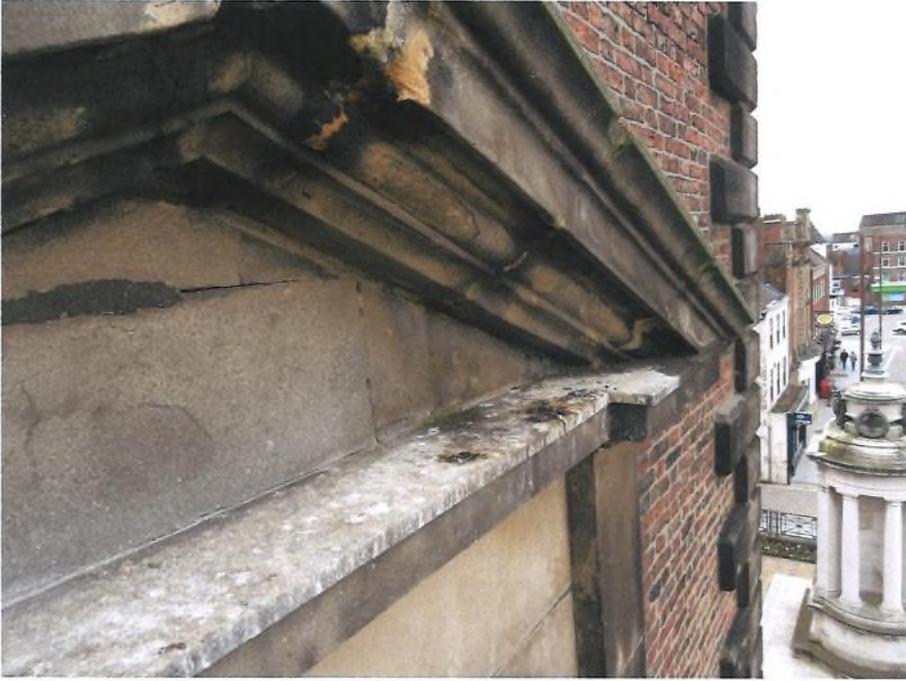
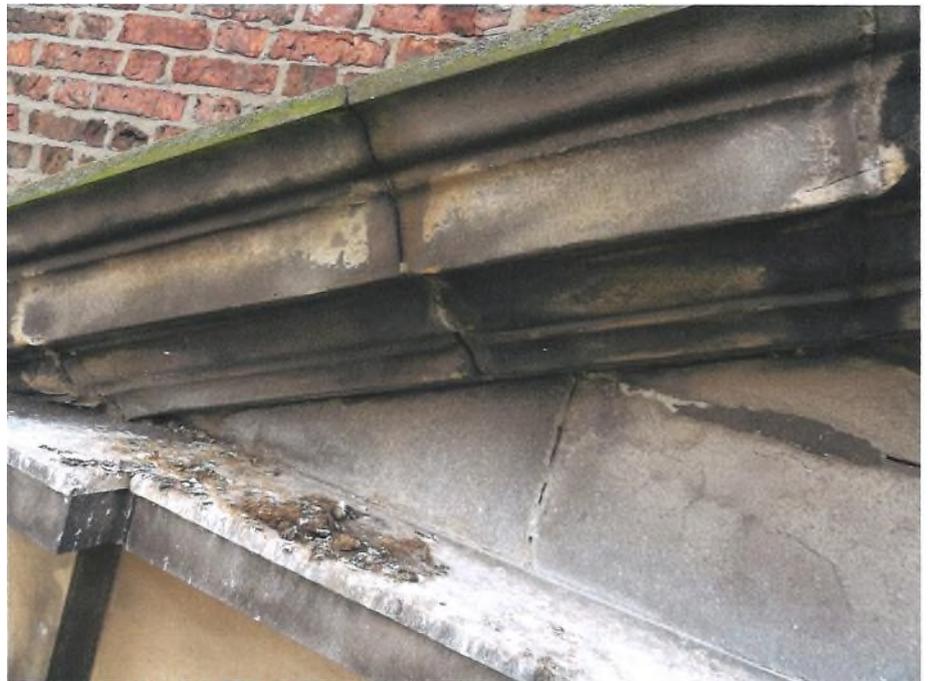
- 1.10 The brickwork on the left hand side between the stringcourses is severely weathered and most mortar joints are failing.
- 1.11 The window near to ground level has failed mortar joints.

Examples of window and surrounding stonework.

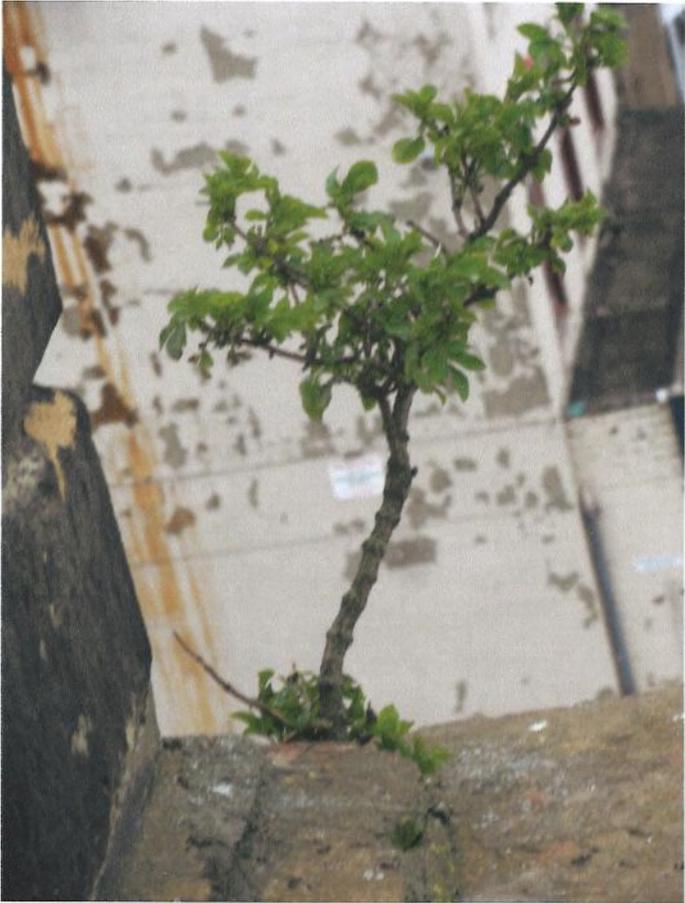
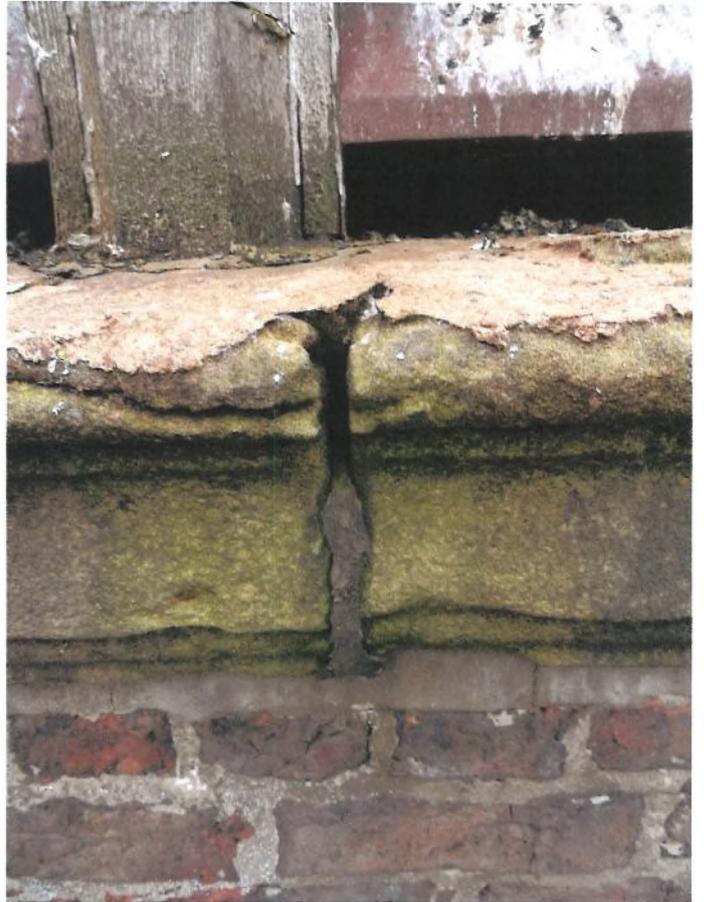
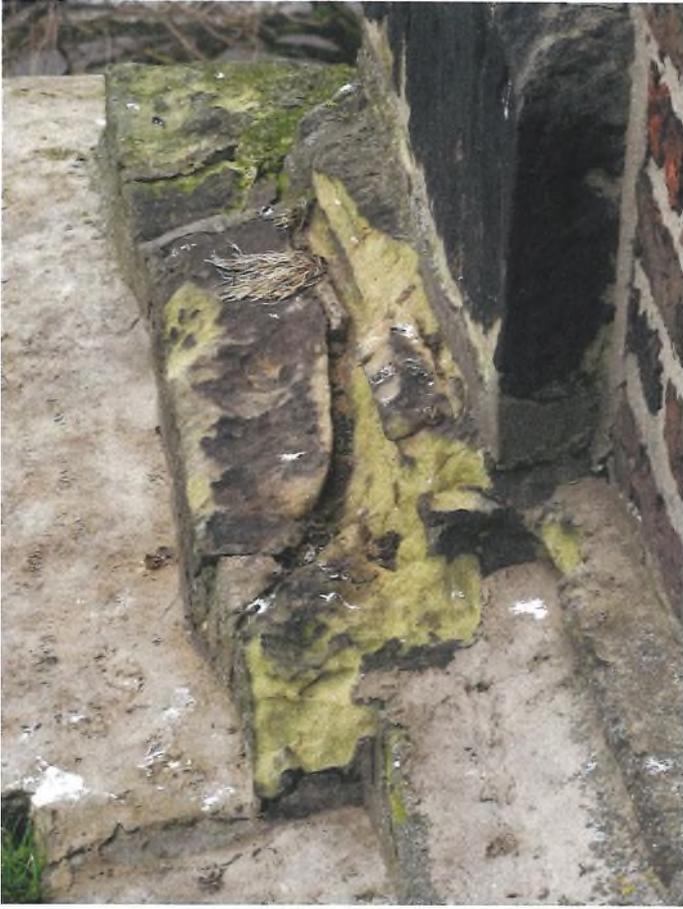
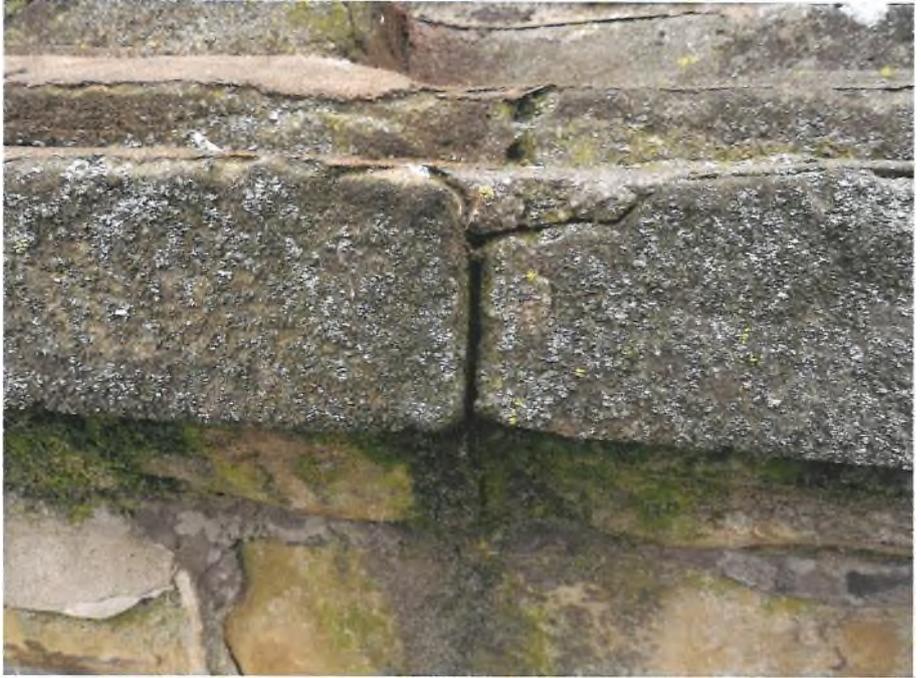
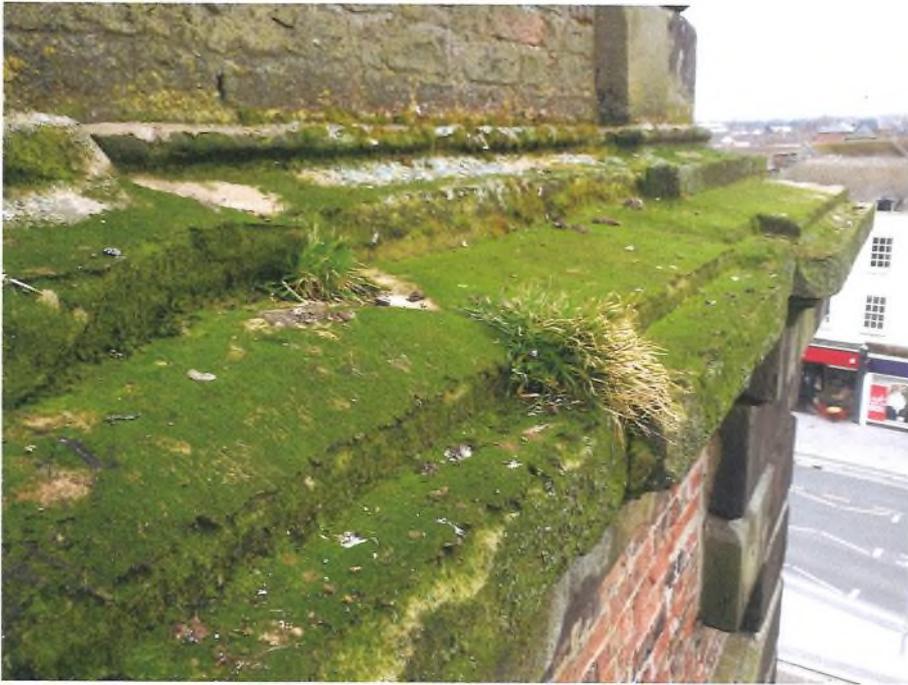
Examples of vegetation and stringcourses

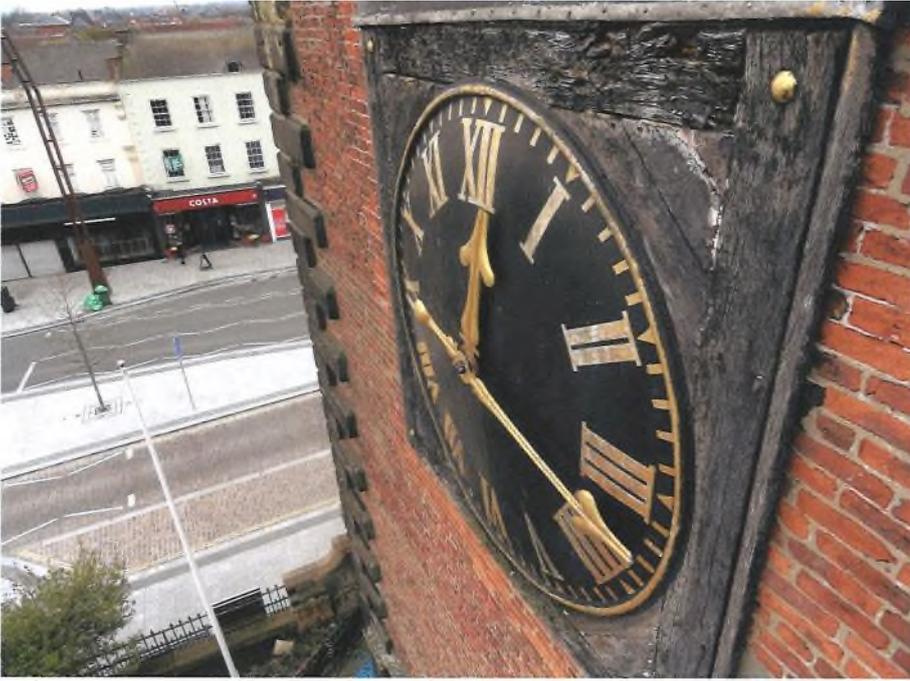
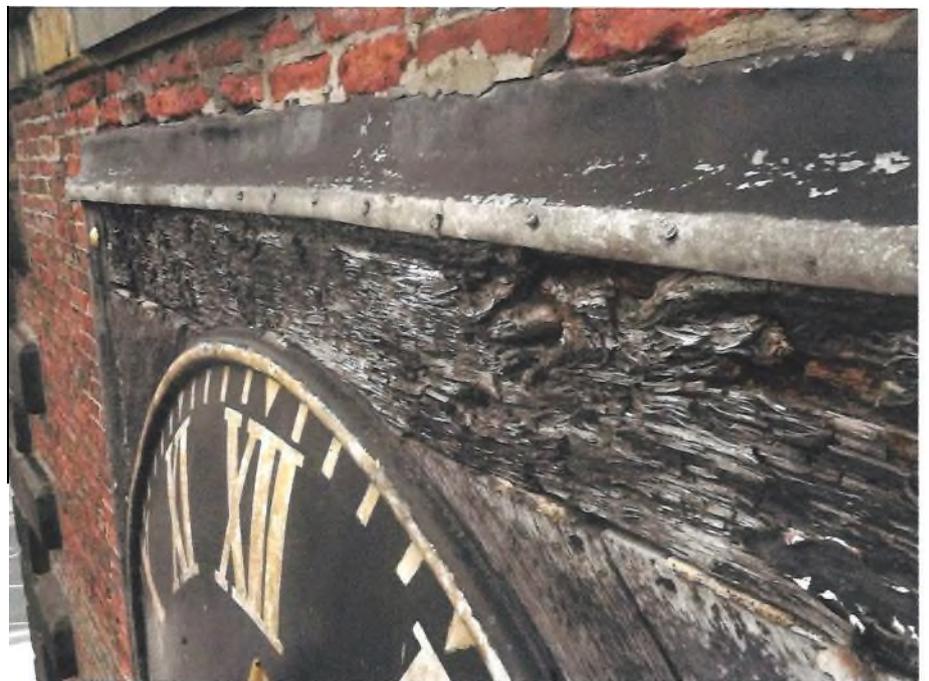
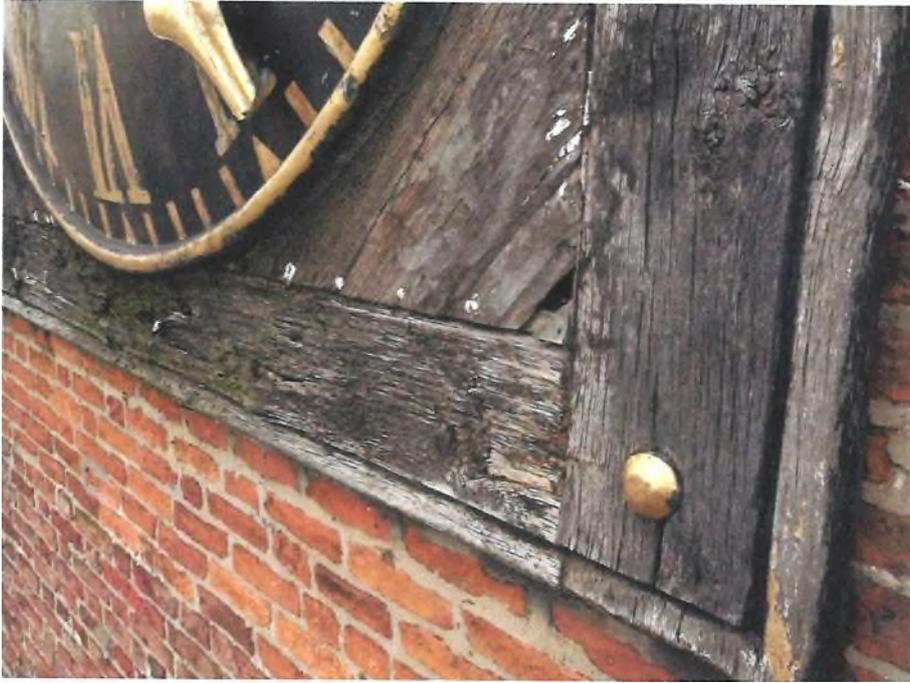
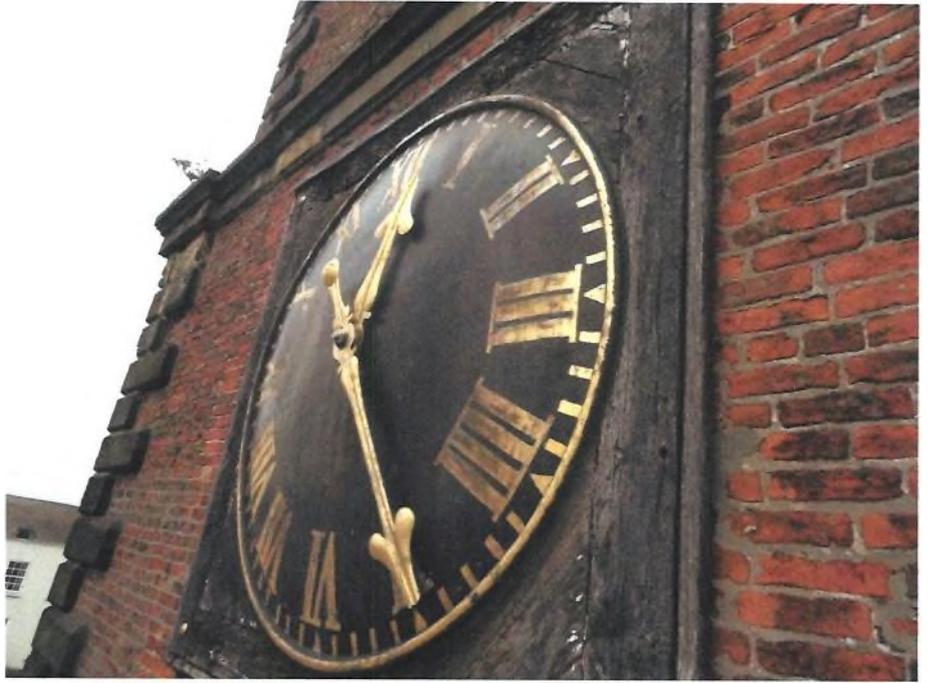
Examples of the clock.

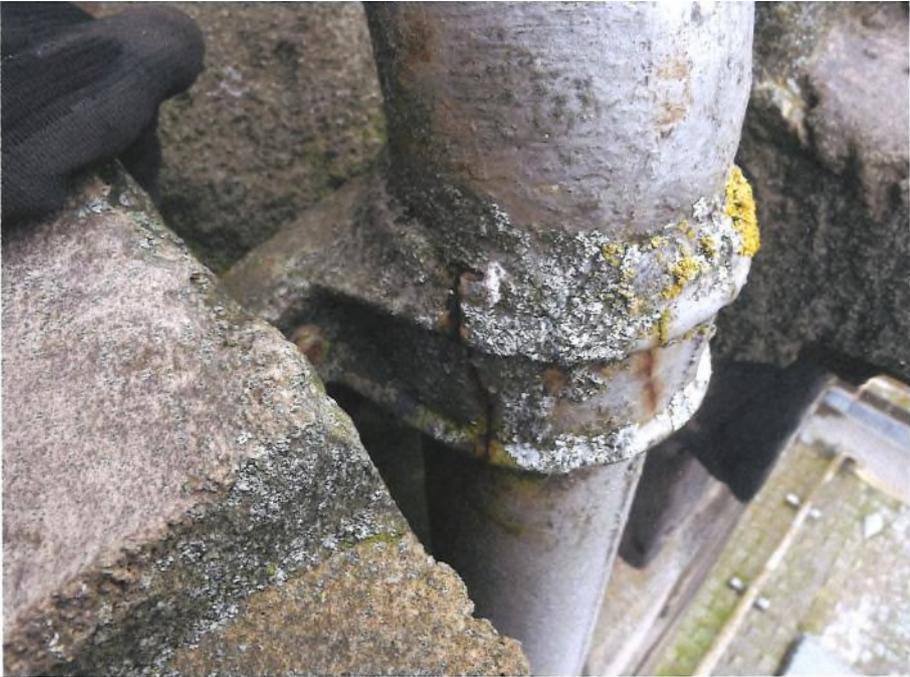
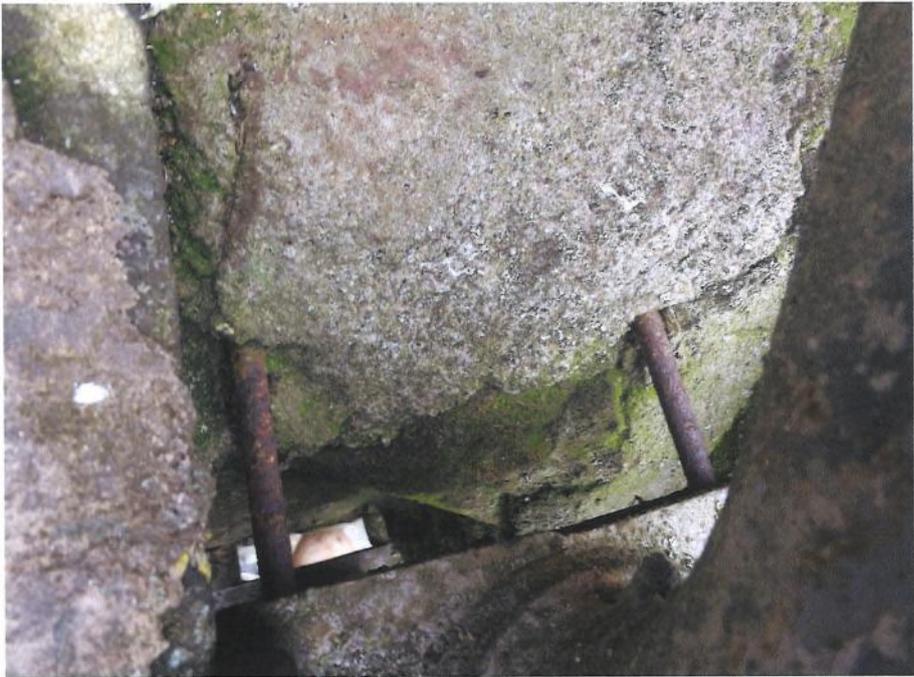
Examples of downpipe.

- 5.11 Remove and replace the rotten sections of timber around clock and refit failed lead flashing.
  - 5.12 Replace failed S bend and fit spacers for bolts. Refit Bottom 6' section of downpipe
