St MICHAEL SULGRAVE

Washington

QUINQUENNIAL REPORT

14 March 2018

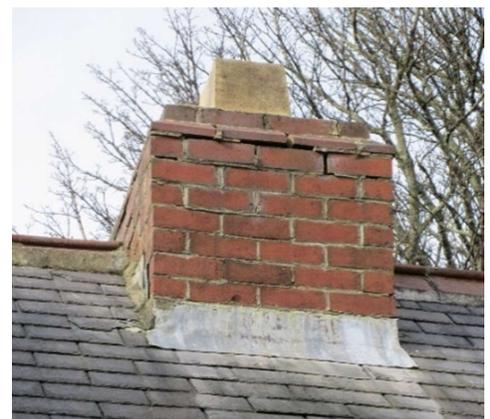
22. The offshot E wall leans out a little, probably pushed by deflection of the truss on the pier between the windows.
23. At the disused chimney the two pots appear well set but brick joints at the top of the stack E side are open. Given both flues are now disused and the chimney need repairs (flashings para 11 and this rebedding of brickwork) an alternative to repair might be to remove the chimney and slate over.

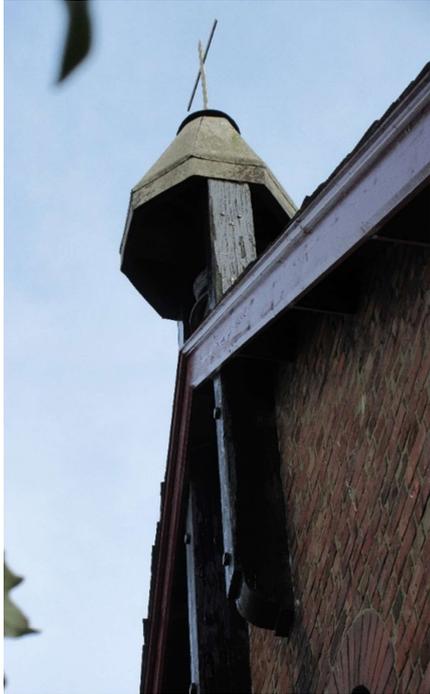
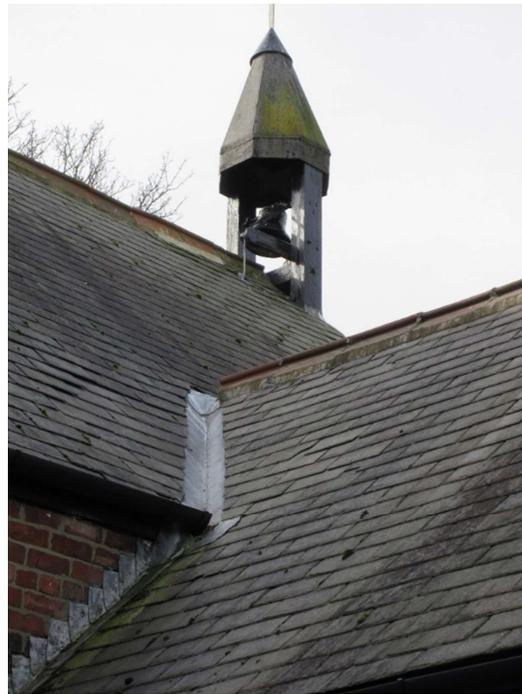
Bellcote, Bell

24. Two stout timber posts bolted to the W gable brickwork support an octagonal timber spirelet covered in Nuralite sheeting with a cross on a metal cap. The painted timbers look mainly sound but in the next five years will need treatment of any decay and repainting.
25. A single bell hangs between the posts, tolled by rope through the roof without weathering where the rope passes through the slate. The rope passes over a bracketed pulley in what may be an altered arrangement.
26. Flashband weatherings between the slates and bell posts have limited life.

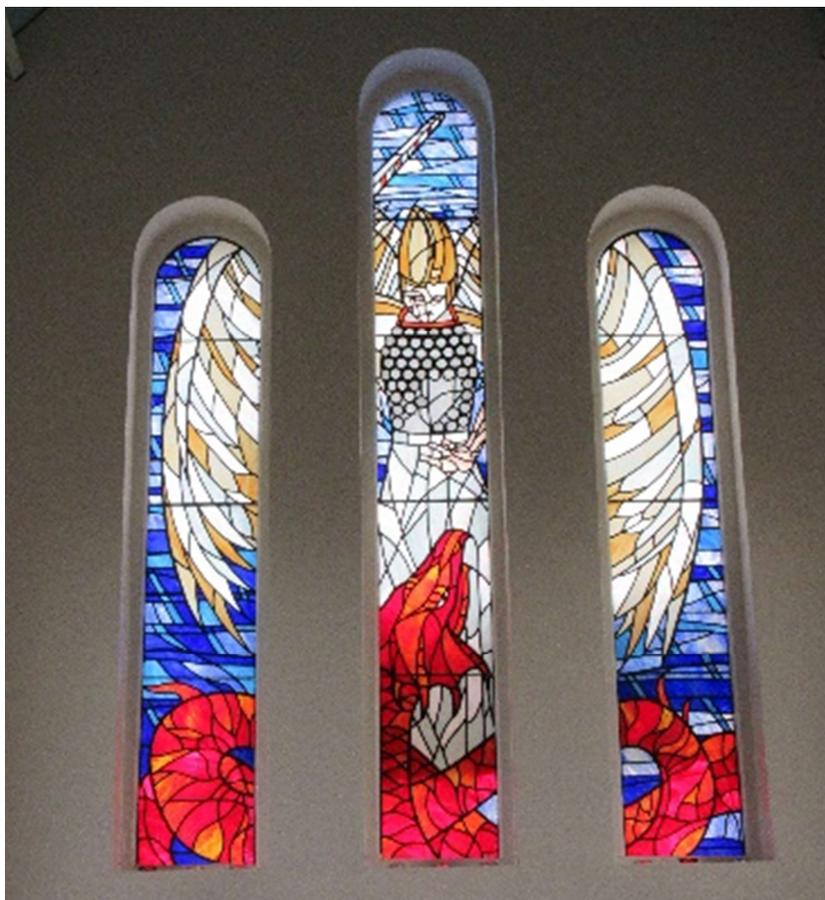
49. The three E chancel lancets have very vivid modern 'St Michael' coloured glass with saddle bars in the wooden frames.

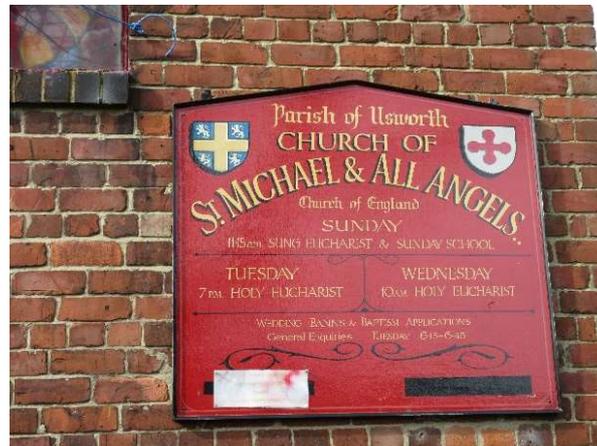
80. Painted signs fixed to the Chancel gable (out of date) and on the offshot gable.
