# Quinquennial Inspection Report

Holy Trinity Church  
Swalwell, Tyne and Wear  
Diocese – Durham  
Archdeaconry – Sunderland  
Deanery – Gateshead West

**Date of report:** 4 March 2022

**Ref:** 21027 A

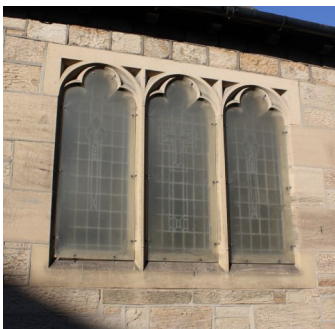
<b>2.7 Windows and window masonry:</b>		
Condition	<p>The glazing and leading is in good condition apart from</p> <ul style="list-style-type: none"> <li>- a small piece of glass missing from Chancel north window</li> <li>- a small star crack to Chancel NE window.</li> <li>- the polycarbonate outer glazing to the Chancel S and SE windows is clouded due to UV light (see photo).</li> </ul> <p>The window masonry is generally in sound condition but there are some receding joints to mullions and at the base of the lintels to some of the window.</p> <p>West gable window above gallery See 5.8 for comments on infestation of flies.</p>	
Repair needs	<p>Consideration to replacing the polycarbonate outer glazing in UV resistant polycarbonate.</p> <p>Localised raking out and repointing of open joints to window masonry in lime mortar.</p>	E
		D

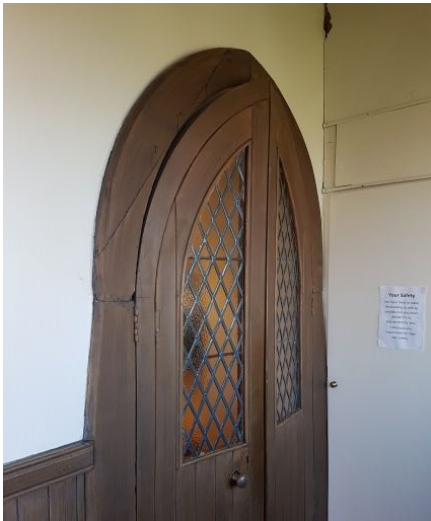
<p><u>Partitions:</u> The timber stud partition enclosing the kitchen, toilet and passage is in good structural and decorative condition.</p> <p><u>Panelling:</u> Wall panelling in the Chancel and Nave appears in good structural and decorative condition.</p> <p><u>Doors:</u> Nave - internal timber framed and glazed panelled doors – in good condition.</p> <p>Toilet – lightweight cored doors with veneered facings – in good condition.</p> <p>Porch/Lobby – timber framed doors with solid lower panel and upper glazed panel with diamond leading. The doors do not close against each other correctly (see photo). The lower bolt does not engage with the floor socket. Adjustment is needed.</p>	C
