**QUINQUENNIAL INSPECTION REPORT
OF
FISHBURN, ST. CATHERINE**

**DIOCESE OF DURHAM
ARCHDEACONRY OF DURHAM
DEANERY OF SEDGEFIELD**

**QUINQUENNIAL INSPECTION AND REPORT
SEPTEMBER 2017**

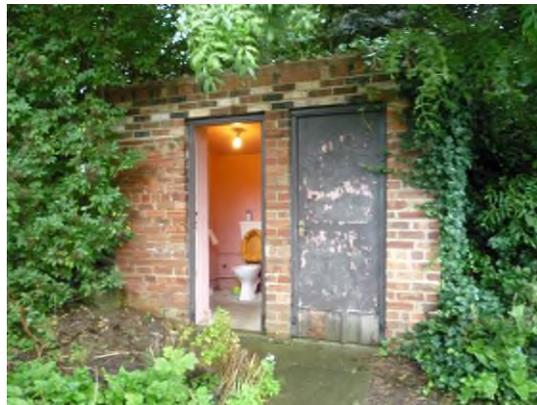
**W.C. BLOCK:**

The monopitch metal roof has no gutter to it, however it has a good enough overhang to fall ok. Albeit it does to the adjoining slot between the wall and sea container that is by it and this is difficult to sweep out.

The walls are in fair condition though the north west corner stonework is breaking down and should be repaired. The W.C. and basin are good enough but the room itself does not meet disabled standards. The adjoining storage cupboard was full of lumbar and as a consequence the door could not be opened to inspect it fully.

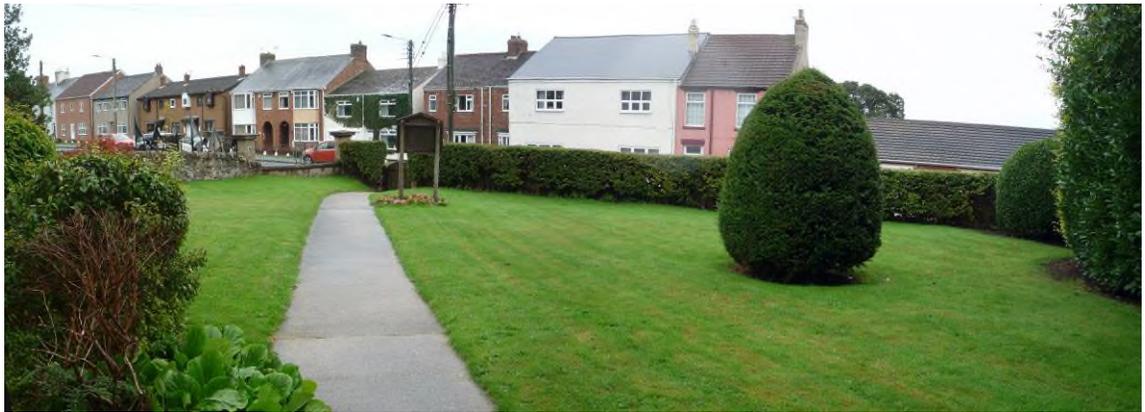
Externals:

The grounds are very well maintained, comprising grass with concrete paths and some paving slabs to the war memorial and path to the hall. The path around the north side and to the disabled entrance gate has cracks and holes that need filling. There are stone walls to all three elevations apart from the west, where there is a shrub boundary with no fencing. The maintenance of this looks to be the responsibility of the adjoining owner. It will be worthwhile establishing which walls are in the PCC's ownership and so which they are responsible to maintain. The north wall has some areas of walling that are breaking down, particularly the north west corner. The east wall has open joints that need filling. The south wall is in good condition though the gate post is leaning a little albeit that it works ok. The concrete surround to the base of electric pole looks tardy and could do with being tidied up.

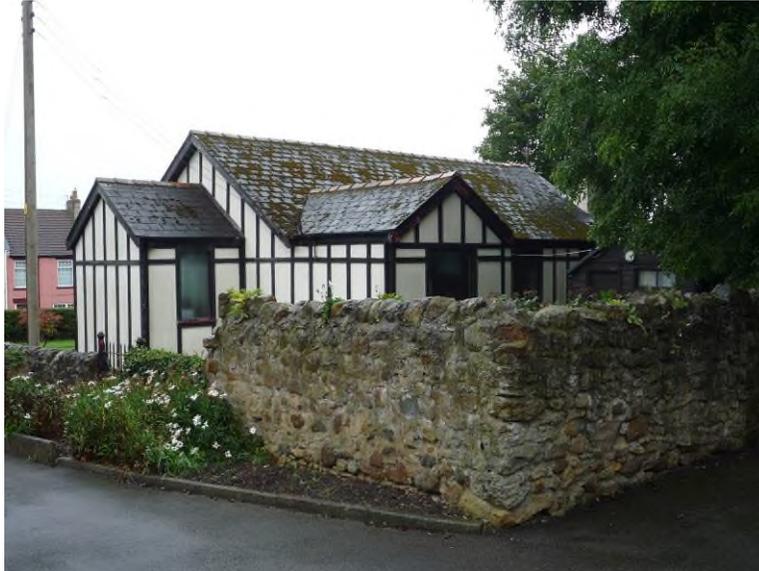
D East Boundary:

Poor quality random stonework wall, heavily restored in cement a lot of open joints to the cemetery path side, slight cracking at the northern end.

Recommendation: repoint open joints, redecorate and ease gate

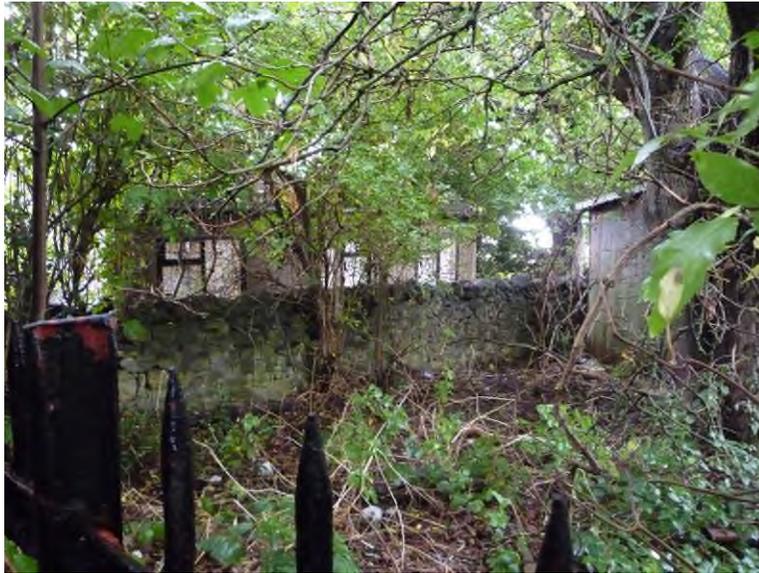
D North Boundary:

Mostly enclosed by a neighbour land which is overgrown, so not possible to inspect the neighbour side of the wall well, though it is obvious that there are open joints. Can see the W.C. doesn't have any drainage to it just drips on the back and there's an area of stonework which looks very poor adjoining the railings. There's a large sea container looking like a very permanent installation, close to the north wall and this is covered in ivy it's unable to be inspected.

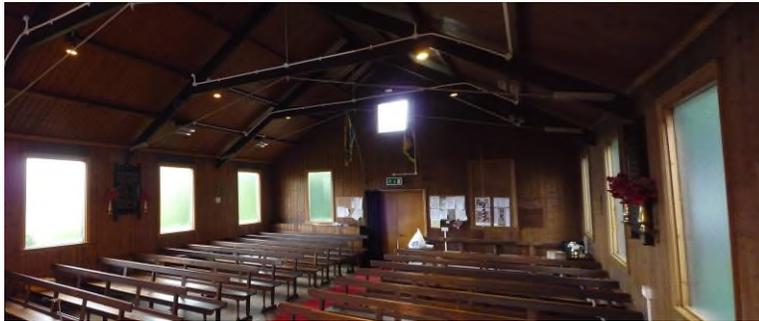
D **Nave:**

Ceiling – T&g boarded roof with three timber trusses with steel tie rods, no water marking, and good condition. Bubbling to the varnish is not caused by the heaters, it is actually over the whole of the ceiling surface.

Recommendation: consider renewing decoration, fix wall boards, repair west door and glass

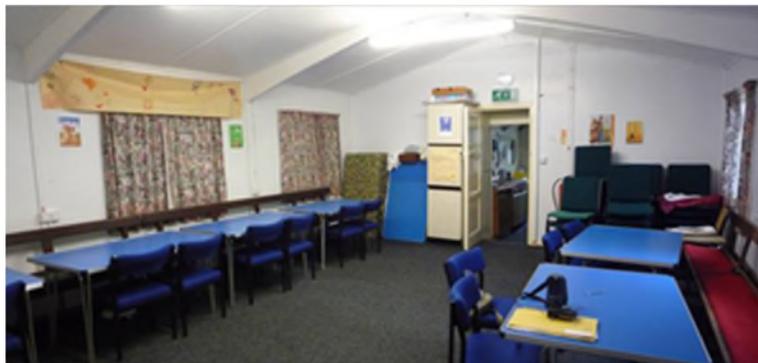
Hall:

- Ceiling – Open trussed roof with board panels with cover strips, slight rippling to one of the boards over the doorway.
- Walls – Probably hardboard panelled walls, some of the joints are showing now.
- Floor – Suspended timber floor covered in Flotex type carpet with no obvious defects.
- Windows – The windows have been commented on externally but the decoration is poor and there is no security on the windows.
