**Quinquennial Inspection Report  
St Alban's Church, Windy Nook, Gateshead  
Deanery of Gateshead  
Archdeaconry of Sunderland  
Diocese of Durham**

Report prepared by

David Jowett - Architect, BA, DipArch, RIBA  
25 Roseworth Avenue  
Gosforth  
Newcastle upon Tyne  
NE3 1NB  
Tel: 07788 710 204  
email: [david@davidjowett-architect.co.uk](mailto:david@davidjowett-architect.co.uk)

11 March 2021

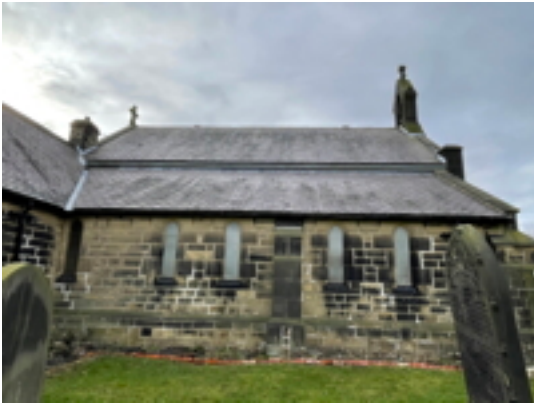
**North Aisle Roof**

Several chipped slates 3no to South Nave Roof, 1no to North Transept West Roof, 2no to North Aisle. One section of synthetic lead-free flashing has come loose to the nave roof north west gable and needs to be secured immediately.

Replace all chipped slates. £150.00.  
Secure loose flashing. £100.00

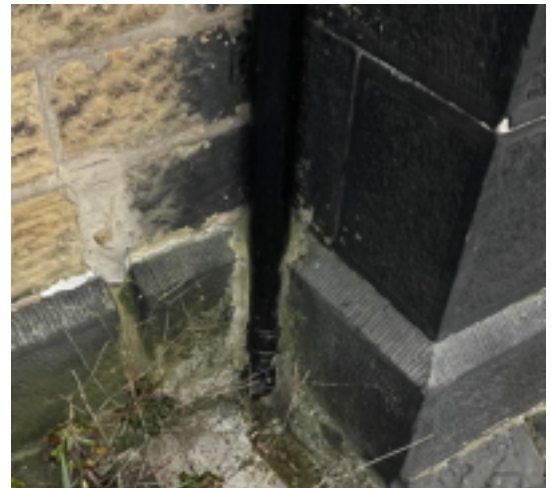
**Rainwater Pipe Cemented In**

Where downpipes are cemented into slots in the plinth stonework these should be observed for deterioration. Replacement in due course should incorporate a suitable offset to avoid this detail being replicated. £5000.00.

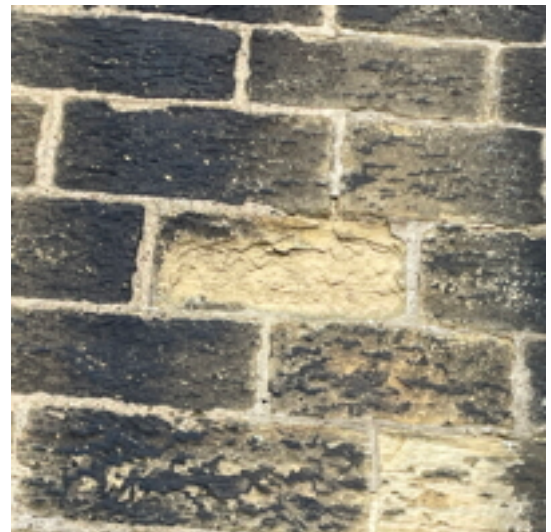
**Eroding Stone to West Wall**

Main west gable: One eroded stone at high level. Porch stonework: cracks around doorway and on rear west wall have been pointed. Nave south: distortion caused by roof spread on this elevation. Chancel south: distortion caused by roof spread on this elevation.

Monitor stonework deterioration.

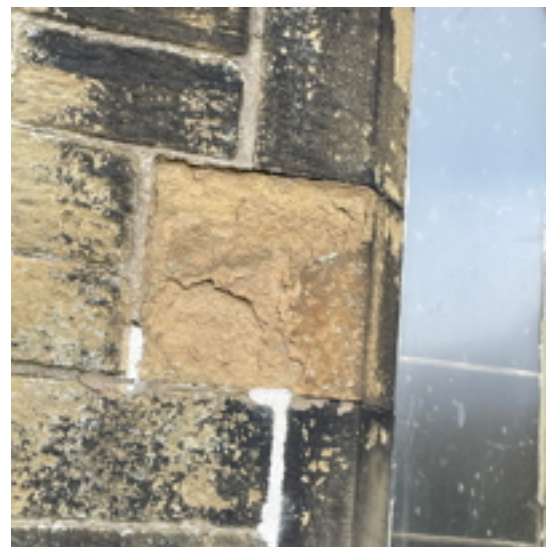
**Eroding Stone to West Wall North Aisle**

West end of aisle: a crack at outer corner has been repointed. One eroded window quoin to North Aisle.

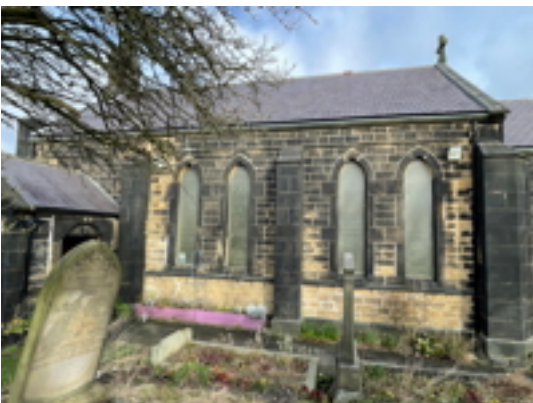
**Nave South Wall**

Some structural movement caused by roof spread is evident in nave and chancel walls but does not appear to be ongoing. A crack to LHS of vestry door has been repointed.

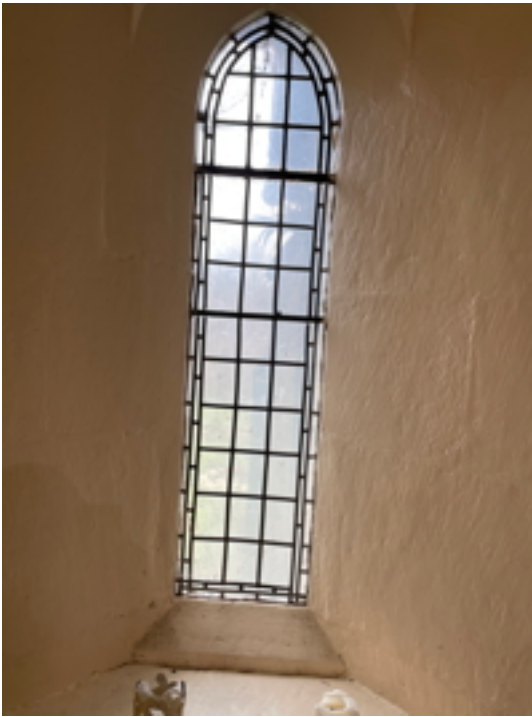
**Window 15 North Aisle, temporary polycarbonate-glazed with applied lead tape.**

Windows 15 and 20 should ideally be replaced

Replace cracked queries and replace 3no windows. £6000.00

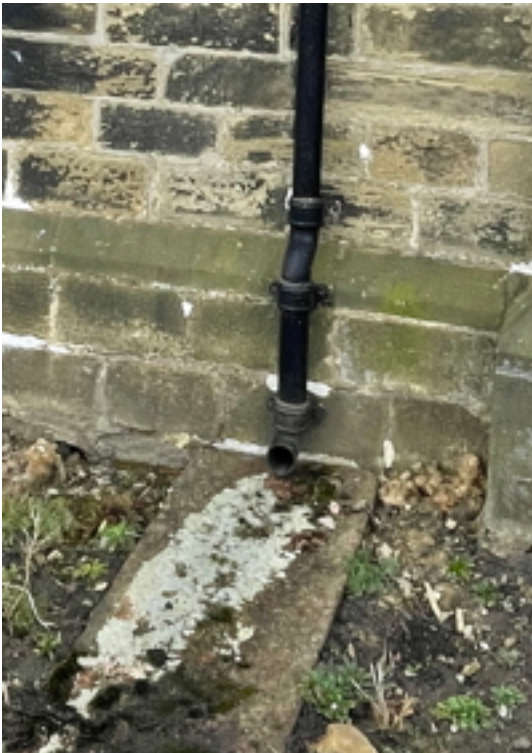
Typical run off on concrete slab

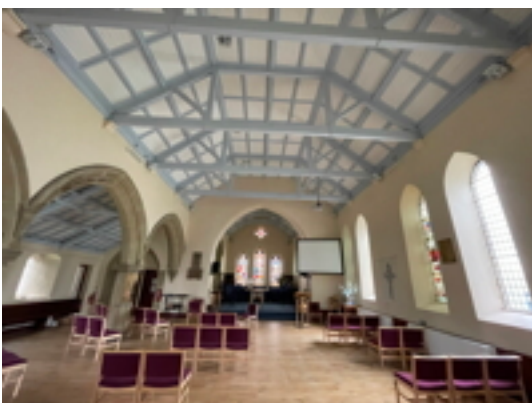
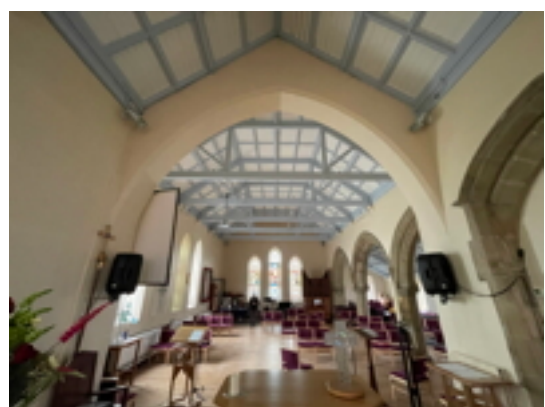
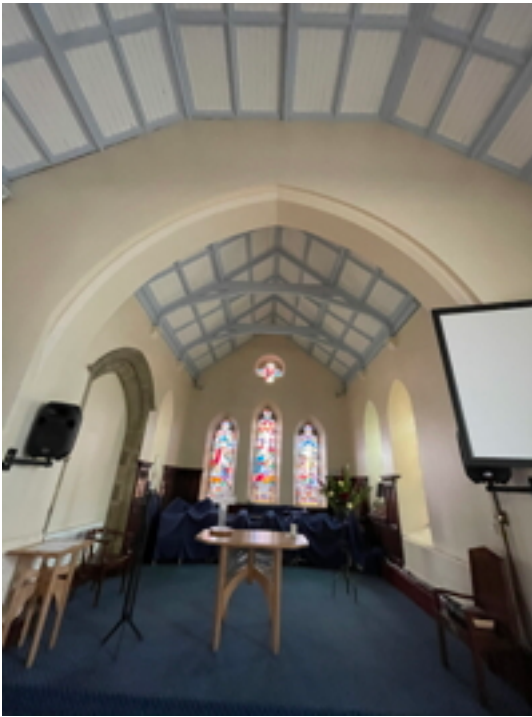
All appear in good condition.

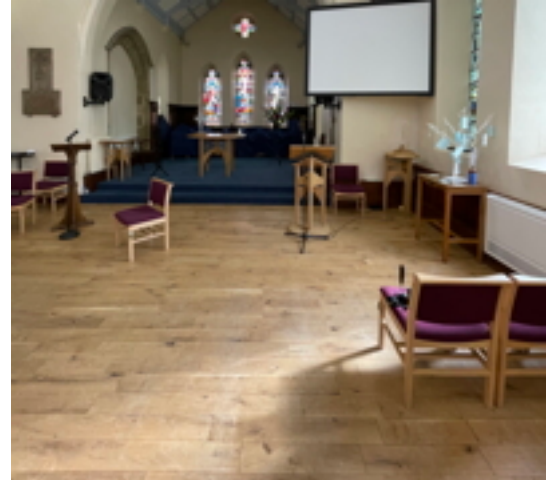
All are in generally satisfactory Condition.

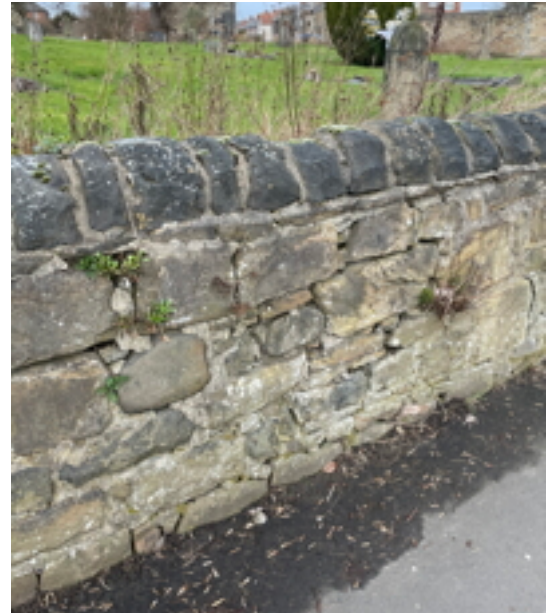
**Typical Stone Walling**

#### Condition

Generally rack out all cement mortar to boundary walls and all loose mortar and repoint as necessary £4,000.00.
