Quinquennial Inspection

**St Mary St Stephen,
Wolsingham**

**For
St Mary St Stephen Parish Council
August 2018
Revised April 2019**

Church: St Mary St Stephen, Wolsingham.
Archdeaconry: Auckland
Diocese: Durham.
Date of inspection: Dec 2017
Weather: Dry and sunny

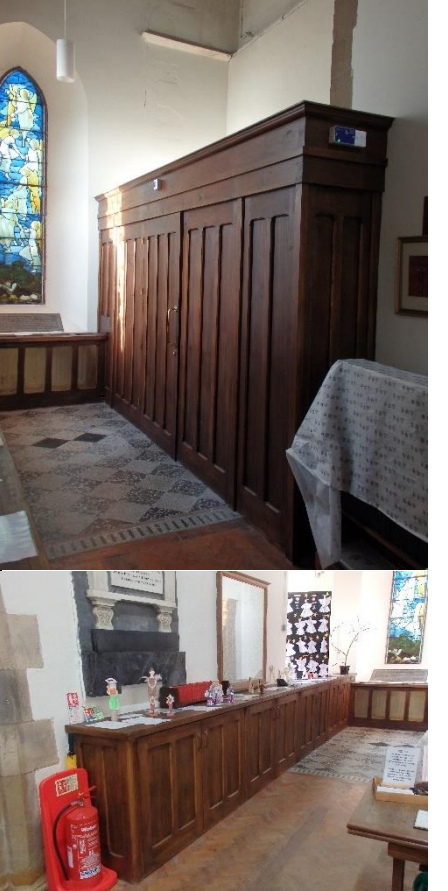
<p>12.5</p>	<p>A kitchen has recently been fitted out on the ground floor of the tower.</p>			
<p>12.6</p>	<p>There are a number of marble, slate and oak memorials which appear to be sound.</p>

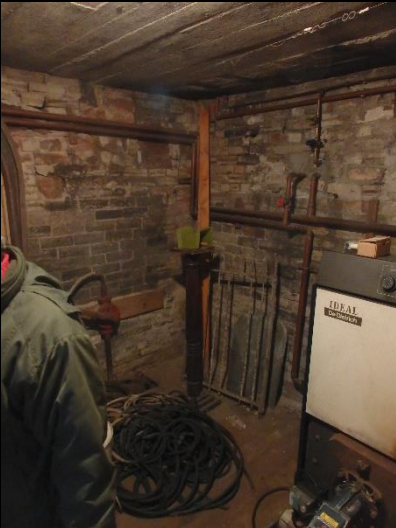
14.1	A significant portion of the electrical installation was renewed recently.	Ensure test certificates are up to date	A	
15.0	Mechanical Installation The heating system is an oil fired boiler (it is understood this will be changed imminently to a gas boiler), located in a chamber beneath the tower. The chamber is dry with a concrete floor above. The oil storage tank is located in an adjacent detached bunker. The heating system is piped reusing some original cast iron pipework and relatively new copper to new pressed steel and cast iron radiators It is understood the system is effective.	Ensure regular maintenance check is up to date.	A
