# St Mary's, Woodland

Quinquennial Inspection

## CONDITION SURVEY 2021

Ian Wells B Arch RIBA AABC

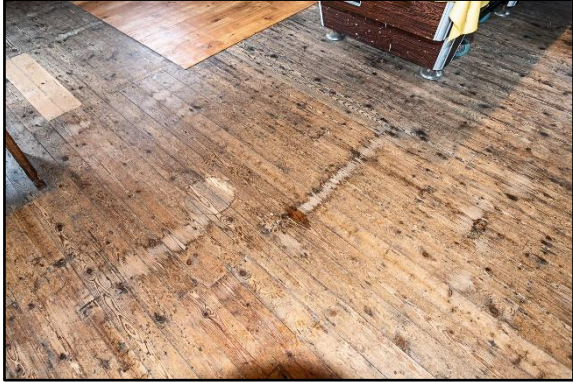
<p>Exposed floorboards in the nave. Vinyl floor finish in kitchen area. Carpet in the chancel.</p> <p><b>Nave Floor Under Floor Ventilation</b></p> <p>The ventilation of this floor void is poorly protected and this needs to be sorted out.</p>

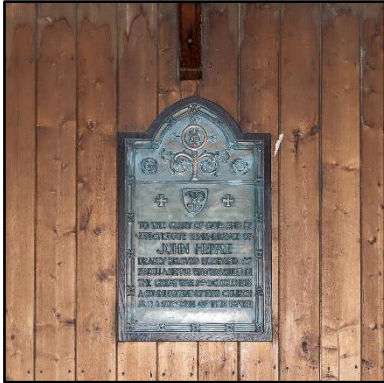
4.12	Monuments, tombs, plaques etc	<p><b>World War One Plaque</b></p> <p>On the north wall of the nave. Hammered bronze.</p>

<p>For full details see this link to Northeast War Memorials Project. <a href="http://www.newmp.org.uk/detail.php?contentId=10038">http://www.newmp.org.uk/detail.php?contentId=10038</a></p> <p>In very acceptable condition.</p> <p>I have posted the image to the IWM memorials website.</p>
------	-------------------------------------	--

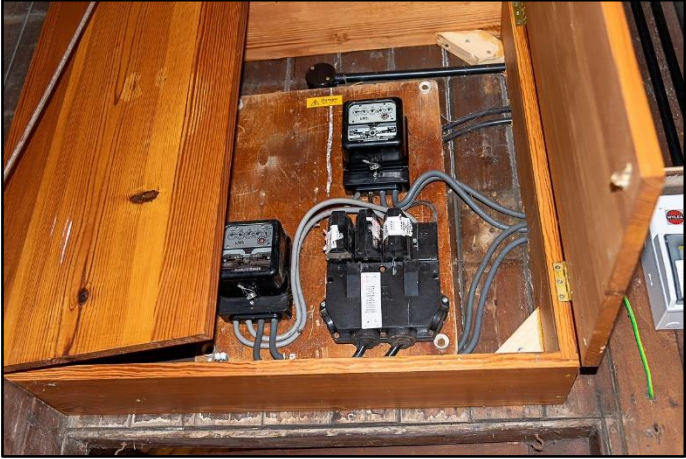
5.03	Gas installation	None.
5.04	Electrical installation	<p>An overhead supply is bracketed onto the apex of the west gable of the nave and enters the porch.</p>

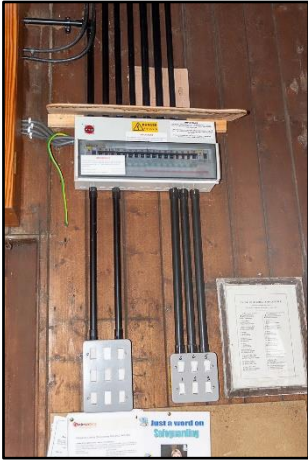
<p>The meters and distribution boards are located on the west gable over and adjacent to the entrance door to the porch.</p>
