**INSPECTION AND REPAIR OF CHURCHES
CARE OF CHURCHES MEASURE 2018
amended by the Church of England (Miscellaneous Provisions) Measure 2020**

**QUINQUENNIAL REPORT on the
THE CHURCH OF ST EBBA
EBCHESTER**

Date of inspection and weather conditions: 7th May 2025. Dry day but slightly overcast becoming brighter as the survey progresses. The survey followed a period of very dry weather.

Date of report: 20th August 2025

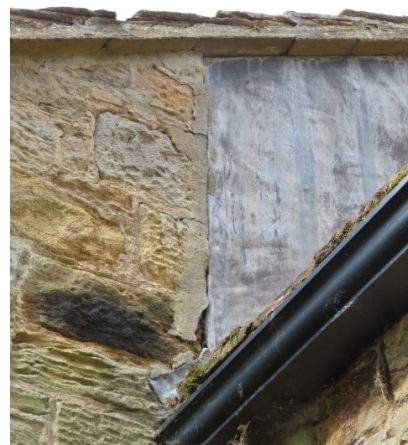
Some high-level pointing has undertaken to the Tower since the last inspection, but a few issues remain including a cracked stone at parapet level which needs repair. The mortar to the edge of the lead panels to the Nave is failing with some section of lost mortar to both the East and West elevations - this needs to be looked at before water ingress becomes an issue. There are a few open joints to the bellcote, but proper inspection was difficult due to tree growth. However, the location of one open joint to the head of one arch would benefit from fairly prompt attention. At lower level vegetation growth at the base of the walls needs to be removed and any resultant open joints pointed – given the location this will be a constant issue and adding this to a regular programme of maintenance would be prudent, a task that could potentially be undertaken by volunteers.

Mortar to edge of lead panels is failing in places

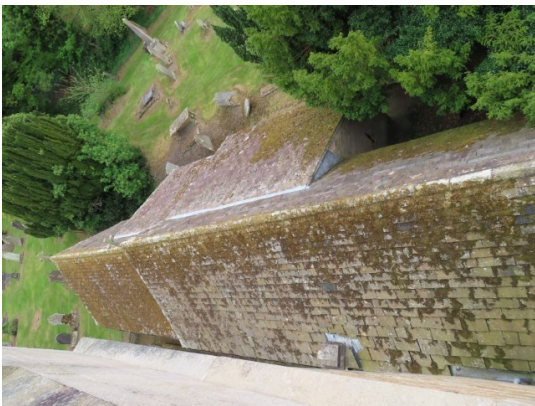
Moss growth is an issue to the Southern slopes in particular, as well as the ridges and some clearance of the most densely covered area would be prudent. Alongside this the yew trees have grown very close to the South West roof slopes and walls with branches now touching the roof. As many of these trees are heavily covered with ivy weighing down branches, contact should be made with Durham County Council to organise maintenance of these trees. This would be a good time to enquire whether they have carried out a recent survey of condition of mature trees within the churchyard generally. This would allow them to schedule any necessary maintenance to other trees as well, as many are on the boundary with the pavement or other properties.

Close proximity of the trees to the Western end of the Church touching the walls/roof in places

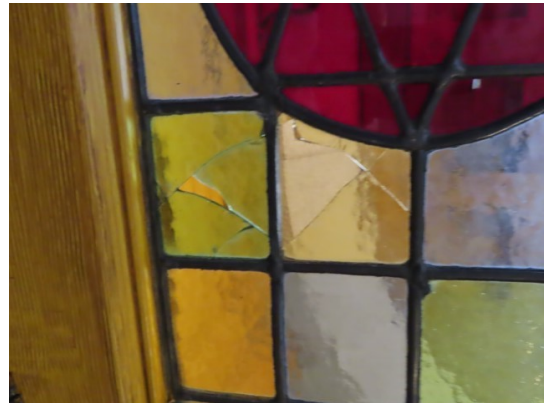
The inner tower doors were mentioned in the last report and sharp edges of failed glass remain. Although most people would avoid touching broken glazing, the location is a concern for children or visitors unfamiliar with the church.

Cracked and missing glass to main internal doors of tower

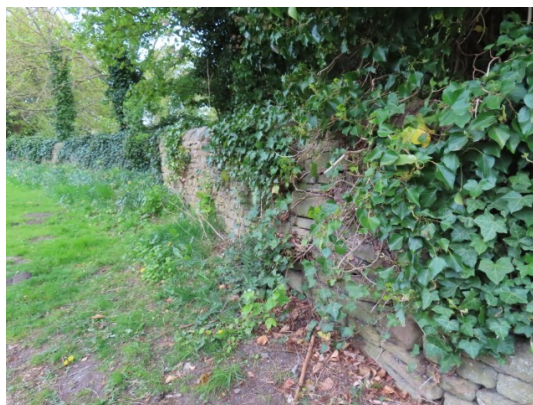
Ivy growth, loss of pointing and bowing around trees to boundary walls
