**Quinquennial Inspection Report
The Church of All Saints', Monkwearmouth
Parish of Monkwearmouth
Archdeaconry of Sunderland
Diocese of Durham**

David Jowett - Architect, BA, DipArch, RIBA
25 Roseworth Avenue
Gosforth
Newcastle upon Tyne
NE3 1NB
Tel: 07788 710 204
email: david@davidjowett-architect.co.uk

11 October 2018

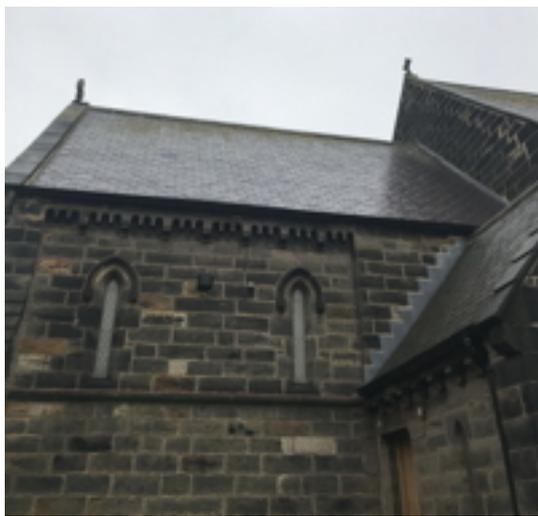
Chancel and Vestry Roofs

Overall the slating appears in excellent condition as are the flashings and ridges.

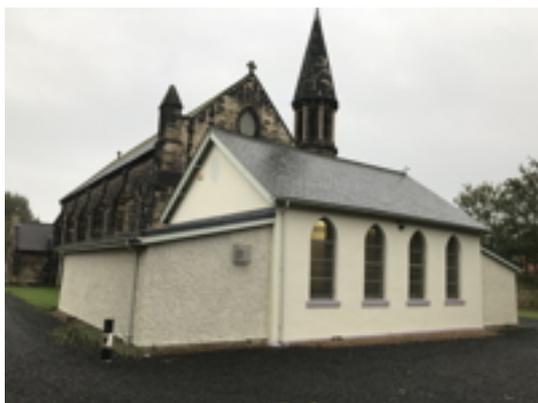
Hall Roofs

Overall the slating and Sarnafil appear in excellent condition as are the flashings and ridges.

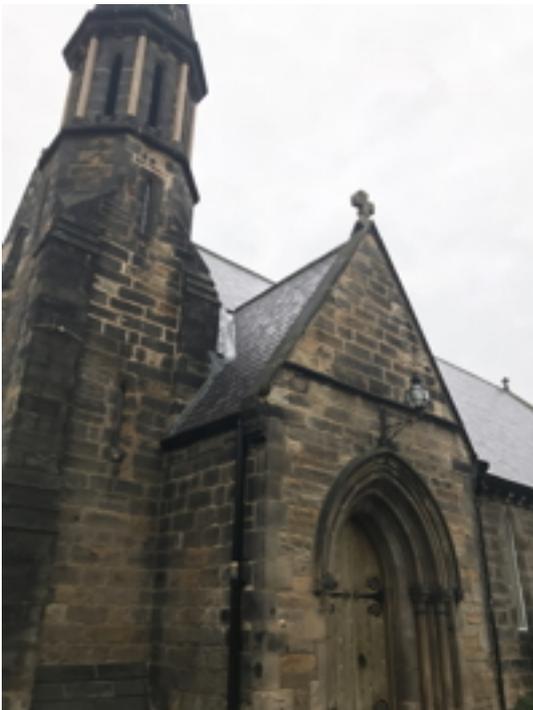
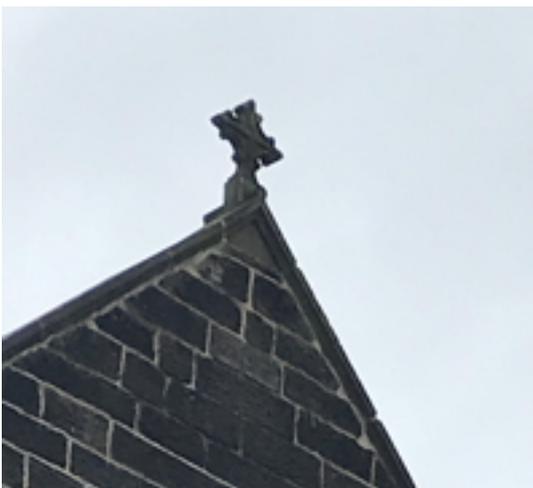
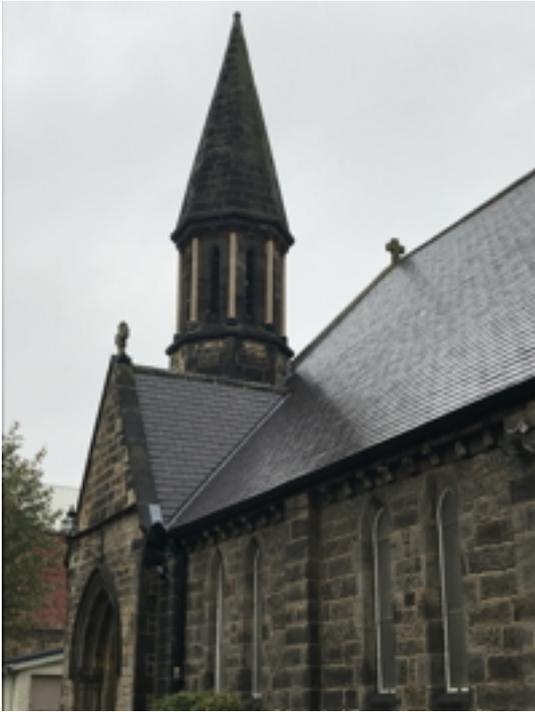
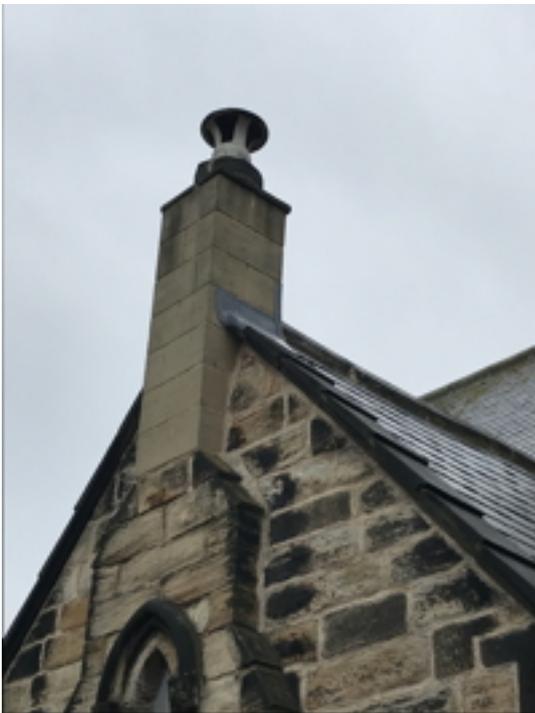
All appear generally sound and in good condition when viewed from ground level.

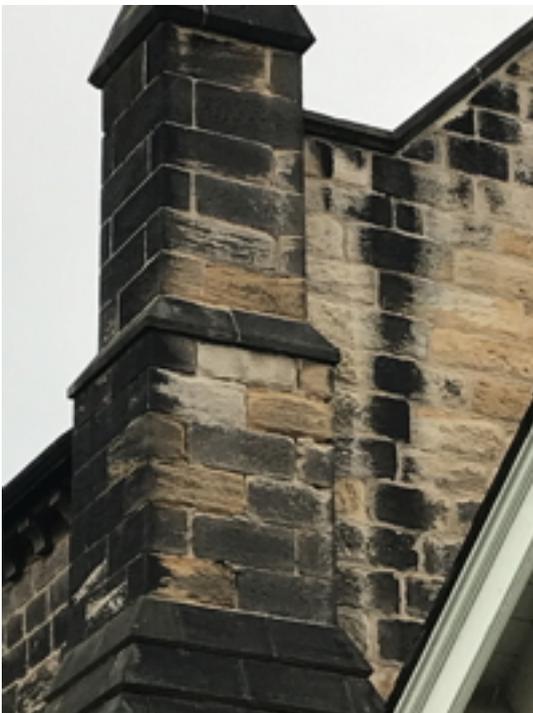
The stone is generally sound although there is slight decay in various areas and a few joints starting to open.

Open Mortar joints to Nave West Wall, North West Corner

Repoint cracking to Chancel north wall and open joints to Nave west wall, north west corner in lime mortar. £750.00

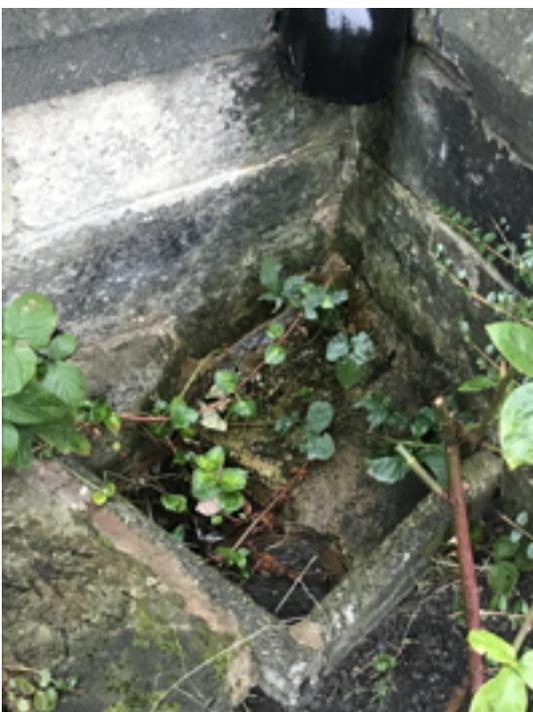
Vegetation starting to grow around gully

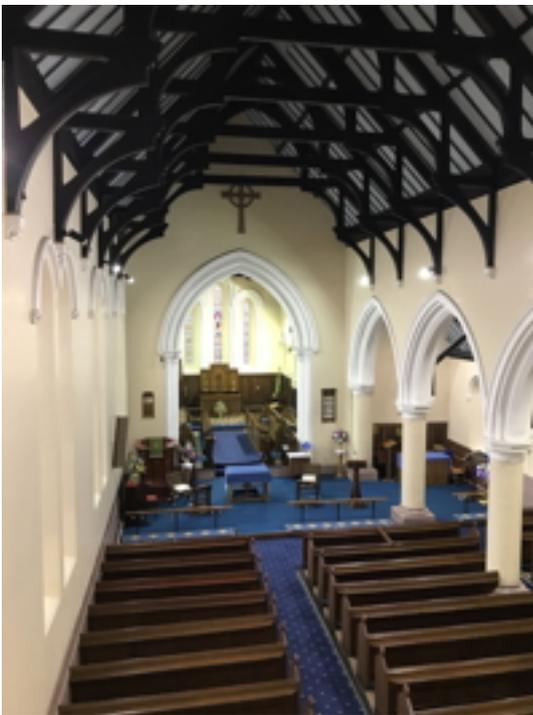
Nave Ceiling

No visible defects to roof timbers.

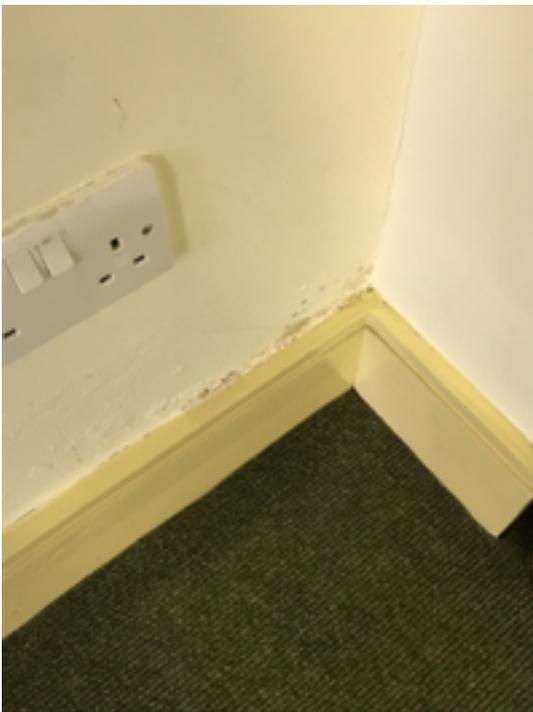
Signs of damp to Meeting Room lower level plaster walls. Here it is possible that the new extensions that have made the original external Meeting Rooms into internal walls are forcing moisture up the walls.

Typical Hall Damp

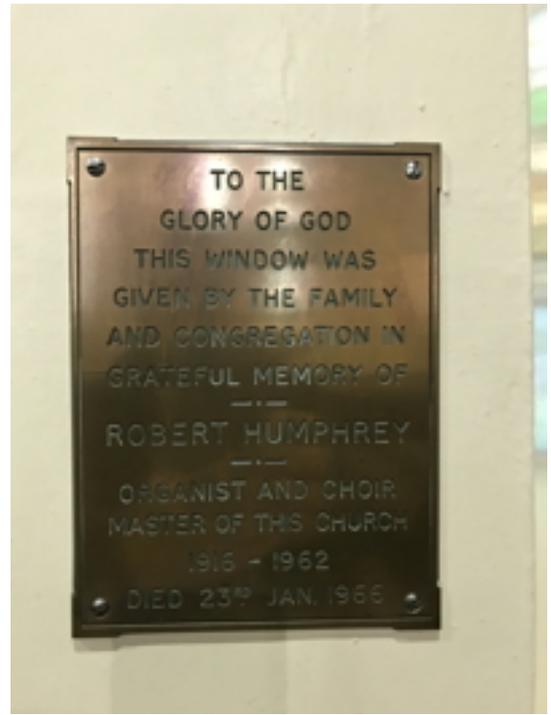
Memorial to Robert Humphrey Organist

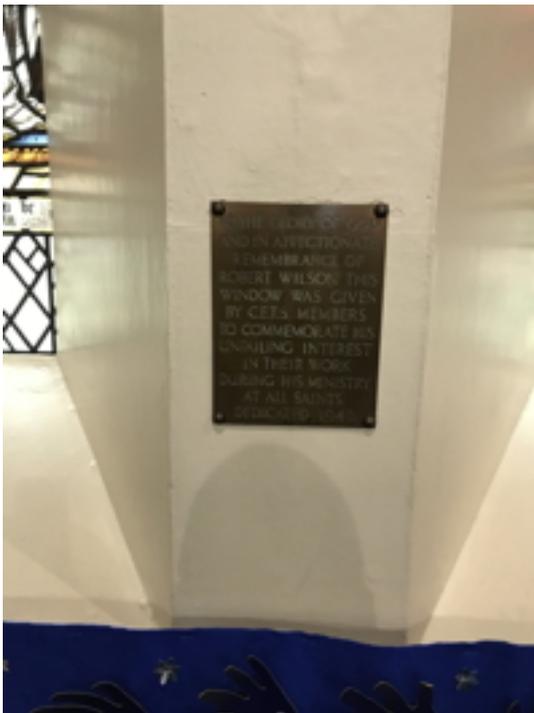
Memorial to Robert Wilson

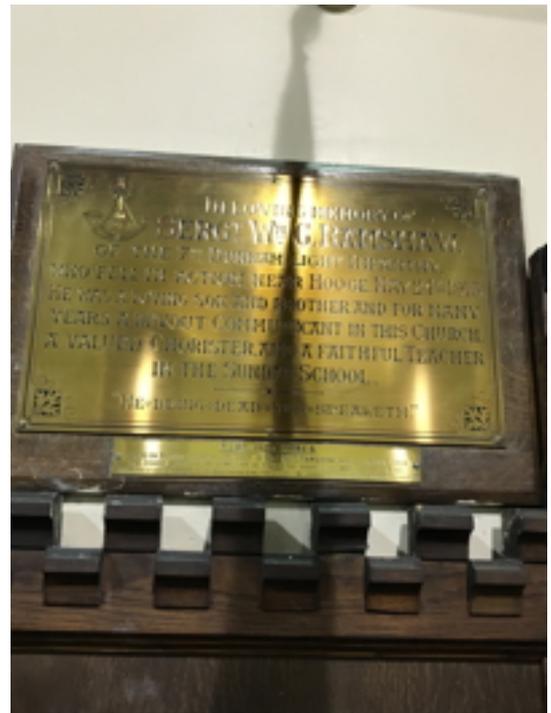
Memorial to William Ramshaw

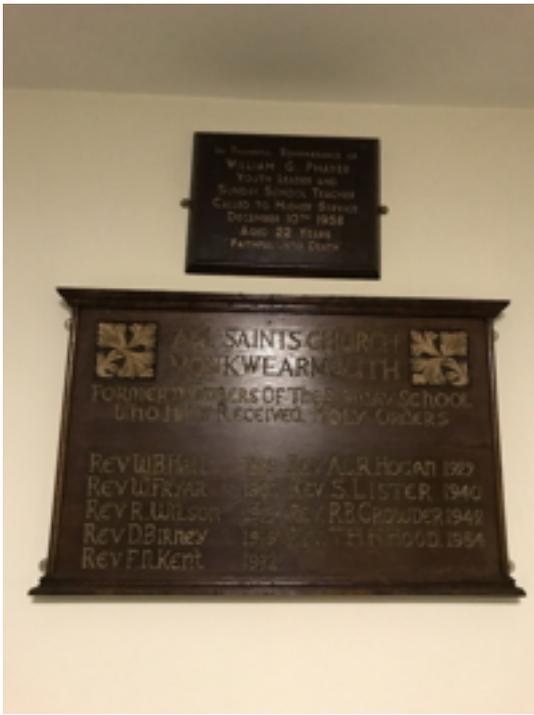
Memorial to William Phayer, Youth Leader

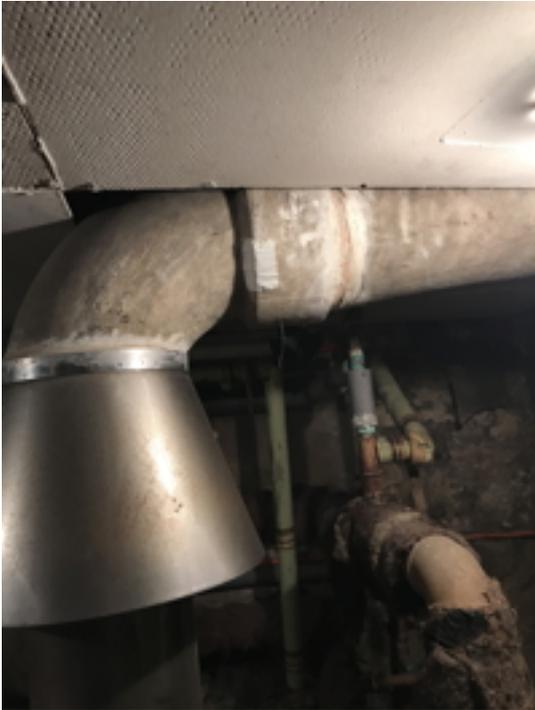
Boiler Flue and Boiler Chamber Ceiling

All is in satisfactory condition.

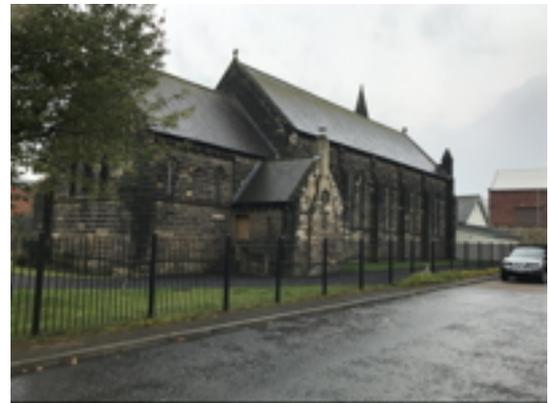
North Boundary Railings

North Wall rails showing signs of advanced rust in places. Churchwarden noted that responsibility for this boundary lies with the adjoining residential development.

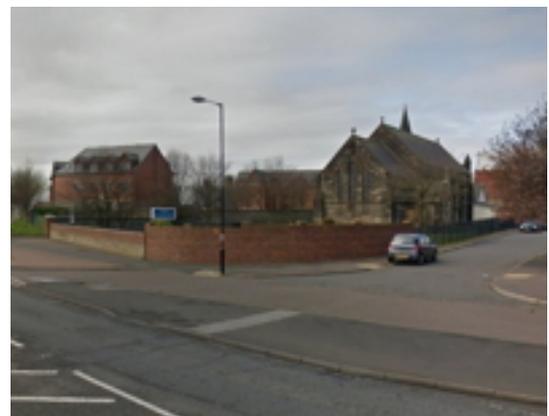
North East Corner Brickwork Wall and Stone and Brickwork East Boundary Wall

The east boundary brickwork is all in good condition. The lower sections of stonework however are in need of patch pointing.

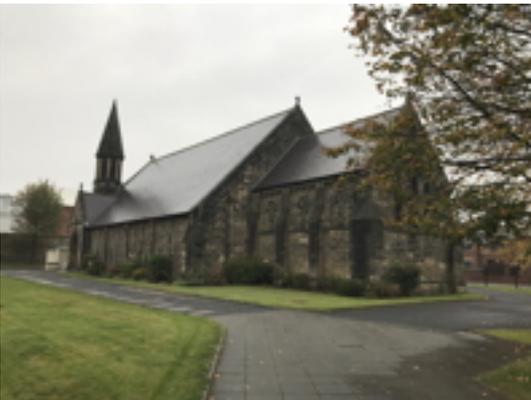
Paving to South East Corner and Planting Bed to South Elevation

All is in good condition and well maintained with the exception of a small area of paving leading from the entrance gates which has become loose and uneven.

Relay area of loose paving. £500.00

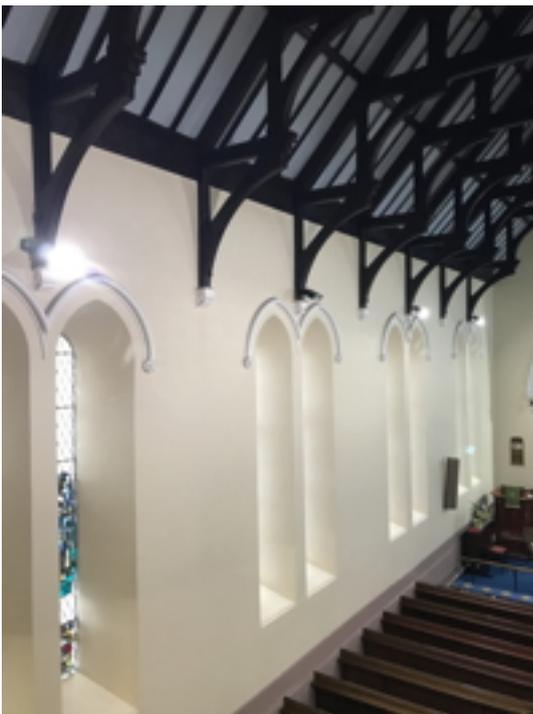
Nave Lighting

A lamp has failed and need replacing to the nave north elevation.

Replace broken lamp. £50.00
