## QUINQUENNIAL REPORT

*For the Parish Church of  
St. Matthew's Church, Newbottle*

**Report Date:** 24<sup>rd</sup> September 2025

Inspecting Architect:  
Becky Smith BA(Hons), MArch, ARB RIBA CR

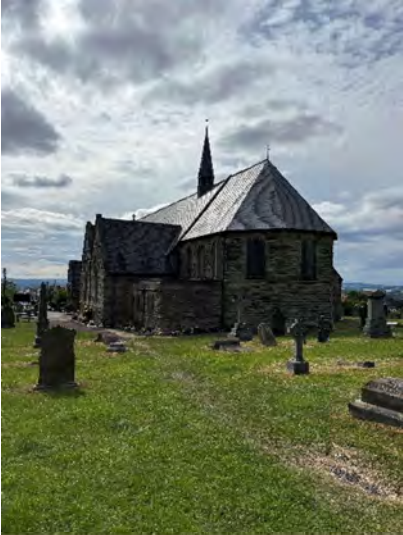
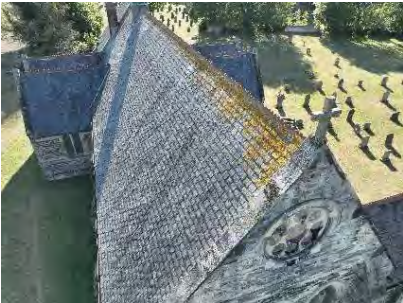
| Image & Location | Description | Condition | Repair Needs | Category |
|---|---|---|---|---|
| <p><u>Roof</u></p> | <p>Welsh slate roof laid in diminishing courses of varying ages with many patch repairs. The roof is in a particularly exposed location and is subject to severe weathering.</p> <p>The south nave and chancel (not on the north side) have been replaced over the years.</p> | <p><b>General Condition</b></p> <p>The roof coverings present a mixed condition overall. The south slope has been renewed at some point in the recent past and appears to be performing satisfactorily.</p> <p>By contrast the north slope is in poor condition, with the extent of deterioration highlighting the need for a full future replacement.</p> | <p>The previous Quinquennial Inspection identified the north side of the main roof as requiring replacement within the next 5-10 year, forming part of the long-term maintenance strategy. This matter was discussed with the church representatives during the initial visit for the present inspection.</p> <p>The church has confirmed its intention to replace this roof pitch in the near future, subject to funding, due to ongoing significant slate loss during periods of high wind. In the interim, it was agreed that an initial plan would involve commissioning a drone survey (Gridmark Survey Ltd) to provide a comprehensive overview of the current condition – of which areas were highlighted to the surveyor by the architect that were not easily visible from ground level including areas around the fleche and chimney. A roofing contractor, used regularly by the church will also access the roof to undertake immediate repairs to missing and slipped slates, and to take close-up photographs to further contribute to the scheduling of a package of works for its replacement.</p> | <p>1</p> <p>2/3</p> <p>12</p> |
| | | <p><b>North Roof</b></p> <p>Significant quantity of slates requiring replacement. Several areas of missing, cracked or slipped slates. Many of these slates are still lying on the ground surrounding the church as much of the damage was caused during the early winter storms of 2025. Some slipped slates are still on the roof but unsecured and as damage has been concentrated in a number of areas, weatherproofing ability of the roof covering has been compromised.</p> | <p>Roof contractor to fix missing, slipped and cracked slates using new or sound salvaged Welsh slate to match the existing in size, thickness and colour. To be fixed as existing.</p> <p>Develop a scheme for full reroofing of the Northern slopes.</p> | |

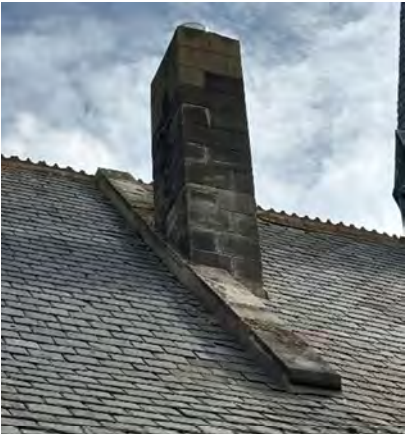
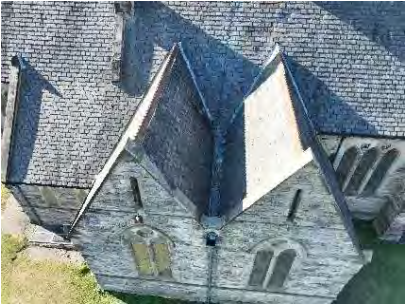
| Image & Location | Description | Condition | Repair Needs | Category |
|---|---|---|---|---|
| <br> | | <p>Loose / deteriorating ridge tiles with some loss of mortar bedding below ridge tiles where mortar has cracked, loosened or fallen away entirely.</p> | Remove failing mortar and re-bed ridge tiles in a suitable lime mortar to prevent water ingress from wind-driven rain. | 3 |
| | | <p>Significant areas of moss growth at ridge level to some areas of the roof.</p> | Remove moss growth to all areas of the roof. | 3 |
| | | <p>Water table stone is delaminating with mortar fillets at junctions between slopes coming away and cracking to the mortar around water table.</p> | Remove areas of failing mortar and repoint with a lime based mortar. Reform mortar fillets to edges of roof. | 3 |
| | | <p><b>Chimney</b><br/>There has been some replacement of stonework, but there are open and hungry joints to visible faces which require pointing. Isolated stones are weathered and should be inspected and repaired if needed when high level access is available.</p> <p><b>North Transept</b><br/>There are many broken pieces of slate in the valley gutter which will likely be preventing water from flowing towards the outlet and possibly causing ponding. These should be cleared to prevent issues arising that could contribute to the damp internally.</p> <p>Significant weathering to ridge tiles with deterioration / loss of mortar bedding below ridge tiles where mortar has cracked, loosened or fallen away entirely. Some variation in ridge tile styles.</p> | <p>Inspect chimney and repoint / carry out repairs to stonework.</p> <p>Remove all slates and debris from valley gutter. Ensure this is undertaken on a regular basis until works to roof complete.</p> <p>This area requires further investigation to understand the cause of damp to interior below and repairs undertaken.</p> | <p>3</p> <p>M</p> <p>2</p> |

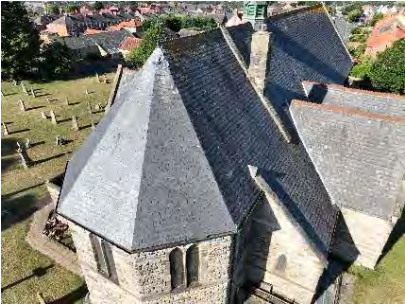
| Image & Location | Description | Condition | Repair Needs | Category |
|---|---|---|---|---|
| | | Several slipped, broken and missing slates. Slates which have previously been replaced appear to have been installed using a modern slate which does not match the existing. | Roof contractor to fix missing, slipped and cracked slates using new or sound salvaged Welsh slate to match the existing in size, thickness and colour. To be fixed as existing. | 1 |
| | | <b>Chancel</b><br>Broken and slipped slates mainly near the ridge, with some missing entirely. | Roof contractor to fix missing, slipped and cracked slates using new or sound salvaged Welsh slate to match the existing in size, thickness and colour. To be fixed as existing. | 1 |
| | | The northern slope is partially continuous with the Nave roof and exhibits similar defects. It would be prudent to reroof this at the same time as the North Nave roof. | Reroof North slope in conjunction with North roof works. | 3 |
| | | Mortar fillets adjacent to the water table are failing. | Replace failing mortar fillets. | 2 |

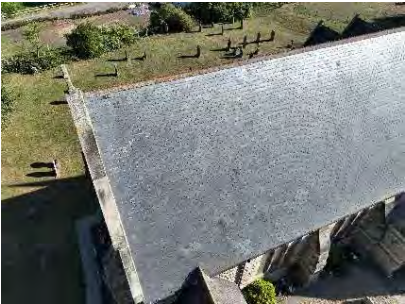
| Image & Location | Description | Condition | Repair Needs | Category |
|---|---|---|---|---|
| | | <b>South Roof</b><br>Some cracked, broken, missing slates to South Roof but not to same quantities as North side. | Replace damaged and missing slates with matching slates. | 1 |
| | | Some deterioration to surface of slates which indicates some weathering and potential delamination of the slate. | Slates to be monitored and replaced where necessary before they begin to fail. | M |
| | | Ridge tiles and stonework are showing moss growth and potential mortar failure in areas, with some more obvious areas of mortar loss to ridges. | Repoint ridge and verge mortar where necessary and remove moss growth carefully. | 2 |

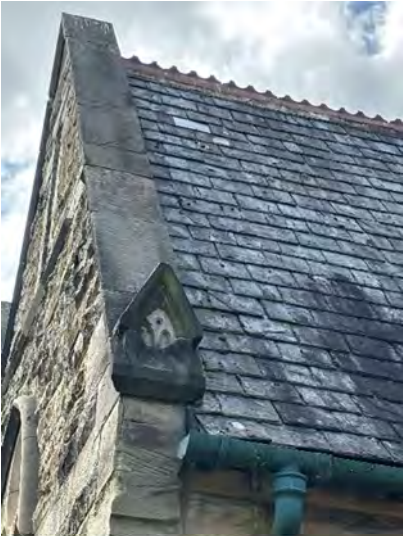
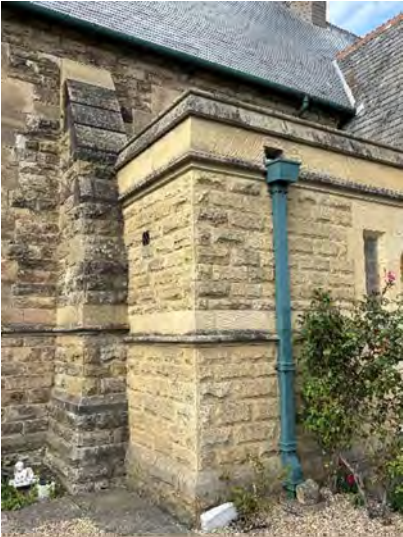
| Image & Location | Description | Condition | Repair Needs | Category |
|---|---|---|---|---|
| <br> | Two flat roof areas covered in mineral felt – locations are above accessible WC and vestry. | <p><b>South Transept</b><br/>Several slipped, broken and missing slates. Slates which have previously been replaced appear to have been installed using a modern slate which does not match the existing.</p> <p>The mortar bedding below the ridge tiles is deteriorating with areas where the mortar has cracked, loosened or fallen away entirely.</p> <p>Some weathering and mortar missing from areas of the water table surface and isolated stones have deteriorated.</p> | <p>Roof contractor to fix missing, slipped and cracked slates using new or sound salvaged Welsh slate to match the existing in size, thickness and colour. To be fixed as existing.</p> <p>Remove failing mortar and re-bed ridge tiles in a suitable lime mortar to prevent water ingress and wind-driven rain.</p> <p>Remove failing mortar and repoint water table where required. Inspect condition of damaged stones to water table and repair or replace as required.</p> | <p>1</p> <p>2</p> <p>3</p> |
| | | <p><b>South Porch</b><br/>Several slipped and delaminating slates. Evidence of variety of slates suggesting many repairs over the years.</p> <p>Failing mortar bedding to ridge with some cracking visible to stone face.</p> <p>Some lead flashing to junction with Nave appears to becoming loose/raised.</p> <p>Some visible timber rot under slates above gutter.</p> | <p>Roof contractor to fix missing, slipped and cracked slates using new or sound salvaged Welsh slate to match the existing in size, thickness and colour. To be fixed as existing.</p> <p>Remove failing mortar and re-bed ridge tiles in a suitable lime mortar to prevent water ingress and wind-driven rain.</p> <p>Re-fix lead flashing where required.</p> <p>Remove damaged section, replace with new ensure treated and sealed.</p> | <p>1</p> <p>2</p> <p>3</p> <p>3</p> |
| | | <p><b>Vestry &amp; Access / WC Roof</b><br/>The flat roofs requires proper inspection as not visible from ground level. There are signs of water ingress below, although possible causes may have been rectified previously this does need cyclical inspection as concealed.</p> | <p>Inspect roof areas and carry out repairs as required.</p> | <p>2 then M.</p> |

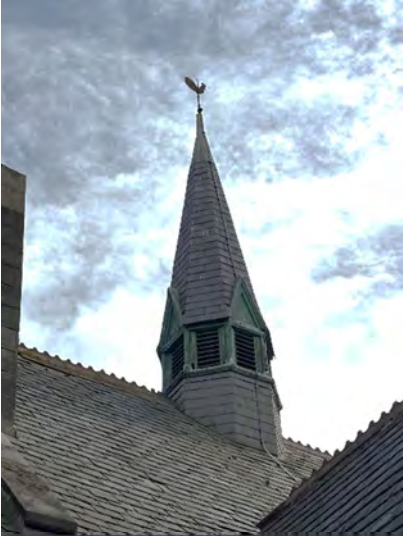
| Image & Location | Description | Condition | Repair Needs | Category |
|---|---|---|---|---|
| | <p><u>Fleche</u><br/>Timber framed structure. Base section clad in welsh slate. Mid section timber louvre panels framed with moulded timber architraves and corner posts. Spire is clad in welsh slate with finial. There is a visible cable running down the fleche which forms part of the lightening protection system.</p> | <p><b>Fleche</b><br/>General Overview:<br/>The paint finish to the fleche looks to have been deteriorating for some time exposing bare timber some of which appears to be ply which is losing its veneer/face. This would benefit from a close up inspection to ascertain exact condition and ensure there are no potential health and safety concerns.</p> | <p>A closer inspection and photographing of the fleche by a roofing contractor is recommended, along with review of the drove survey, to confirm the extent of required repairs and identify any additional issues not visible from ground level.</p> | 2 |
| | | <p>There is significant paint failure to the green painted timber louvres and frames. Some areas of the timber frame/detailing are missing which may also indicate possible surface decay to some parts of the structure.</p> | <p>Paint to be removed sufficient to allow the timber to be inspected for rot. Replace decayed sections with matching timber, treated and repainted using breathable paint which is historically accurate in colour.</p> | 2 |
| | | <p>Slate cladding to the base of the fleche appears ok however there are some minor gaps between slates. Junction between the fleche base and main roof to be inspected to ascertain potential flashing deterioration.</p> | <p>Re-secure / replace any loose slates with match welsh slate and nails. Inspect all lead flashings for cracks or detachment.</p> | 2 |
| | <p>The previous QI reported that the structure was last looked at in 2005 by Howard Smith, the DAC Bells Advisor. A couple of years later a new bell sound system was installed.</p> | <p>Upper slate spire section appears to be ok however should undergo a closer inspection. Remains of weathervane is rusting and connection with the fleche needs checking.</p> | <p>Inspect upper slate spire for slipped / cracked or weather-lifted slates. Repaint weathervane and inspect and repair if required connection with fleche.</p> | 2 |

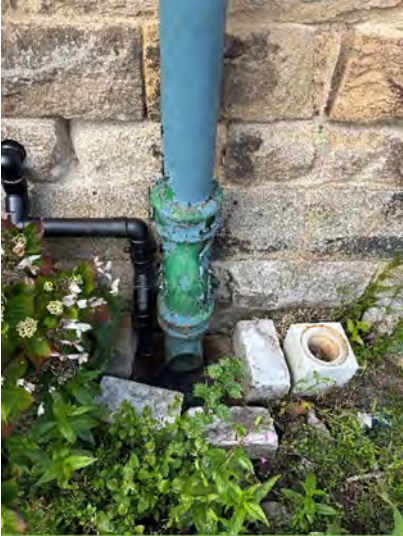
| Image & Location | Description | Condition | Repair Needs | Category |
|---|---|---|---|---|
| | <p>Cast-Iron half round gutters leading into soakaways.</p> | Some gutters have broken pieces of tile in them (likely fallen from recent storm weather & slipped slates) | Clear all vegetation, debris and tiles from gutters. Ensure gullies are clear of debris. | 1/M |
| | | Several soakaways are filled with debris, restricting the discharge of water and increasing risk of overflow and saturation of the surrounding masonry and ground. | Clear all blocked soakaways to restore full function and reduce the potential for water ingress to the building fabric. | 1/M |
| | | Some of the downpipes don't properly connect to soakaways and are therefore likely to be saturating the ground and surrounding masonry. | Ensure downpipes discharge directly to soakaways. | 2 |
| | | The rainwater goods are showing signs of deterioration with significant paint flaking and peeling exposing bare metal underneath. Some heavy paint deterioration at joint areas may be concealing cracks or failed sealant. | Remove existing paint and inspect condition below. Renew any defective sections and repaint. | 3 |

| Image & Location | Description | Condition | Repair Needs | Category |
|---|---|---|---|---|
| | | | Monitor rainwater goods generally during heavy rainfall to identify overflow points or defective components. | M |

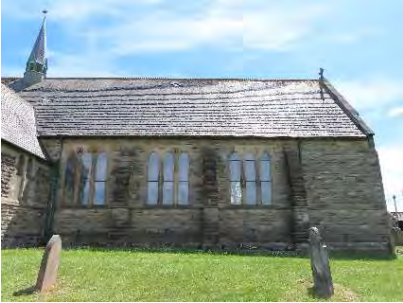
| Image & Location | Description | Condition | Repair Needs | Category |
|---|---|---|---|---|
| <u>North Elevation</u><br> | Traditional stone construction using rock faced, grey freestone from Penshaw Quarry and recovered stone from the previous demolished church. | <p>The walls to this elevation are generally sound. There is some noticeable deterioration of stone behind downpipes across most of this elevation which likely suggests some issue with water saturation over time from downpipe leaks. It was dry at the time of the survey so no assessment of ongoing issues could be made.</p> <p><b>North Transept</b><br/>The walls to this area are generally sound. There is some loss of pointing to the lower courses of stone to side elevation and at high level stone across the north elevation. Some weathering of stonework is visible (see also section on windows)</p> <p><b>Buttresses</b><br/>There is some loss of pointing and weathering to areas of the buttresses across this elevation.</p> | <p>Monitor downpipes to see there are any ongoing leaks and address any issues with downpipes. Repoint stone behind downpipes to ensure no further deterioration.</p> <p>Rake out and repoint lower courses of stone.</p> <p>Rake out and localised repointing to areas of buttresses.</p> | <p>M/3</p> <p>4</p> <p>3</p> |

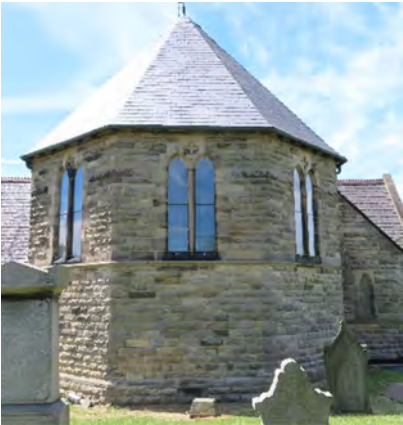
| Image & Location | Description | Condition | Repair Needs | Category |
|---|---|---|---|---|
| <u>East Elevation</u><br> | Traditional stone construction using rock faced, grey freestone from Penshaw Quarry and recovered stone from the previous demolished church. | The walls to this elevation are generally sound. There is some weathering and delamination in areas with isolated failure of pointing. | Continue to monitor walls in case of any future deterioration. Descale stones and assess whether replacement stones are required to areas of weathering and carry out any repointing when similar work is carried out elsewhere. | M/4 |

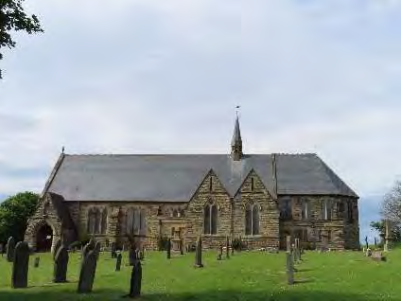
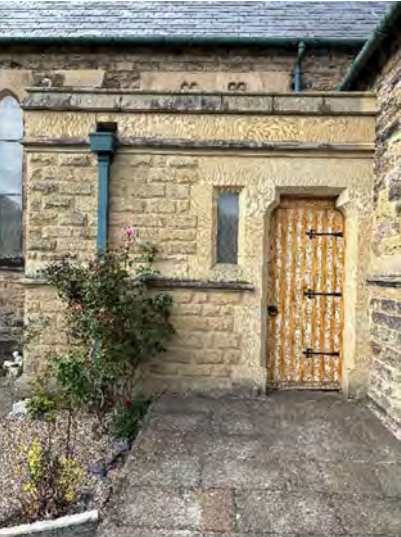
| Image & Location | Description | Condition | Repair Needs | Category |
|---|---|---|---|---|
| <p><u>South Elevation</u></p> | <p>Traditional stone construction using rock faced, grey freestone from Penshaw Quarry and recovered stone from the previous demolished church.</p> | <p>There is a memorial garden to the base of the wall meaning care must be taken during any future scaffolding or maintenance work.</p> <p><b>Porch</b><br/>Stonework appears generally sound with only some minor weathering to some stones. Some open joints to the water tabling and deterioration of stone to water table.</p> <p>There is deterioration / weathering of stone to the niche above the door.</p> <p>There is some more significant loss of pointing and weathering of stone to wall behind the porch with isolated weathering elsewhere. Planting close to walls.</p> <p><b>Accessible Entrance</b><br/>Stonework appears generally sound. Some weathering and staining around the gutter and hopper head area suggesting overflowing has been an issue. Planting is located close to the wall.</p> <p><b>South Transcept</b><br/>Stonework appears generally sound. Some weathering of stone and loss of mortar. Entrance sign is deteriorating with church name unable to be read clearly.</p> <p><b>Vestry</b><br/>Some weathering to lower areas of stone and top course of stones with loss of pointing.</p> <p><b>Buttresses</b><br/>Loss of face to some stones.</p> | <p>Repoint water table – inspect condition of stone and repair or replace.</p> <p>Descalce stones and assess whether replacement stones are required to areas of weathering. Localised areas of repointing.</p> <p>Descalce stones and assess whether replacement stones are required to areas of weathering. Localised areas of repointing.</p> <p>This should be monitored to ensure rainwater goods are functioning properly. Continually manage size to prevent trapping moisture against masonry and ensure airflow.</p> <p>Localised repointing to prevent future water ingress. Assess condition of weathered stones and repair/replace as required. Renew/fix entrance sign.</p> <p>Descalce stones and assess whether replacement stones are required to areas of weathering. Localised areas of repointing.</p> <p>Descalce stones and assess whether replacement stones are required to areas of weathering.</p> | <p>2</p> <p>3</p> <p>3</p> <p>M</p> <p>3</p> <p>3</p> <p>3</p> |

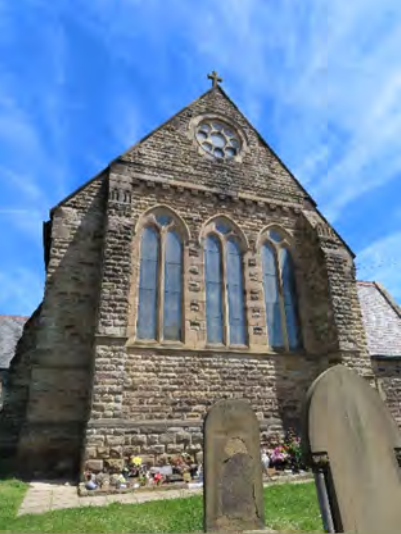
| Image & Location | Description | Condition | Repair Needs | Category |
|---|---|---|---|---|
| <u>West Elevation</u><br> | <p>Traditional stone construction using rock faced, grey freestone from Penshaw Quarry and recovered stone from the previous demolished church.</p> | <p>There is a memorial garden to the base of the wall meaning care must be taken during any future scaffolding or maintenance work.</p> <p>Open / hungry joints to water table.</p> <p>There is some significant deterioration of stone to the lower courses of this elevation with loss of face to some stones and a number of open joints.</p> <p><b>Buttresses</b><br/>Some deterioration and loss of pointing to upper levels of stone.</p> <p><b>Porch</b><br/>Some deterioration of stones and loss of pointing to lower level of stones.</p> | <p>Repoint open joints.</p> <p>Descalce stones and assess whether replacement stones are required to areas of weathering. Repoint any open/hungry joints.</p> <p>Localised areas of repointing.</p> <p>Descalce stones and assess whether replacement stones are required to areas of weathering.</p> | <p>2</p> <p>3</p> <p>3</p> <p>3</p> |

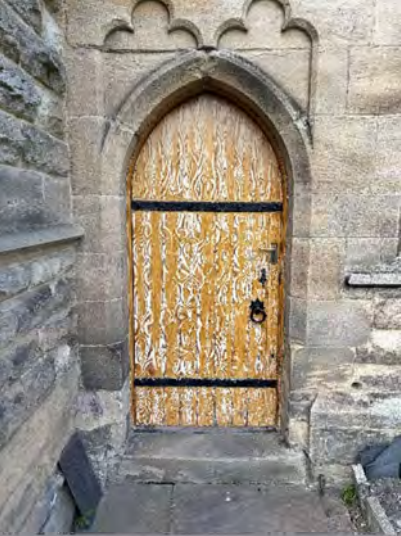
| Image & Location | Description | Condition | Repair Needs | Category |
|---|---|---|---|---|
| <u>Doors</u><br> | | <b>Accessible Entrance</b><br>Timber door is in fair but weathered condition. Finish has significantly degraded. | Sand down and redecorate / re-stain the door to provide renewed weather protection. | 3 |
| | | The Bottom rail to the door has lifted / warped and is show signs of rot and requires replacement/repair. | Sand down and redecorate / re-stain the door to provide renewed weather protection.<br>Replace the bottom rail. | 3 |
| | | <b>Vestry Entrance</b><br>Significant surface erosion of paint/stain to door. | Sand down and redecorate / re-stain the door to provide renewed weather protection. | 3 |
| | | Some weathering to mortar joints surrounding doorway. | Monitor and repoint mortar joints as part of next general maintenance. | 4 |

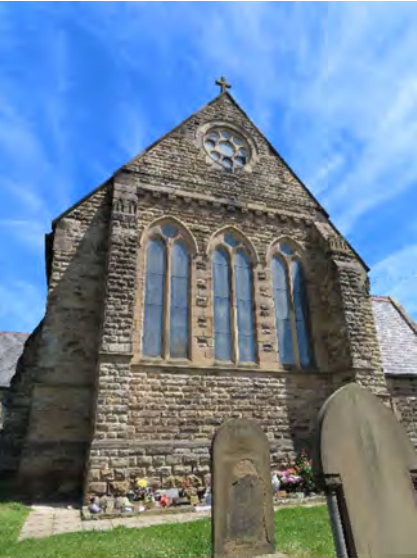
| Image & Location | Description | Condition | Repair Needs | Category |
|---|---|---|---|---|
| <u>Windows</u><br> | | <b>West Elevation:</b><br><br><b>W1</b><br>Some deterioration of stone surround in various locations. Window appears sound. | Descale weathered stones and assess whether repair or replacement stones are required.<br>Repoint where required. | 3 |
| | | <b>W2</b><br>Some deterioration of stone surround in various locations. Window appears sound. | Descale weathered stones and assess whether repair or replacement stones are required.<br>Repoint where required. | 3 |
| | | <b>W3</b><br>Some deterioration of stone surround in various locations. Window appears sound. | Descale weathered stones and assess whether repair or replacement stones are required.<br>Repoint where required. | 3 |

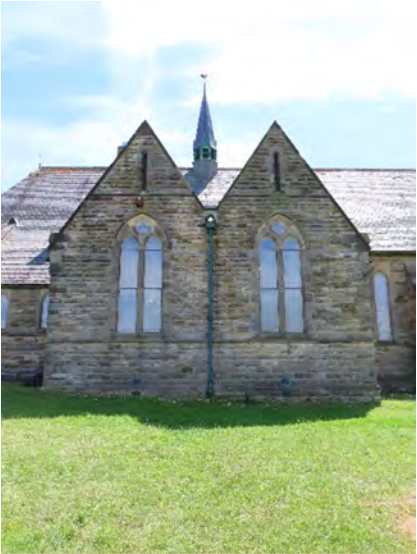
| Image & Location | Description | Condition | Repair Needs | Category |
|---|---|---|---|---|
| <p><u>Windows</u></p> <br> | | <p><b>North Elevation:</b></p> <p><b>W4</b><br/>Some loss of pointing to stone surround. Some delamination of stones and right hand side of right mullion. Window appears sound.</p> <p><b>W5</b><br/>Generally ok. Some delamination to left side upper mullion. Window appears sound.</p> <p><b>W6</b><br/>Some delamination of stone surround, particular to right side of window. Delamination to both mullions to both sides. Window appears sound.</p> <p><b>W7</b><br/>Generally ok. Some delamination of stone to upper left of surround and area of missing stone/pointing to upper right of stone tracery. Window appears sound.</p> <p><b>W8</b><br/>Some delamination to lower right cill with delamination of stone faces to left side of surround and upper right. Window appears sound.</p> <p><b>W9</b><br/>Some delamination to left and ride side of stone surround. Window appears sound.</p> <p><b>W10</b><br/>Generally appears ok. Some minor loss of pointing to right side upper areas of surround. Some moss growth to cill. Window appears sound.</p> | <p>Descale weathered stones and assess whether repair or replacement stones are required. Repoint where required.</p> <p>Descale weathered stones and assess whether repair or replacement stones are required. Repoint where required.</p> <p>Descale weathered stones and assess whether repair or replacement stones are required. Deterioration to mullion may be caused by rusting saddle bars internally. Repoint where required.</p> <p>Monitor weathered stones. Repoint where required.</p> <p>Descale weathered stones and assess whether repair or replacement stones are required. Repoint where required.</p> <p>Descale weathered stones and assess whether repair or replacement stones are required. Deterioration to mullion may be caused by rusting saddle bars internally. Repoint where required.</p> <p>Remove areas of moss to cill.</p> | <p>3</p> <p>3</p> <p>3</p> <p>3</p> <p>3</p> <p>3</p> <p>4</p> |

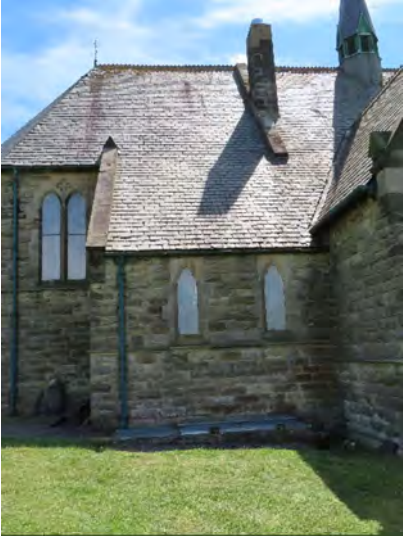
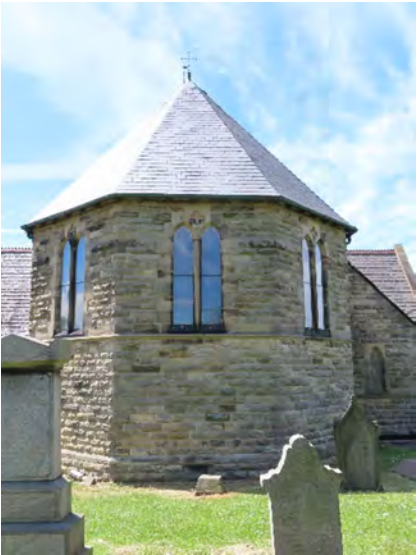
| Image & Location | Description | Condition | Repair Needs | Category |
|---|---|---|---|---|
| <p><u>Windows</u></p> | | <p><b>W11</b><br/>Some cracking and delamination to stone cill with some moss growth. Some debris and dust behind perspex. Window appears sound.</p> <p><b>East Elevation: W12</b><br/>Some dust/debris behind perspex. Some delamination of stone to upper areas of surround. Window appears sound.</p> <p><b>W12a / W13 / W14 &amp; W15</b><br/>General Note: Hairline cracking and spalling to stone cill around metal pipe fixings, difficult to assess without further investigation whether due to installation or pipe deterioration.</p> <p><u>W12a</u><br/>Some delamination of upper left surround. Some delamination of left upper mullion.. Window appears sound.</p> <p><u>W13</u><br/>Cracking to top of stone surround. Delamination to both sides of mullion. Some delamination to stone surround in various locations. Darkening / soiling of stone surround. Window appears sound.</p> <p><u>W14</u><br/>Delamination primarily visible to left side of stone surround and central mullion left side. Darkening / soiling to cill and parts of mullion. Window appears sound.</p> <p><u>W15</u><br/>Some areas of delamination to surround. Darkening / soiling to cill, mullion and upper tracery. Window appears sound.</p> | <p>Descale weathered stones and assess whether repair or replacement stones are required. Repoint where required. Remove moss growth. Remove perspex to clean debris and dust and refix.</p> <p>Repoint where required. Remove perspex to clean debris and dust and refix.</p> <p><b>W12a / W13 / W14 &amp; W15</b><br/>Investigate purpose of metal pipe projecting through the cill (it may be a drain). Ensure pipe is functioning</p> <p>Descale weathered stones and assess whether repair or replacement stones are required. Repoint where required.</p> | <p>3</p> <p>3</p> <p>3</p> <p>3</p> |

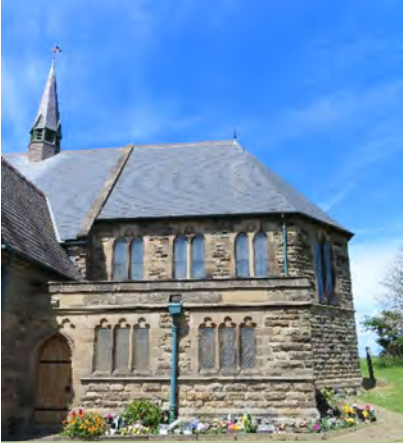
| Image & Location | Description | Condition | Repair Needs | Category |
|---|---|---|---|---|
| | | <p><b>W15a/W15b/W15c</b><br/>Visibility externally limited due to location of Vestry. Upper parts of stone surround appears sound with some minor delamination of stone.</p> <p><b>South Elevation:</b></p> <p><b>W16</b><br/>Generally appears sound. Some minor cracking and delamination to surround and mullions. Windows appear sound.</p> <p><b>W17</b><br/>Some cracking, delamination to right mullion. Some delamination of right upper stone surround. Windows appear sound.</p> | Repoint where required. | 4 |

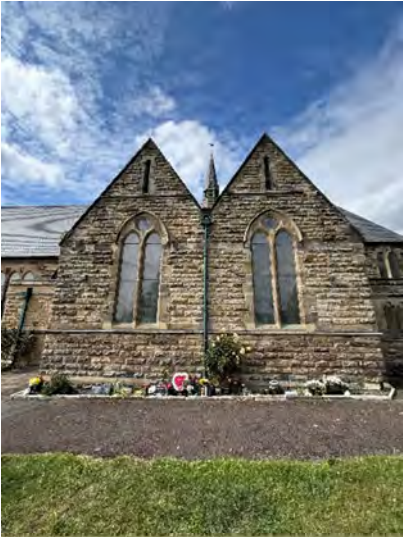
| Image & Location | Description | Condition | Repair Needs | Category |
|---|---|---|---|---|
| | | <p><b>W18</b><br/>Some delamination of stone mainly to right side of surround with some hairline cracking. Window appears sound. Slight weathering to mullion.</p> <p><b>W19</b><br/>Delamination of stone to right side mid and upper tracery. Some hairline cracks to upper left side of tracery. Some rubble/debris to right window behind perspex possibly suggesting loss of pointing to areas. Windows appear sound</p> | <p>Repoint where required.</p> <p>Descale weathered stones and assess whether repair or replacement stones are required. Repoint where required.</p> <p>Descale weathered stones and assess whether repair or replacement stones are required. Repoint where required. Remove perspex to clean debris and dust and refix.</p> | <p>3</p> <p>3</p> |

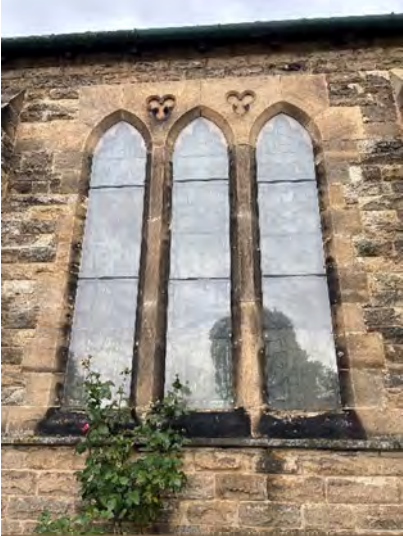
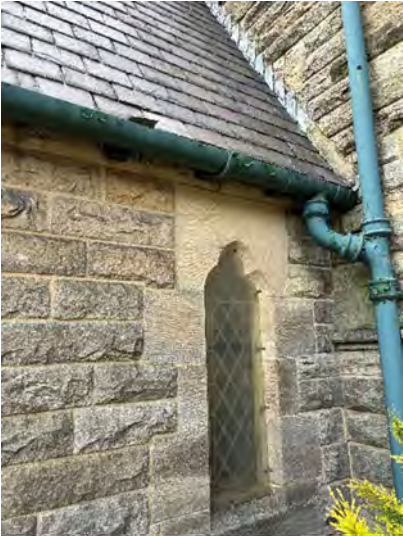
| Image & Location | Description | Condition | Repair Needs | Category |
|---|---|---|---|---|
| <p><u>Windows</u></p> | | <p><b>W21</b><br/>Significant deterioration to the top of stone cill to all three lights. Darkening / soiling of cill. Areas of spalling stonework to both sides of surround. A schedule of works had previously been produced for replacements/repairs to these cills in 2007. From photos viewed from that period the cill doesn't appear to have deteriorated much further since then. Vegetation from memorial garden in front is beginning to encroach on the window and this should be managed to ensure it doesn't touch any parts of the window. Window appears sound.</p> | <p>Likely cill replacement stones required. Descale weathered stones and assess whether additional replacement stones are required. Repoint where required.</p> | 2 |
| | | <p><b>W22</b><br/>Generally ok with some minor hairline cracks and minor loss of point to areas. Window appears ok.</p> | <p>Repoint where required.</p> | 3 |
| | | <p><b>W23</b><br/>Some discolouration to perspex. Window appears ok. Isolated weathering of stonework.</p> | <p>Consider replacing perspex.</p> | 4 |

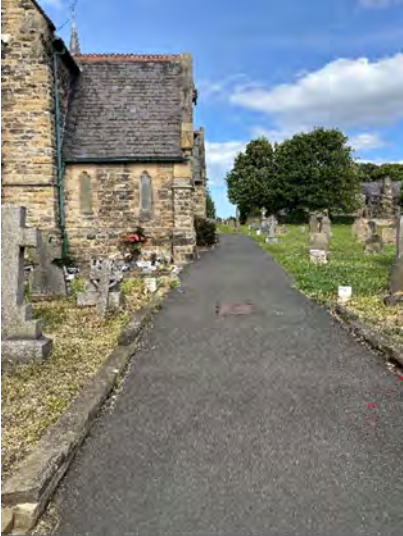
| Image & Location | Description | Condition | Repair Needs | Category |
|---|---|---|---|---|
| <u>Churchyard</u><br> | <p>Large closed graveyard with many burials and monuments and maintained by Sunderland City Council.</p> <p>Ashes memorials are at the foot of the west and south walls.</p> | <p><b>Tarmac Path from Main Gates:</b></p> <p>Condition ok. Some weed growth to junction stone edging and around manhole and ramp.</p> <p>Areas of older tarmac to the East showing some deterioration, cracking and weed growth.</p> <p>Some kerbs to south of church are leaning, however they are currently firmly set in place.</p> <p><b>Graves:</b></p> <p>Open joints and some low level damage to Colpitt grave.</p> <p><b>Paved Paths:</b></p> <p>More significant grass growing between and over edges of path.</p> <p>Damage to angled paving to South East corner of vestry.</p> | <p>Remove vegetation annually and repair any damage to tarmac.</p> <p>Monitor and resurface when required.</p> <p>Some listing. Check Sunderland are carrying out routine check on graves and mature trees.</p> <p>Remove vegetation annually.</p> <p>Replace 2 stones as in a reasonably trafficked area.</p> | <p>M</p> <p>M</p> <p>M</p> <p>M</p> <p>2</p> |

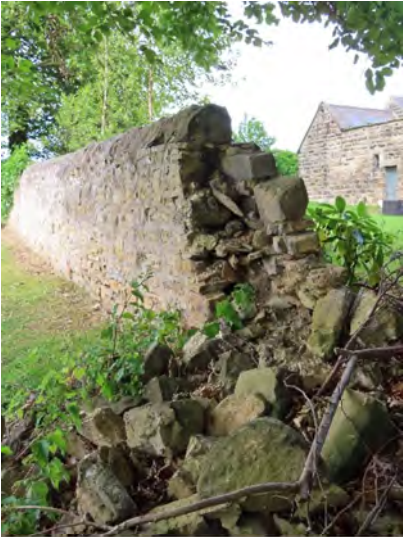
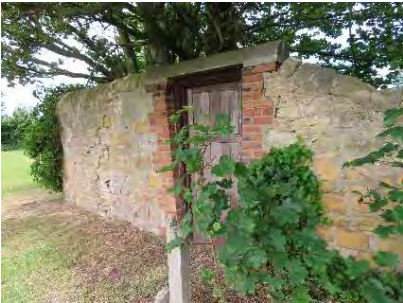
| Image & Location | Description | Condition | Repair Needs | Category |
|---|---|---|---|---|
| <u>Boundaries</u><br><br> | <p>There is a section of railing to the far south then with a stone wall at varying heights and stepped heights as it runs to the north.</p> | <p><b>East South End</b><br/> There are several mature and semi-mature trees to both sides of boundary with significant sections concealed with ivy. There is some cracking and isolated loss of stones.</p> <p>There is a section which has fallen near the house with a tree and pole behind.</p> <p>There is a slight lean to standing sections to immediate north – the wall to the south appears fairly hollow.</p> <p><b>North End of East Wall</b><br/> There is some weathering to stone with open joints to the base of the wall and cracking.</p> <p>The wall around the Sycamore tree is cracked and leaning towards the house.</p> <p>The wall at the corner near the gate is bulging with significant cracking and leaning. This requires urgent attention.</p> <p>Lintel and upper courses of bricks have moved. Loss of finish to gate.</p> | <p><b>All areas of walls and fencing:</b><br/> Discuss overall repair needs with the Local Authority and agree priorities and a programme for repair.</p> <p>Remove/manage areas of more significant ivy growth.</p> <p>Section of wall to be rebuilt and address any issues with trees.</p> <p>This requires barrier / fence protection in the interim period to keep pedestrians away from it until the issue is fixed.</p> <p>The gate requires re-staining.</p> <p>Repair wall.</p> | <p>2-5</p> <p>M</p> <p>2</p> <p>1</p> <p>3</p> <p>2</p> |

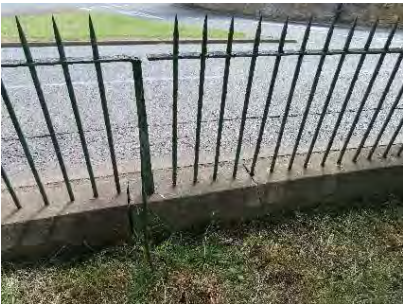
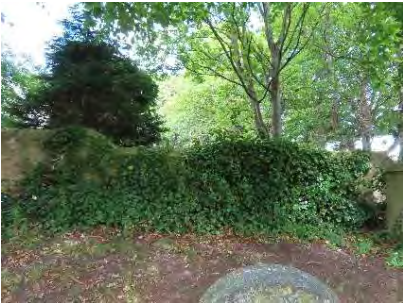
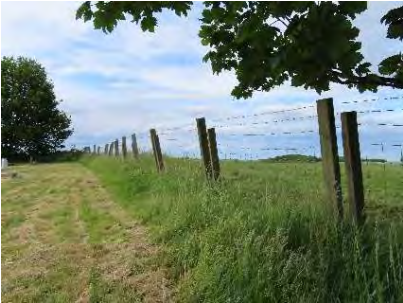
| Image & Location | Description | Condition | Repair Needs | Category |
|---|---|---|---|---|
| <u>Boundaries</u><br><br><br> | <p>Stone retaining wall with metal railing over.</p> | <p><b>South Wall</b><br/>Internally there is quite a sharp point at hip height with very rusty sections and loss of paint along the entire length.</p> <p>There are gaps in the railing – elder between the wall and gravestone is forcing the grave to lean. Isolated railings bent or missing, missing details or sections with lots of opening joints to coping.</p> <p><b>Southern Boundary to North of Vicarage</b><br/>Significant ivy coverage at west end – loss of pointing and some deterioration to stone to visible sections.</p> <p>Loss of pointing near outbuilding.</p> <p><b>East End of South</b><br/>Significantly overgrown wall which becomes a barbed wire fence. The wire is not at a consistent height and has some missing sections. This may become an issue if area beyond here is used by others in the future.</p> <p><b>East Boundary</b><br/>High stock fence however some posts are leaning. Many appear to be rotting in the ground.</p> <p><b>Northern End of East Boundary</b><br/>Boundary is behind nettles and undergrowth – no visibility.</p> | <p>The metal railing requires repainting. Consideration should be given as to mitigate / warn about the sharp points to the metal railing.</p> <p>Replace missing sections of railings and repoint joints to coping. Maintain / remove vegetation.</p> <p>Boundary / particular walls – see note to start of section.</p> <p>Contact farmer to discuss rectification of fence.</p> | <p>1(warning)<br/>3 (works)</p> <p>2</p> <p>2<br/>(with 2-5 for completion of works)</p> <p>1-2</p> |

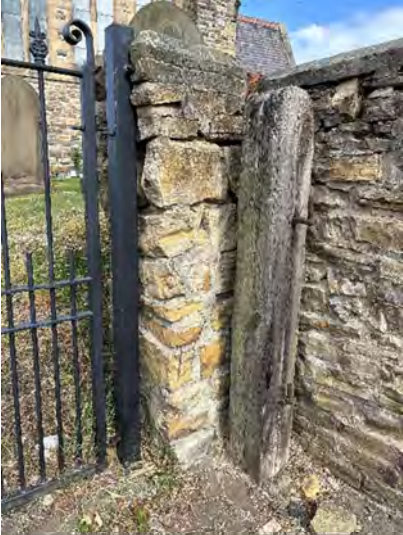
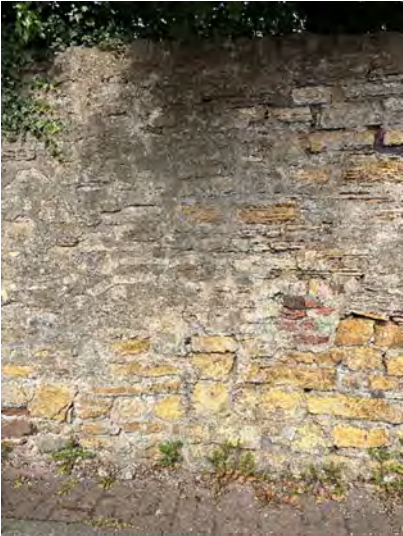
| Image & Location | Description | Condition | Repair Needs | Category |
|---|---|---|---|---|
| <u>Boundaries</u><br><br><br><br> | | <p><b>East Boundary to North Side</b><br/>Stock fence – appears sound.</p> <p><b>Northern Boundary</b><br/>Appears to be fenced with but vegetation concealing visibility.</p> <p>Where areas are visible there are at least 2 posts which are rocking – animals behind so may need to contact owner.</p> <p><b>Wall to West End</b><br/>Issues with mortar and cracking.</p> <p><b>North End of West Wall</b><br/>Loss of mortar and cracking. Ivy growth including g between stones – slight lean – bulging in places.</p> <p><b>Vehicle Gates</b><br/>Padlock is rusting. Issues to both sides with cracking, loose/missing stones. Some are very badly weathered especially to right hand side.</p> <p><b>External Walls (approach to vehicle gates)</b><br/>There is some significant deterioration of stone to external walls with loss of pointing and weathering to many sections.</p> | <p>Replace fence posts.</p> <p>See note to start of section.</p> <p>Consider new padlock. Repair and repointing to area around gates.</p> | <p>2</p> <p>2-3</p> |

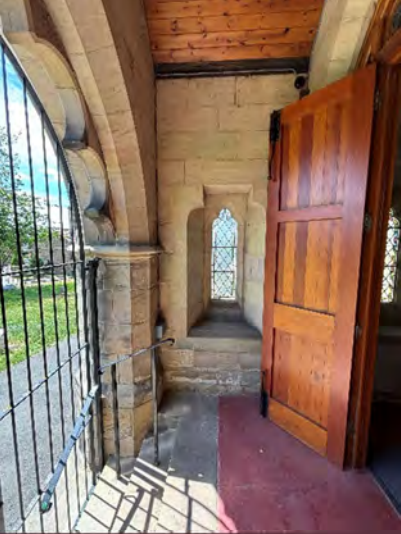
| Image & Location | Description | Condition | Repair Needs | Category |
|---|---|---|---|---|
| <u>Porch</u><br> | <p>Covered entrance area with stone walls and accessed via double metal gates. Stepped access into porch by concrete (part painted) steps with metal handrails. Timber clad ceiling with light fitting. Stained glass windows and double timber entrance doors with glazed surround.</p> | <p>Stone Walls – Some deterioration of stones / loss of face. Weathered stone to upper left area above gates and window surround – could potentially be due to water ingress.</p> <p>Timber Ceiling – appears to be in sound condition.</p> <p>Metal Gates/Handrails – Minor flaking of paint to areas.</p> <p>Windows – Appear to be in sound condition.</p> <p>Timber Frame to Doors – Some flaking of paint and minor cracking at joints.</p> <p>Timber Entrance Doors – appear to be in good condition.</p> | <p>Monitor stones throughout this period to identify any further deterioration.</p> <p>Repaint in next period of decoration.</p> <p>Restain frame in next period of decoration.</p> | <p>M</p> <p>M</p> <p>M</p> |

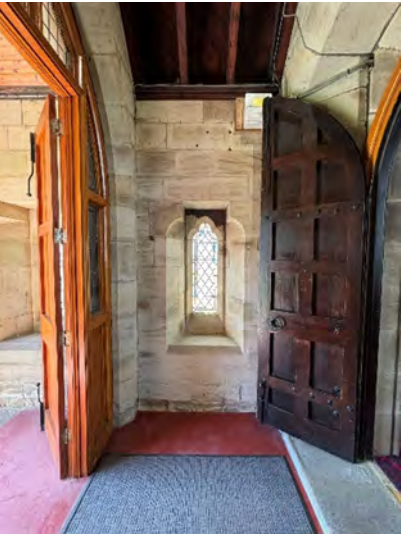
| Image & Location | Description | Condition | Repair Needs | Category |
|---|---|---|---|---|
| <u>Lobby</u><br> | <p>Stone walls accessed via double timber doors from porch with open timber ceiling. Painted concrete floor with entrance mat and stained glass windows. Double timber entrance doors into Nave. Fusebox located above entrance doors.</p> | <p>Stone Walls – Deterioration of stone to lower two courses.</p> <p>Timber Doors into Nave – Some minor cracking above doors. Doors appear to be in working order.</p> <p>Windows – Some loss of pointing between to sill to both W23 &amp; W26. Crack to W23 sill. Loss of pointing to head stone. Stained Glass appears to be in sound condition.</p> <p>Timber Ceiling – appears to be in sound condition.</p> | <p>Monitor stones throughout this period to identify any further deterioration.</p> <p>Monitor cracks and repoint during next period of decoration.</p> | <p>M</p> <p>M</p> |

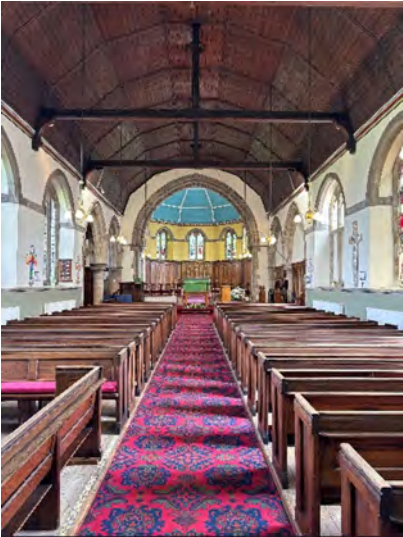
| Image & Location | Description | Condition | Repair Needs | Category |
|---|---|---|---|---|
| <p><u>Nave</u></p> | <p>Floor: Carpeted and timber boarded (to pew areas)</p> <p>Walls: Plaster Painted</p> <p>Ceiling: Exposed trusses with painted boarding.</p> <p>Windows: Stained Glass. W20 partially infilled to lower part of window.</p> <p>Other: White radiators, pendant lighting</p> | <p><b>General Walls:</b><br/>There is some cracking to plaster above all radiators which may be due to change in temperatures. However, the crack above W21 appears slightly deeper than others.</p> <p><b>North Wall:</b><br/>W4 – Crack below window cill and flaking paint to upper area of window frame.<br/>W5 – Some minor cracking to stained glass pieces. Minor delamination of stone. Crack below window cill.<br/>W6 – Minor cracking to top of window.</p> <p><b>South Wall:</b><br/>Some minor cracking to stone window heads. Lower areas of walls painted green showing some signs of cracking / flaking.<br/>W20 – Some cracking below cill<br/>W21 – Some minor delamination of stone faces. Minor cracking<br/>W22 – Minor crack to stone surround.</p> <p><b>West Wall:</b><br/>Flaking yellow paint visible to walls, mainly to top edges of walls. Likely due to unsuitable paint. Some flaking paint visible to window surrounds.</p> <p>Dust visible on cills from recent electrical works in roof void.</p> <p><b>General Ceiling:</b><br/>Ceiling appears to be in acceptable condition.</p> | <p>These cracks should be monitored to establish if any further movement occurs, particularly due to the condition of W21 externally.</p> <p>The cracking to window surrounds to all internal elevations is likely historical and to be expected from a building of this age, these minor cracks should continue to be monitored to ensure no further deterioration. Repaint with similar work.</p> <p>Repainting to lower areas of wall in line with planned ongoing maintenance programme. Consideration to be given to paint choice for longevity.</p> <p>Remove existing yellow paint finish from west wall where failing and review condition of wall below. Appropriate paint to be considered for redecoration.</p> <p>Clear dust from cills and monitor to identify if it reoccurs.</p> <p>Restain during next period of decoration.</p> | <p>M</p> <p>M</p> <p>M</p> <p>4</p> <p>M</p> <p>5</p> |

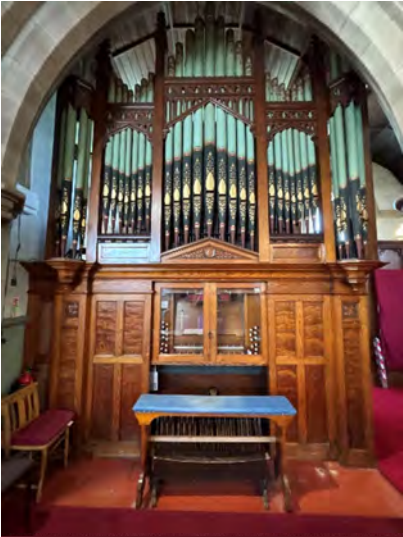
| Image & Location | Description | Condition | Repair Needs | Category |
|---|---|---|---|---|
| <p><u>Organ</u></p> | <p>Located in the North Transept and is a Nelson &amp; Co (Durham) pipe organ which was relocated from Langley Park Methodist Church approx. 1978. It has 2 manuals and 22 stops, pine panel enclosure and painted display pipes.</p> | <p>The church confirmed the organ is played regularly and serviced however one key is currently not working.</p> <p>There is some minor cracking to one of the timber panels.</p> | <p>Continue to carry out annual inspection and tuning. Key to be fixed.</p> | <p>M/5</p> |

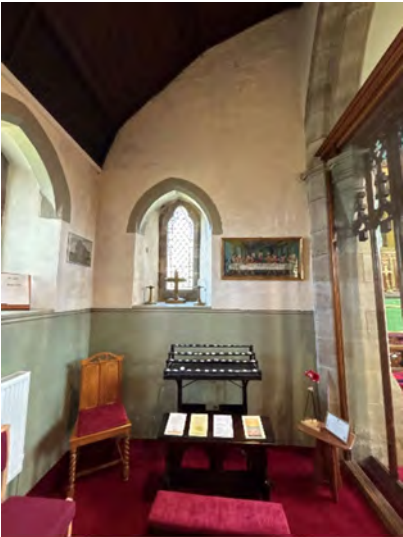
| Image & Location | Description | Condition | Repair Needs | Category |
|---|---|---|---|---|
| <p><u>Memorial Chapel</u></p> | <p>Entrance to Memorial Chapel stepped access with oak doors.</p> <p>Floor: Carpeted</p> <p>Walls: Plaster Painted</p> <p>Windows: Timber Glazed screen connecting to chancel and glazed external windows.</p> | <p>Small patch of missing carpet to approach to Memorial Chapel.</p> <p>Blistering and deterioration of plaster and stone above entrance and W10 due to issues with dampness. Potentially related to chimney/roof issues above in this location.</p> <p>Remaining walls rough plaster but in ok condition.</p> <p>Windows and glazed screen appear to be ok within this area.</p> | <p>Patch repair carpet with matching piece until next period of new carpet installation.</p> <p>Once cause of water ingress identified and rectified assess condition of wall. Replaster any areas of significant damage and allow to dry before repainting.</p> | <p>5</p> <p>2<br/>4 for<br/>reinstatement</p> |

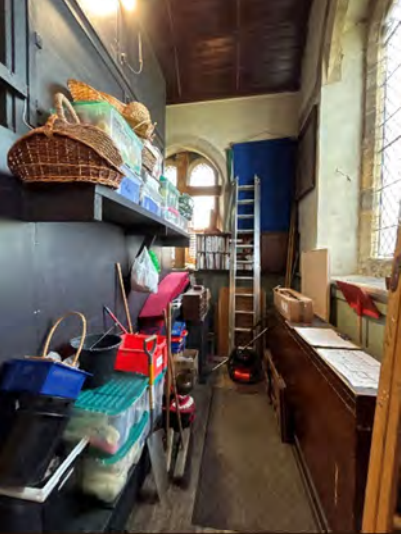
| Image & Location | Description | Condition | Repair Needs | Category |
|---|---|---|---|---|
| <u>North Transept</u><br> | <p>Floor: Timber Boarded</p> <p>Walls: Plaster Painted</p> <p>Ceiling: Timber clad</p> | <p>There is significant plaster failure / deterioration. The plaster is peeling and detaching from the substrate.</p> <p>W7 – Appears to be ok. Super superficial cracking of plaster visible to surround from what could be seen at a distance. There is a crack running from the bottom of the window down the wall which was difficult to access however appears to be quite large.</p> <p>W8 – There is significant deterioration to parts of the stone tracery / surround. Glazing appears to be ok.</p> <p>W9 – Difficult to access however also appears to be suffering from damp ingress to stone tracery / surround.</p> | <p>The source of water ingress requires investigation. Therefore, the approach to repair should be roof down. Once the immediate roof repairs have been undertaken the plaster should be removed to allow the walls to breathe and dry out fully. This would then allow for a review of the condition of the walls to identify if any further works are required to the walls prior to establishing a repair strategy.</p> <p>The deterioration within this area was not mentioned within the previous QI therefore this would suggest this issue has been declining significantly during the 5 years period since the last QI (unless it was missed). Carry out repairs to stonework alongside works noted above.</p> | <p>2-4</p> <p>3</p> |

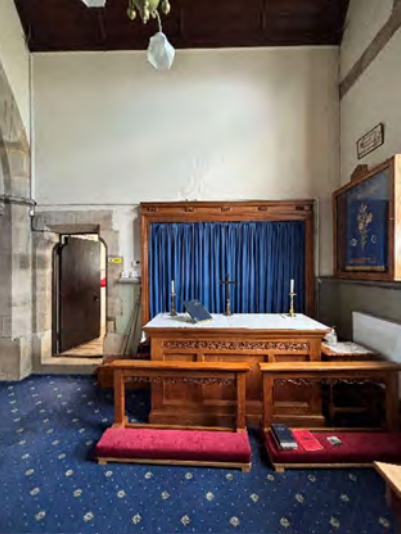
| Image & Location | Description | Condition | Repair Needs | Category |
|---|---|---|---|---|
| <u>Lady Chapel / Sunday School</u><br> | <p>Floor: Carpeted</p> <p>Walls: Plaster Painted</p> <p>Ceiling: Timber Boarded</p> <p>Windows: Glazed North Wall</p> | <p>Generally rough plaster to walls but ok to East and West wall.</p> <p>Issues to South wall significant, blistering paintwork and flaking to area.</p> <p>Significant delamination/deterioration of stone to left side of window.</p> <p>Cracking visible to plaster below cill and missing pointing between stone cill.</p> <p>Cupboards in good working condition with worktop above.</p> | <p>Monitor to identify any further deterioration and carry out repairs to plaster once ongoing issues are rectified.</p> <p>Monitor to identify any further deterioration and carry out repairs when similar works are carried out elsewhere.</p> <p>Monitor to identify any further deterioration and address before the area is next decorated.</p> | <p>M</p> <p>M</p> <p>M</p> |

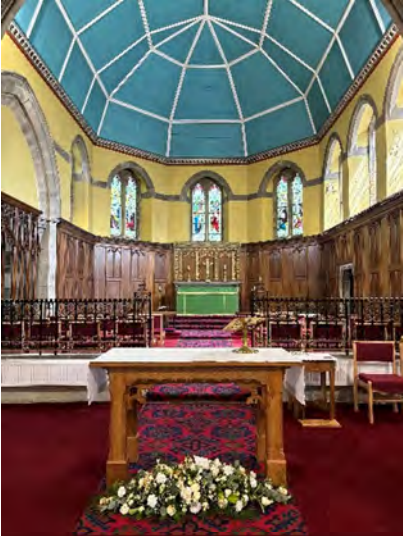
| Image & Location | Description | Condition | Repair Needs | Category |
|---|---|---|---|---|
| <u>Chancel</u><br> | <p>Floor: Carpeted</p> <p>Walls: Lower part Timber Panelled with yellow painted upper half.</p> <p>Roof: Painted timber roof – blue painted.</p> | <p>Timber panelling appears to be in good condition.</p> <p>Some flaking paint evident to yellow paint, appears to be occurring more frequently where sun is more dominant.</p> <p>W12a – Some cracking / flaking paint to left side of stone</p> <p>W13 – Some slight delamination to stone faces. Crack above window.</p> <p>W14 – Crack above window</p> <p>W15 – Crack above window</p> <p>W15a – Flaking paint to surround and minor delamination of stone.</p> <p>W15b – Flaking paint to surround and delamination to left side stones.</p> <p>W15c – Flaking paint to surround.</p> <p>Return area of wall appears to be wet. Paint is flaking / blistering primarily to right area.</p> | <p>Monitor existing cracking and address issues with plaster and stone and paint finish in next period of decoration.</p> <p>Investigate cause of possible damp during roof works.</p> | <p>5/M</p> <p>2</p> |

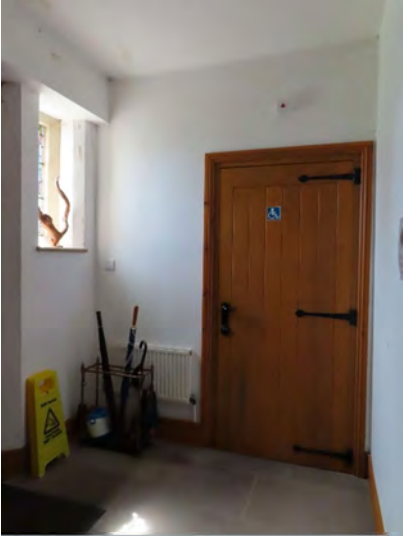
| Image & Location | Description | Condition | Repair Needs | Category |
|---|---|---|---|---|
| <u>Accessible Lobby</u><br> | Walls: Plaster painted<br><br>Ceiling: Flat painted ceiling<br><br>Floor: New stone flags with recessed mat.<br><br>Accessible entrance. | Umbrella stand within lobby possibly impedes independent use of the accessible WC due to turning circle requirements of a wheelchair user.<br><br>North Wall - Nail pop and marks to wall.<br><br>East Wall -Very minor open joints and slight cracking – however this is not significant at present.<br><br>South Wall -Staining to bulkhead and to wall with failing paint to western reveal.<br><br>Cracking to boxing over window – left hand side at junction between ceiling and boxing over the door.<br><br>Staining of ceiling in some areas. | Consider relocating umbrella stand or be aware this may be required to be moved for independent use.<br><br>Investigate issues and rectify when roof issues have been resolved. | 1/M<br><br>1 – Roof<br>3 - Repair |
| <u>Accessible WC</u> | Walls: Plaster painted<br><br>Ceiling: Flat painted ceiling<br><br>Floor: Vinyl floor with coved skirting. | Wheelchair and changing mat located within corner will be impeding use by wheelchair users.<br><br>Staining to south wall, ceiling and bulkhead following water ingress from frozen outlet. Some staining down wall possibly indicating rusty item above ceiling – check before rectifying.<br><br>Boxing behind WC is deteriorating.<br><br>Some loss of paint near electrical conduit and switch.<br><br>Cracking over door in north east corner. | Either manage this proactively or relocate.<br><br>Monitor and investigate if no obvious ongoing cause. Make good finish to allow easier ongoing monitoring.<br><br>May require to be partially replaced and repainted.<br><br>Touch up paint to this area.<br><br>Monitor to establish if cracking deteriorates and repair before room is next redecorated. | 1/M<br><br>3<br><br>3<br><br>M<br><br>M |

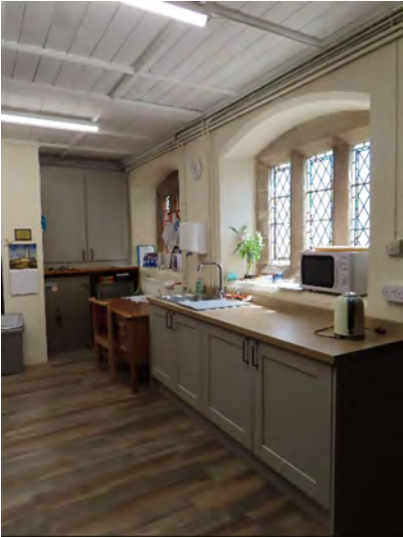
| Image & Location | Description | Condition | Repair Needs | Category |
|---|---|---|---|---|
| <u>Vestry / Kitchen</u><br> | <p>This space has been refurbished since the previous QI.</p> <p>Walls: Plaster Painted</p> <p>Ceiling: Flat boarded ceiling with exposed structure, all painted.</p> <p>Floor: Vinyl floor on timber boards.</p> <p>Windows – Plain glazing with some coloured glass. Exposed stone surround to windows. New kitchen units.</p> | <p><b>South Wall:</b><br/>Plaster is rough in places, but sound. Painted in a modern paint – no current issues except slight blistering / bubbling near door. Remains round plugs to right hand reveal.</p> <p>Right-hand window: There is some slight deterioration of stonework to right hand window and hungry joints. The mortar fillet around glazing is beginning to crack in places.</p> <p>Left-hand window: Stone head of window is shaling/delaminating with slight cracking.</p> <p>Rusty saddlebars to both windows with 1 cracked pane to central light on right hand window – it is held securely at present.</p> <p><b>East Wall:</b><br/>Areas of rougher plaster but generally sound. Blistering painted over to reveal of door to chancel and an area of plaster appears to be poorly bonded to right hand side reveal – it is held securely at present.</p> <p><b>North Wall:</b><br/>Slight streaking under high level pipes to left hand side wall units.</p> <p><b>West Wall:</b><br/>Areas of rougher plaster but sound.</p> | <p>Rectify issue / re plaster before next period of decoration.</p> <p>Monitor and remove any sections if appear likely to fail. This may require intervention in due course but currently ok.</p> <p>Monitor cracking to identify any further deterioration and repaint when similar work is carried out elsewhere.</p> <p>Consider repainting saddlebars.</p> <p>Repair plaster before next period of decoration.</p> <p>Monitor to ascertain if this is a roof or pipe issue and rectify any ongoing issues.</p> | <p>5</p> <p>M</p> <p>M</p> <p>5</p> <p>4</p> <p>2</p> |

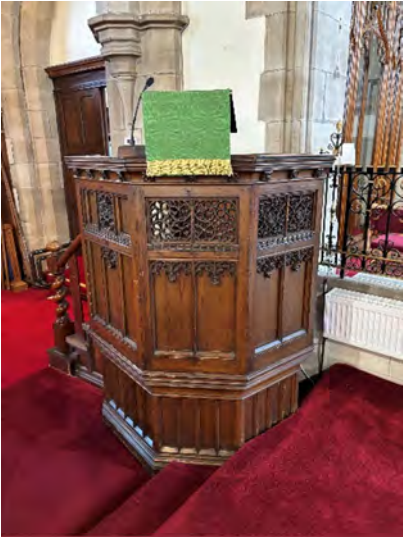
| Image & Location | Description | Condition | Repair Needs | Category |
|---|---|---|---|---|
| <p><u>Internal Fittings:</u></p> | <p>Altar</p> <p>Pulpit</p> <p>Font</p> | <p>Appears to be in good condition.</p> <p>Appears to be in good condition. Some minor wear to top of handrail.</p> <p>Appears to be in good condition.</p> | | |

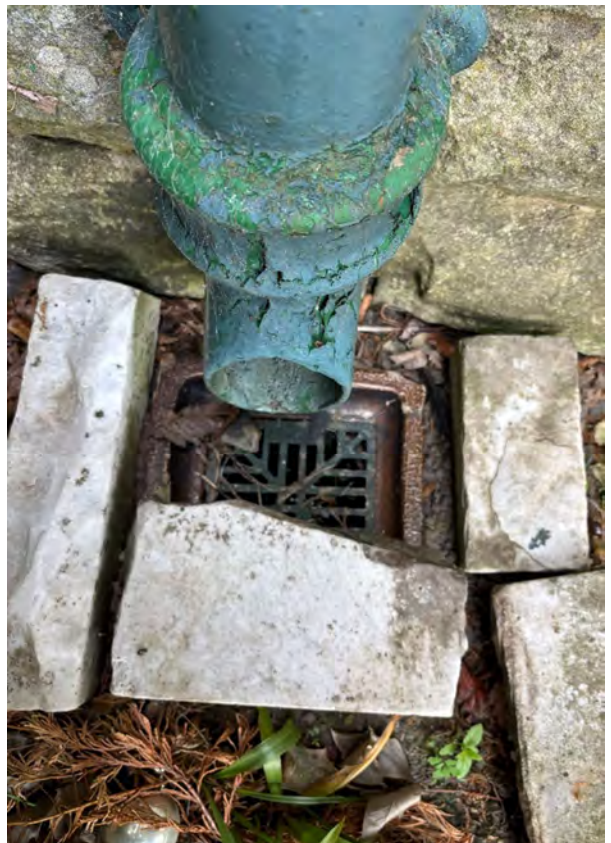
Stones surrounding some soakaways to multiple locations.
