## QUINQUENNIAL REPORT

*For the Parish Church of  
St. Matthew's Church, Newbottle*

**Report Date:** 24<sup>rd</sup> September 2025

Inspecting Architect:  
Becky Smith BA(Hons), MArch, ARB RIBA CR

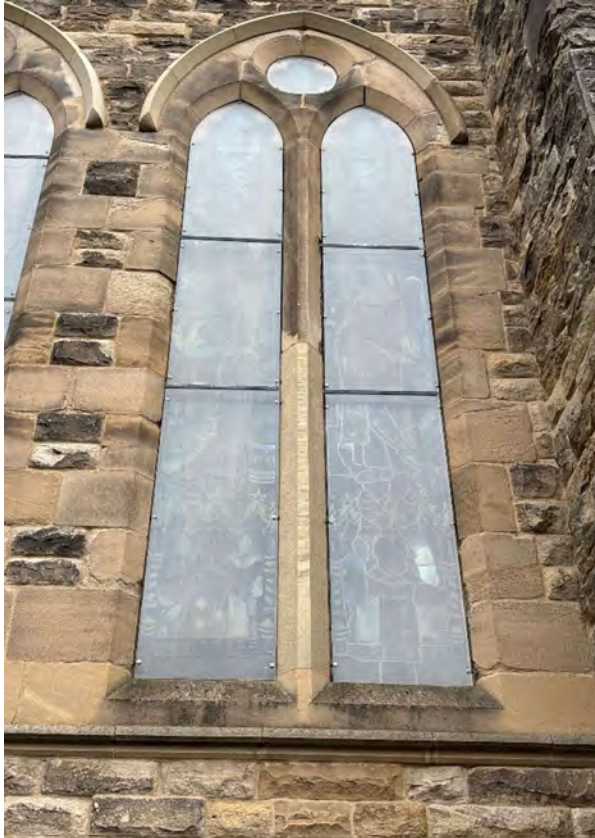
| Image & Location | Description | Condition | Repair Needs | Category |
|---|---|---|---|---|
| <u>Windows</u><br> | | <b>West Elevation:</b><br><br><b>W1</b><br>Some deterioration of stone surround in various locations. Window appears sound. | Descale weathered stones and assess whether repair or replacement stones are required.<br>Repoint where required. | 3 |

W1 – General overview of window.

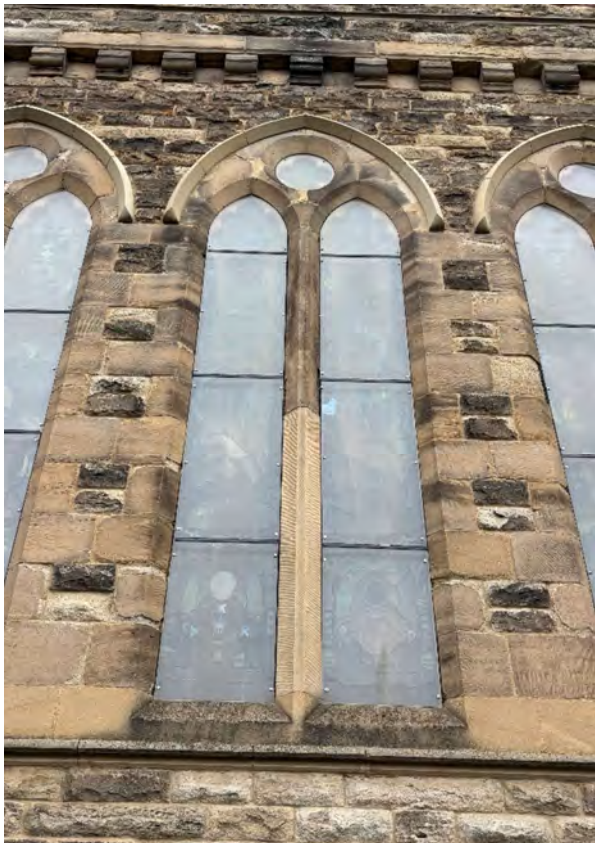
| Image & Location | Description | Condition | Repair Needs | Category |
|---|---|---|---|---|
| | | <b>W2</b><br>Some deterioration of stone surround in various locations. Window appears sound. | Descale weathered stones and assess whether repair or replacement stones are required.<br>Repoint where required. | 3 |

W2 – General overview of window.

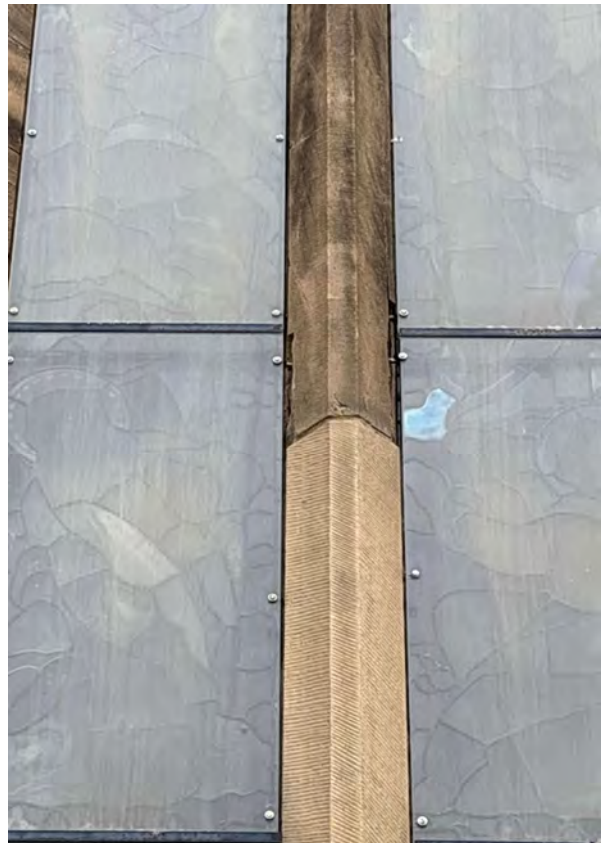
W2 – Weathering of stone around central mullion.

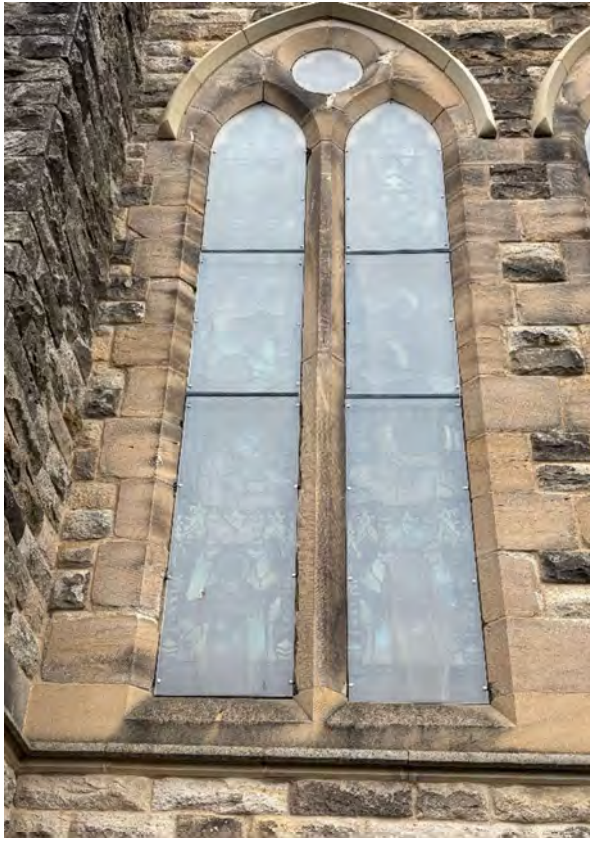
| Image & Location | Description | Condition | Repair Needs | Category |
|---|---|---|---|---|
| | | <b>W3</b><br>Some deterioration of stone surround in various locations. Window appears sound. | Descale weathered stones and assess whether repair or replacement stones are required.<br>Repoint where required. | 3 |

W3 – General overview of window.

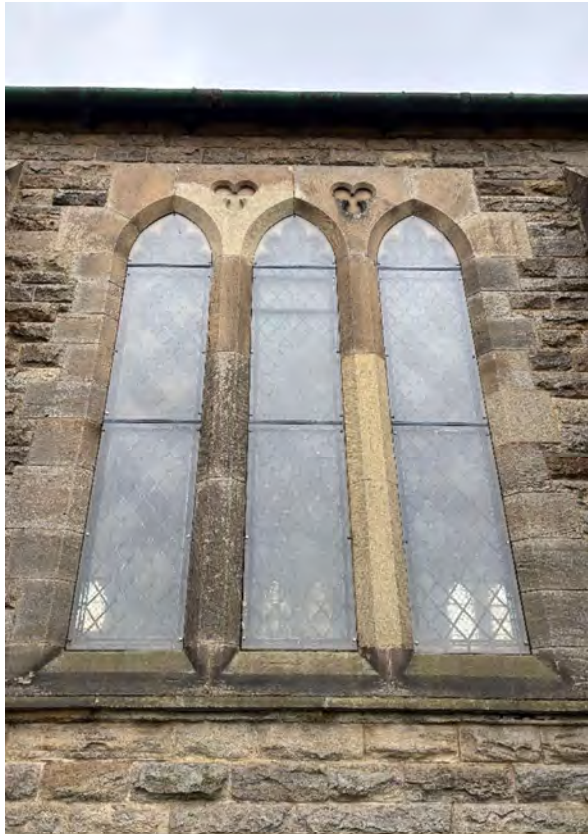
W5 – General overview of window.

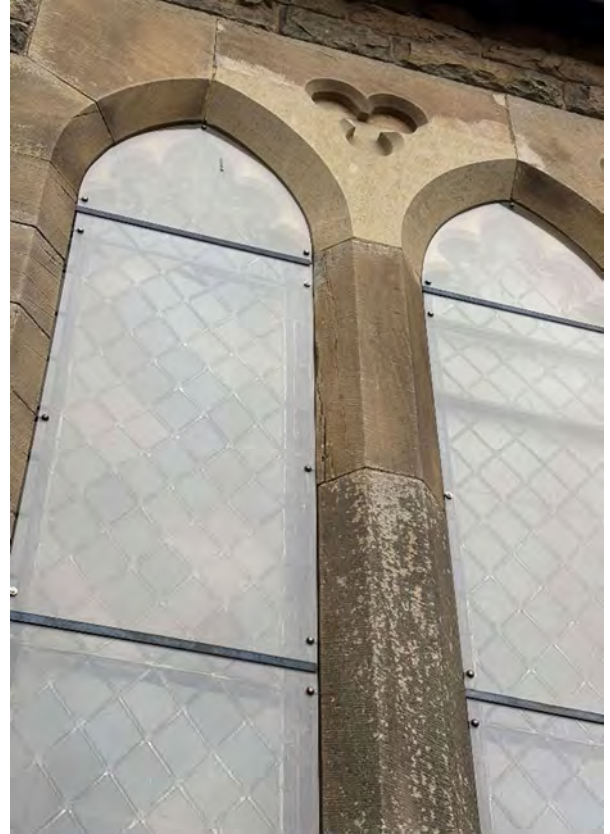
W5 – Some delamination to upper left mullion.

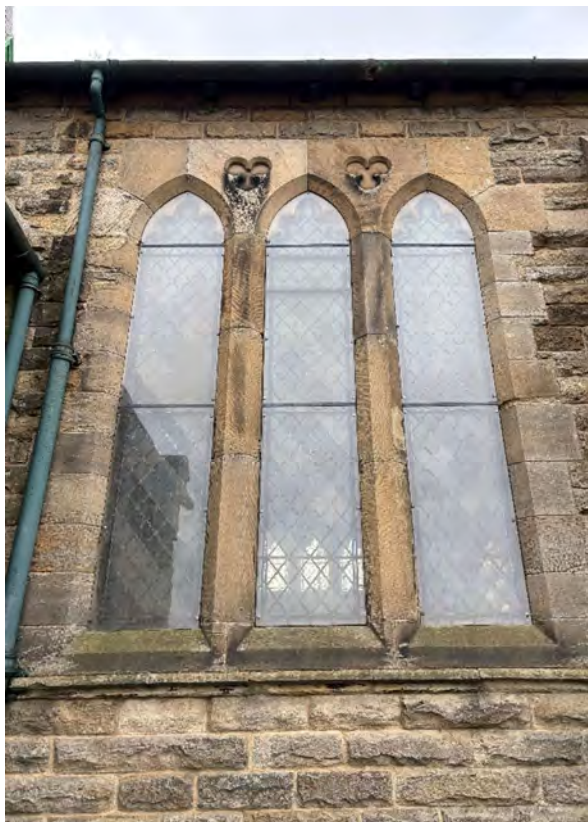
W6 – General overview of window.

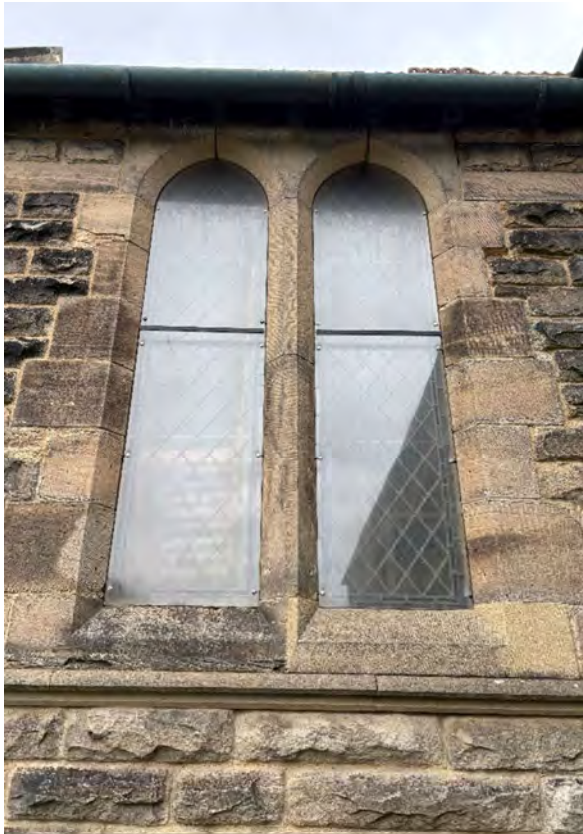
W7 – General overview of window.

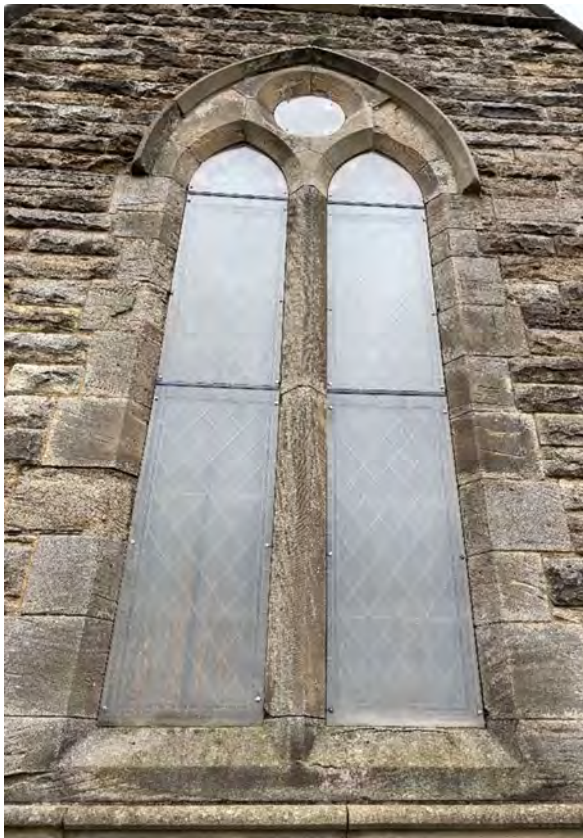
W8 – General overview of window.

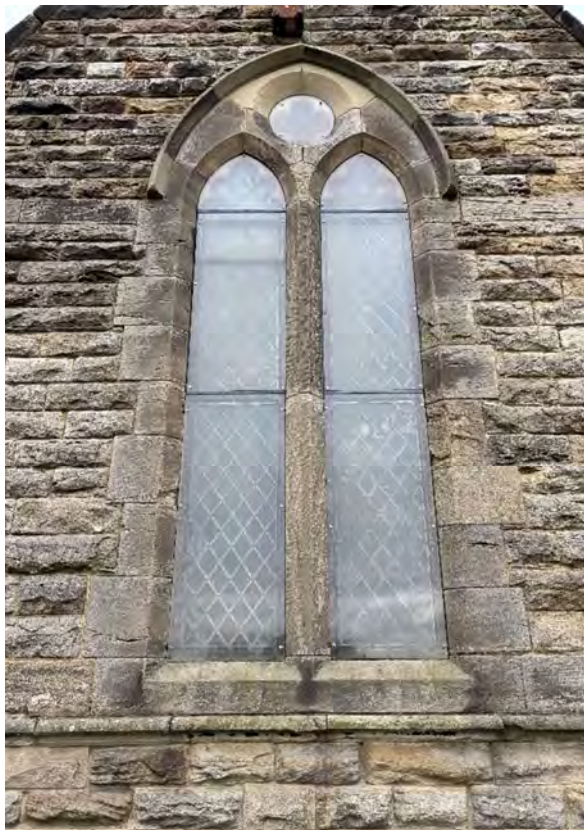
W9 – General overview of window.

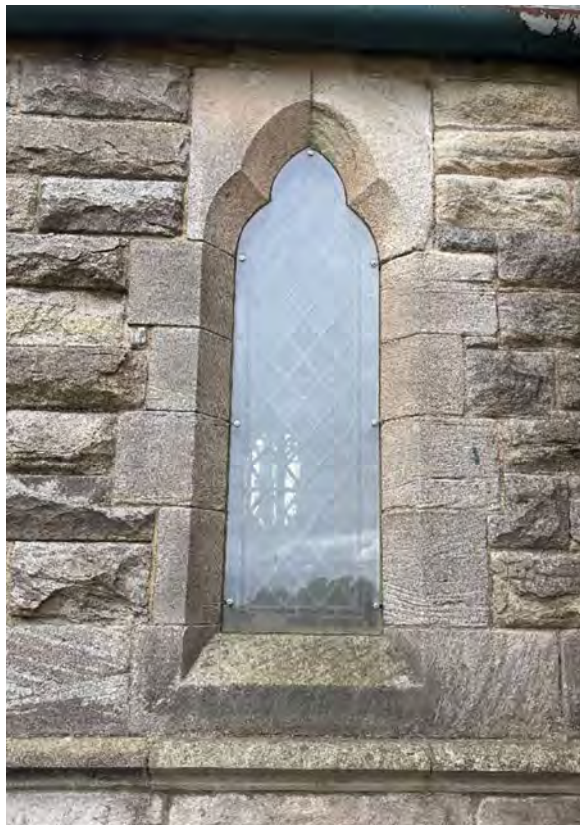
W10 – General overview of window.

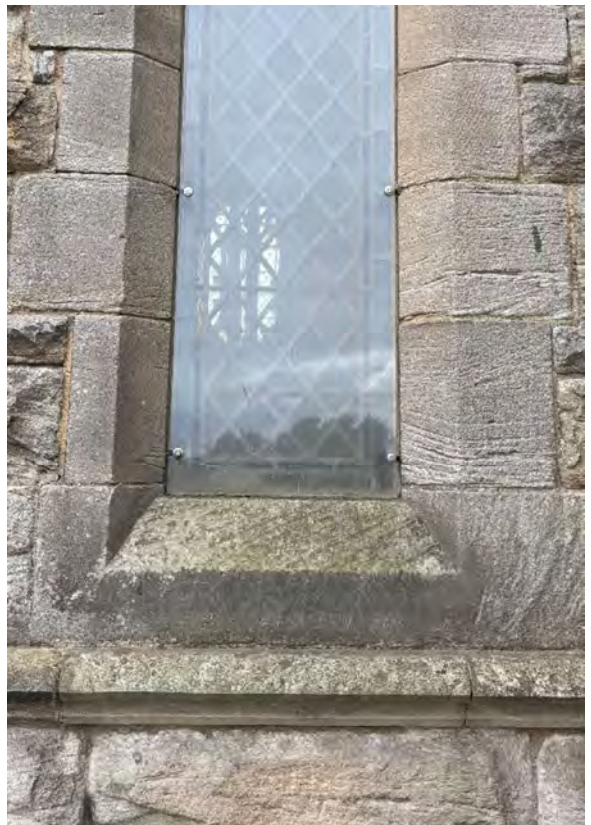
W10 – Some moss growth to cill.

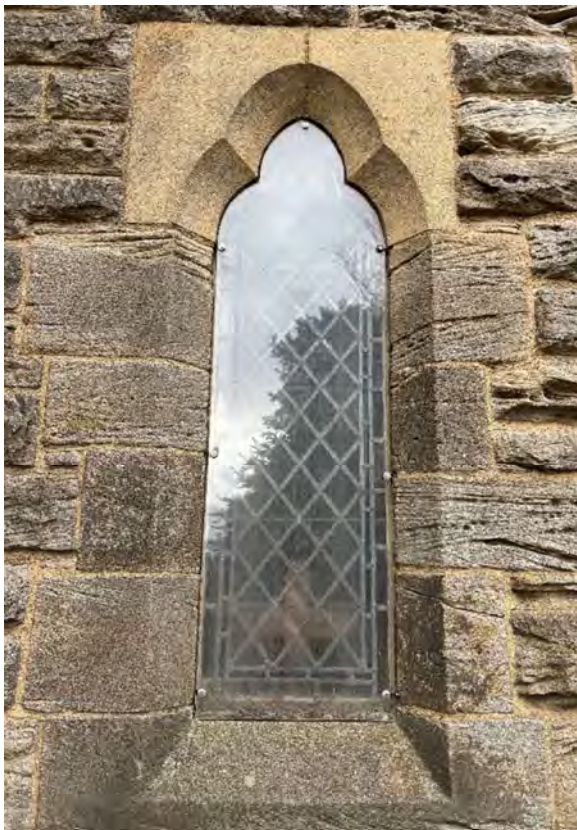
W12 – General overview of window.

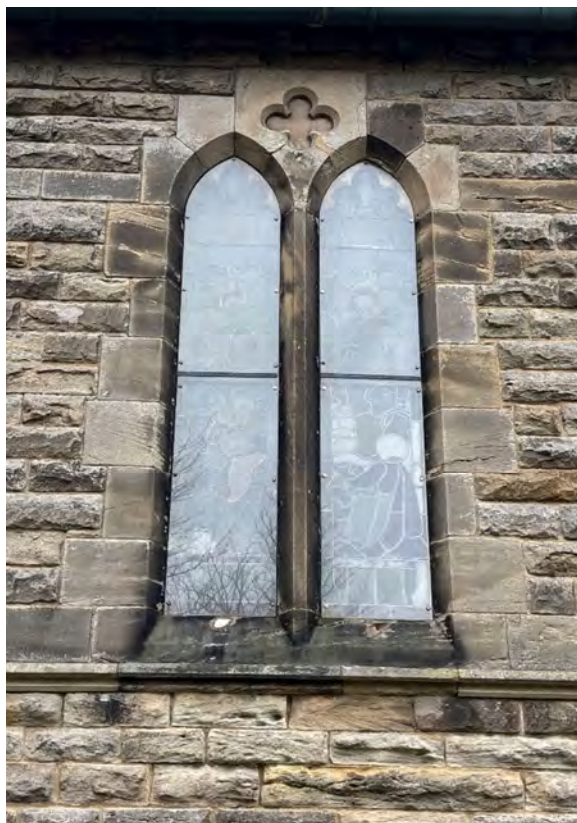
W13 - General overview of window.

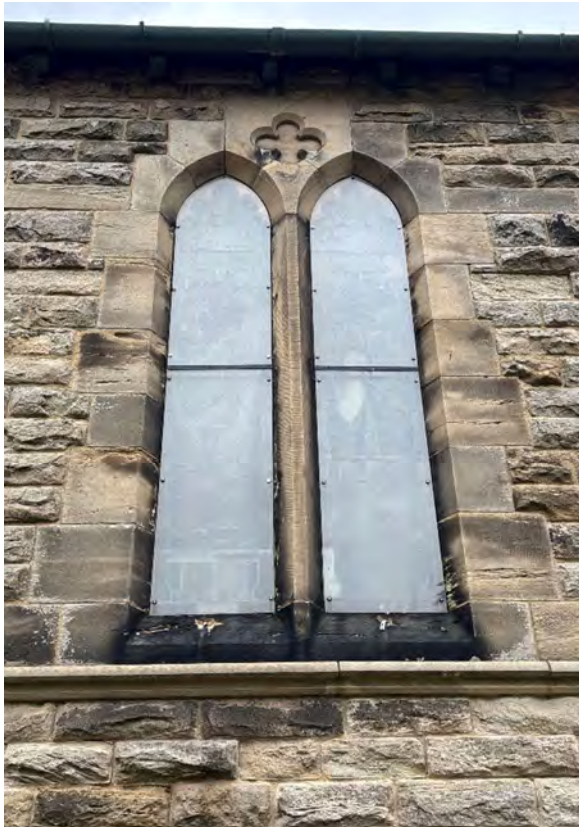
W14 – General overview of window.

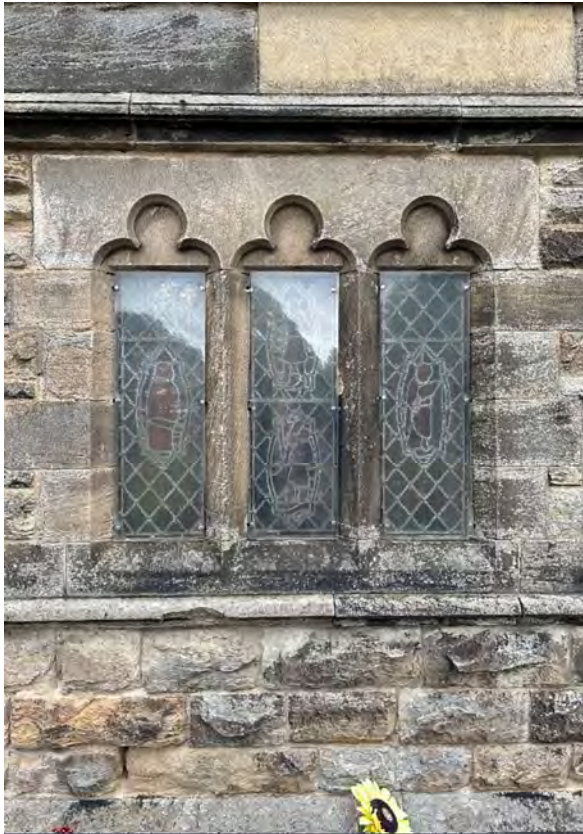
W16 – General overview of window.

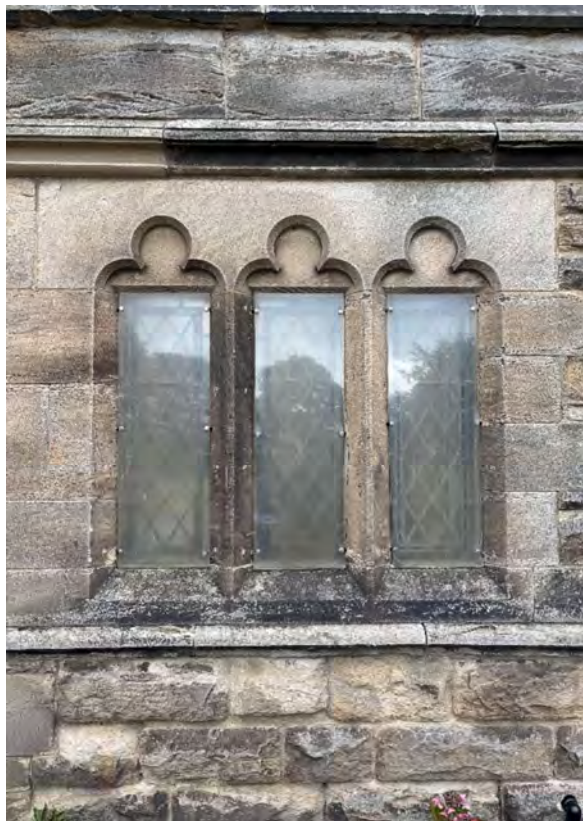
W17 – General overview of window.

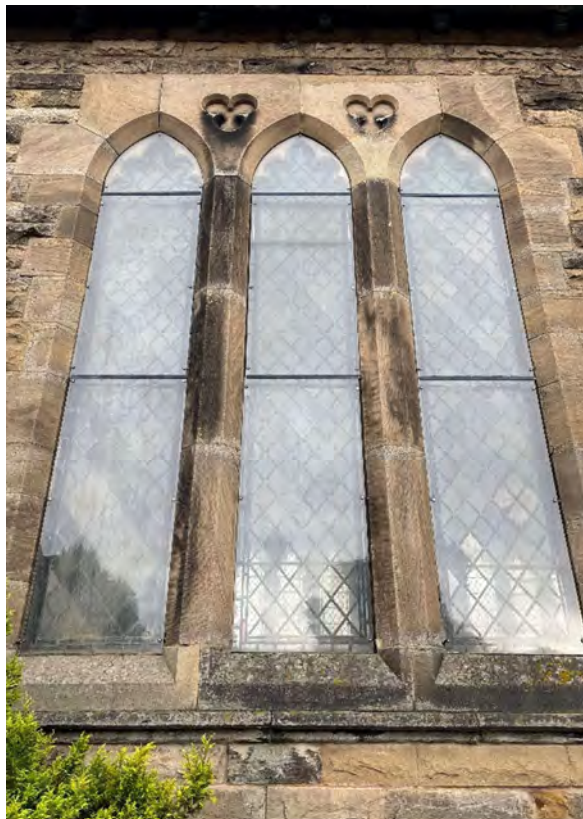
W22 – General overview of window.

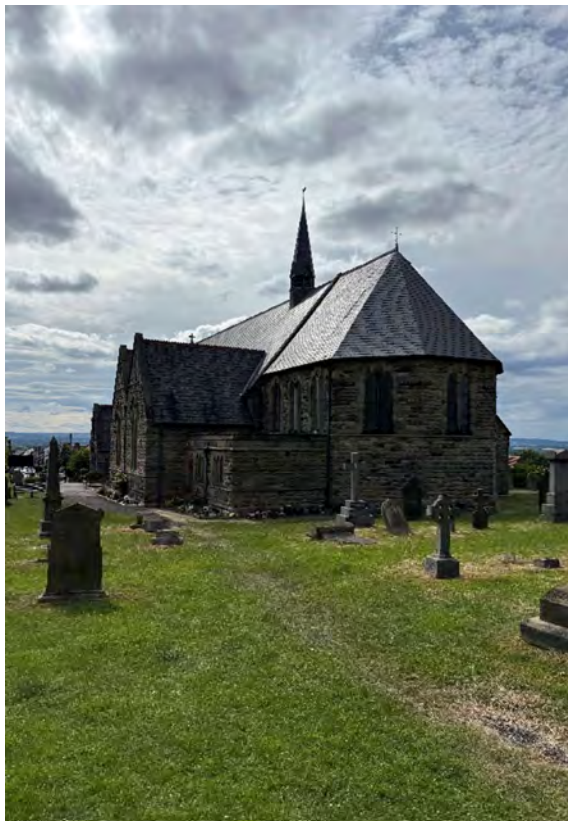
Overview of some of graveyard.

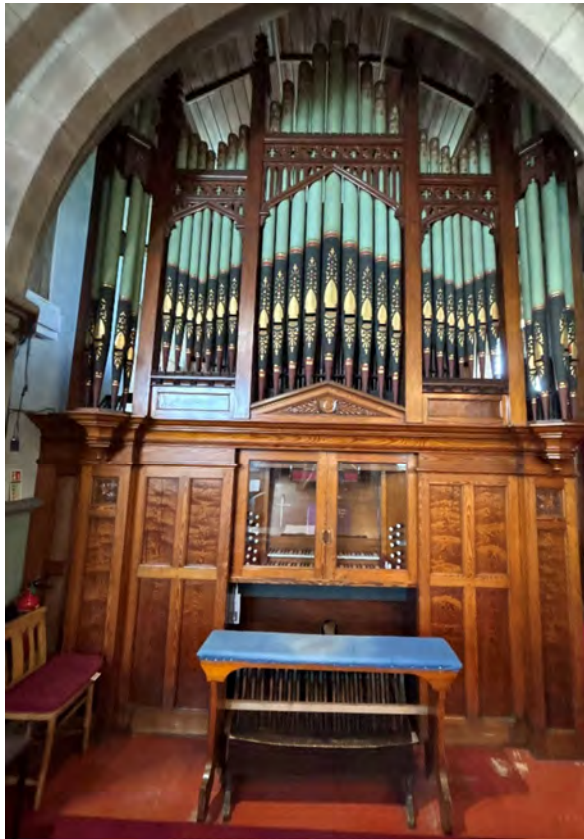
Overview of Organ

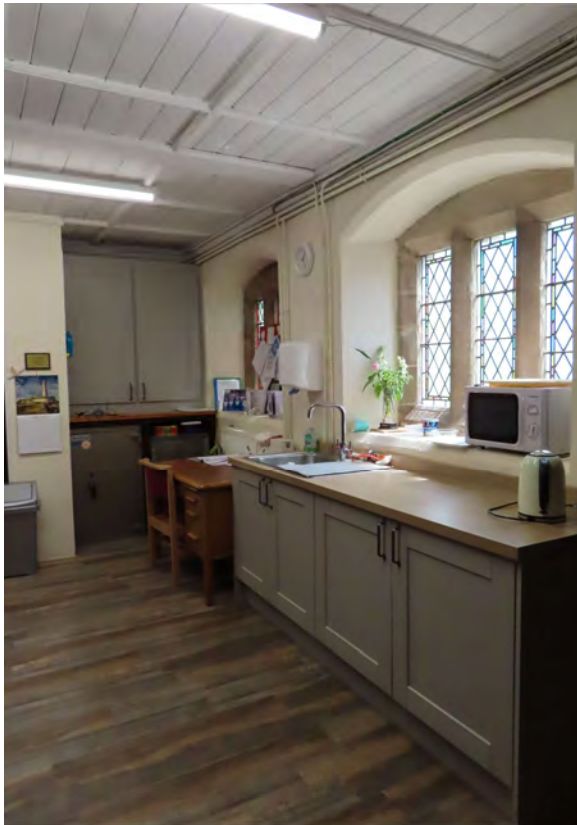
New Vestry Kitchen since previous QI

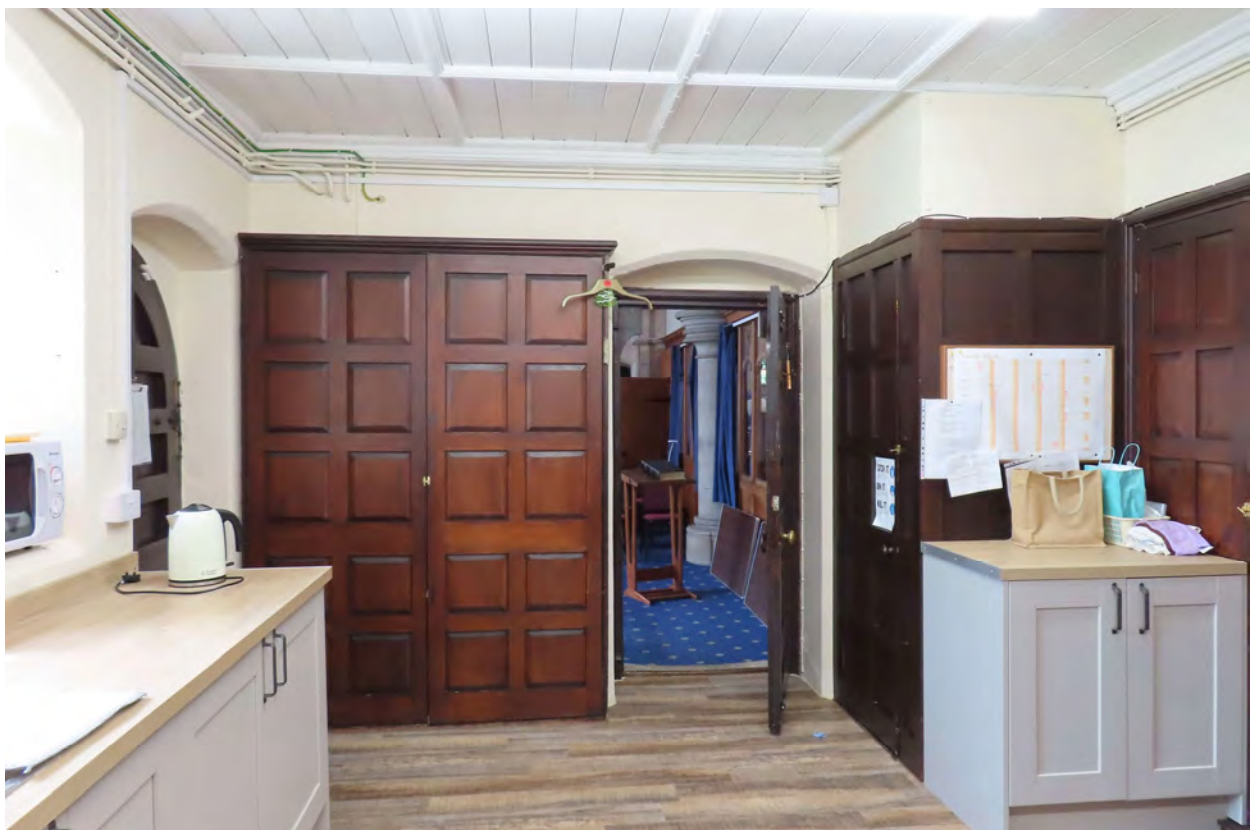
New Vestry Kitchen since previous QI
