**Quinquennial Inspection Report
The Church of St Michael and All Angels, South Westoe
Archdeaconry of Sunderland
Deanery of Jarrow
Diocese of Durham**

David Jowett - Architect, BA, DipArch, RIBA
25 Roseworth Avenue
Gosforth
Newcastle upon Tyne
NE3 1NB
Tel: 07788 710 204
email: david@davidjowett-architect.co.uk

17 September 2025

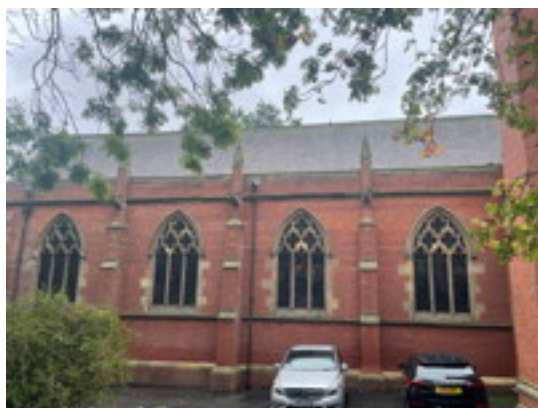
Roof South Elevation

Overall the slating appears in reasonable condition, as are the flashings and most of the ridges. A few sections of ridge tiles have missing mortar pointing and require repointing. There was no access to view the flat roof areas and the heavy tree cover obscures several sections of the pitched roofs.

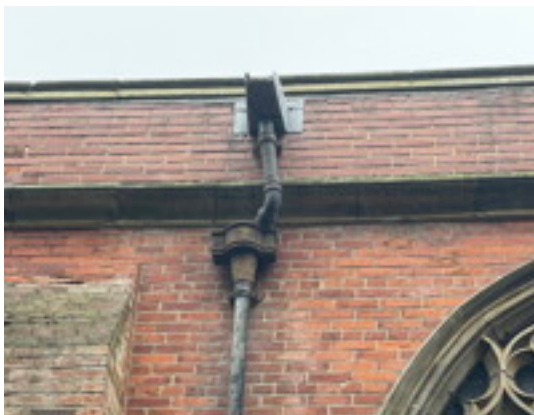
Parapet Outfall

Everything appeared watertight at time of the inspection. One blocked parapet outlet to south elevation. All cast iron rainwater goods are in urgent need of decoration.

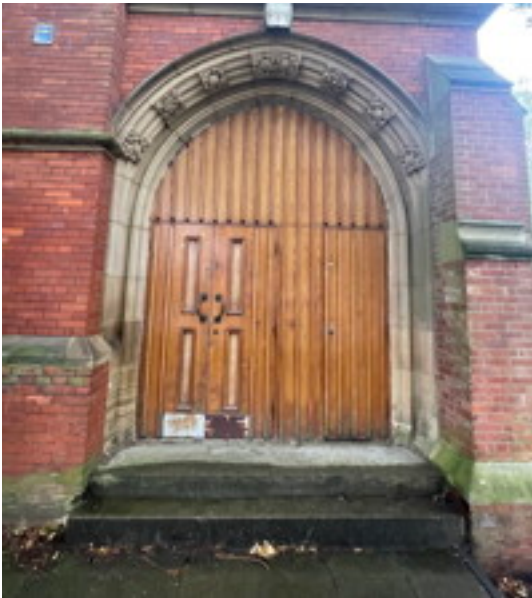
North Porch Door

All windows are in reasonable condition. North porch and Lady Chapel doors are in need of decoration. Rot to bottom of boiler house door.

Category B, Requires attention within the next twelve months

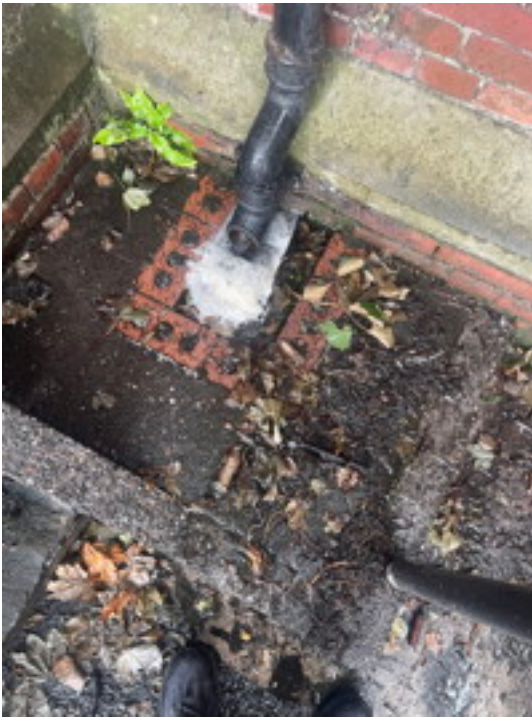
Typical Blocked Gully

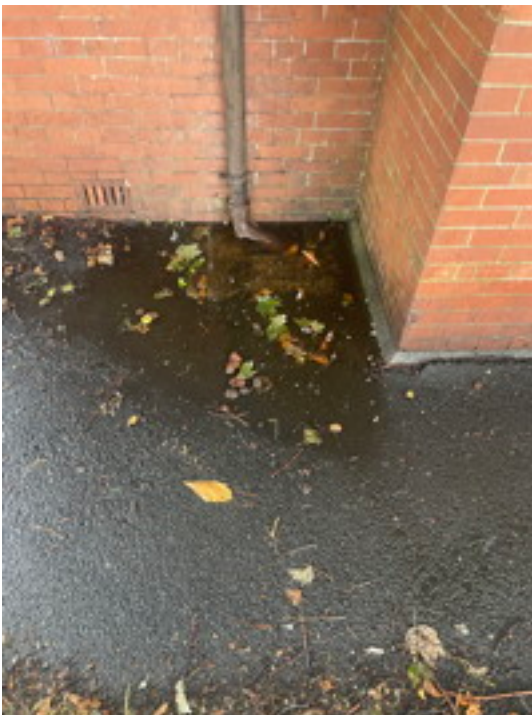
Blocked North Elevation East End Gully

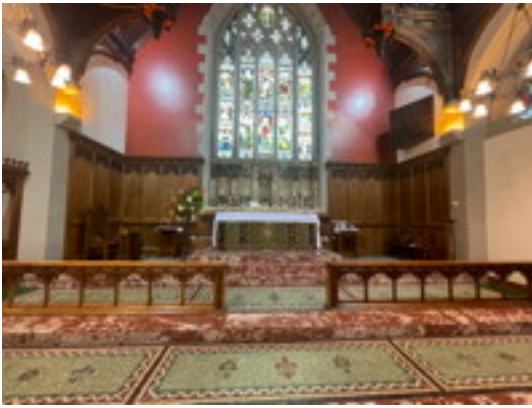
East Wall Red Paintwork

Slight damage by rising damp on south aisle south elevation east end. All others areas are satisfactory.

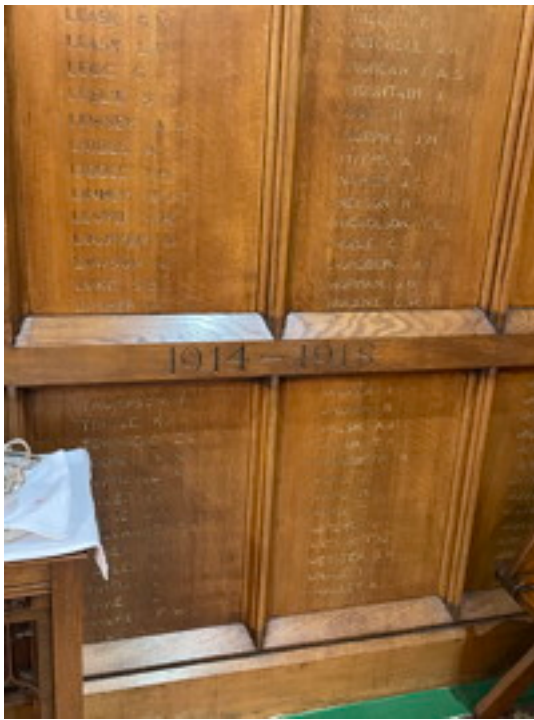
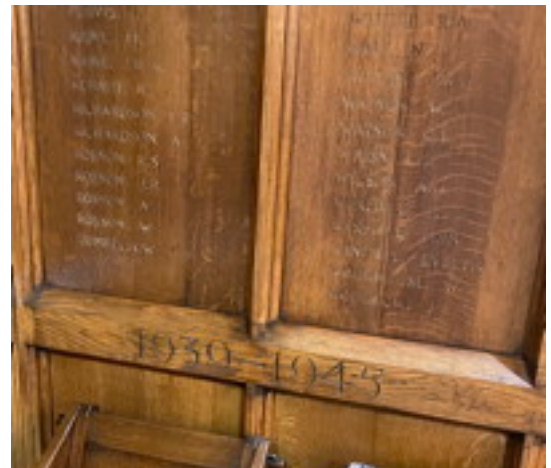
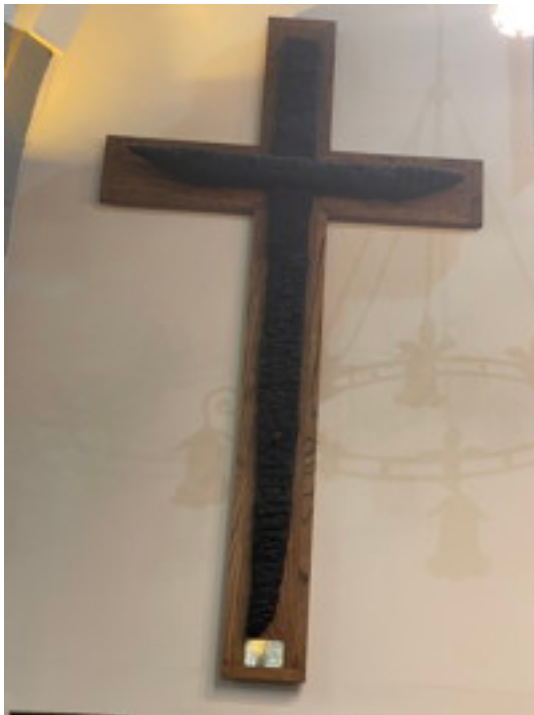
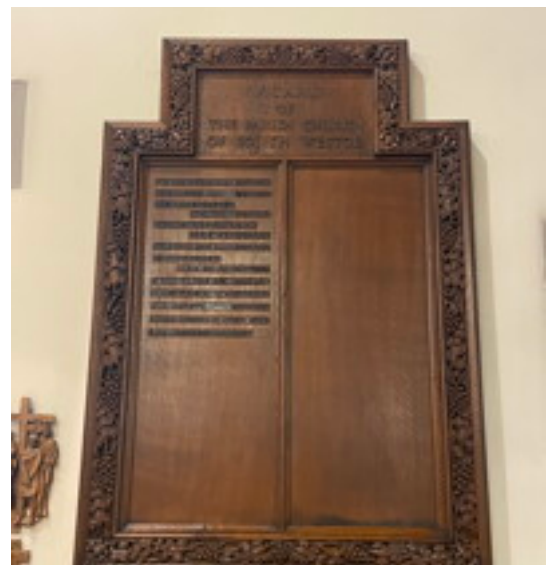
All memorials are in good condition and well cared for.

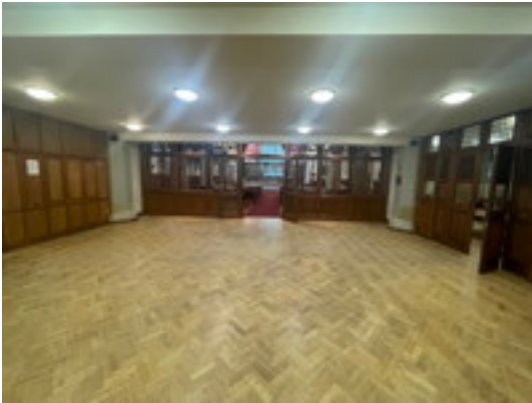
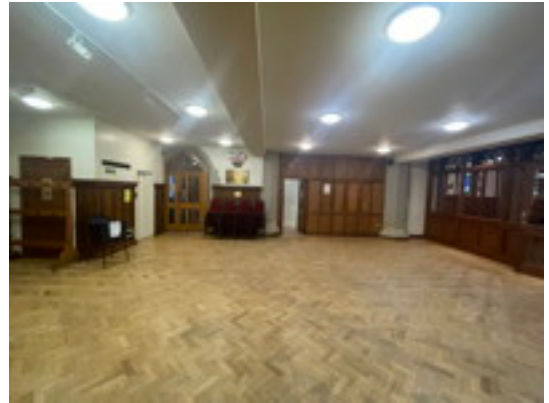
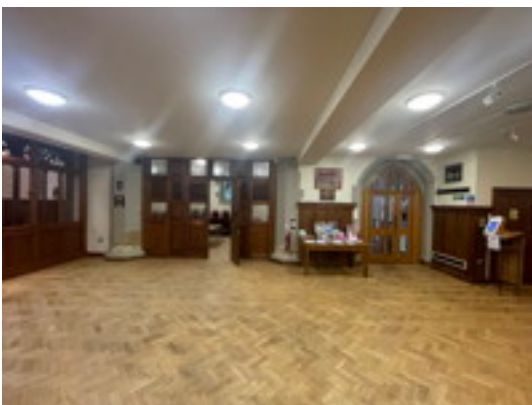
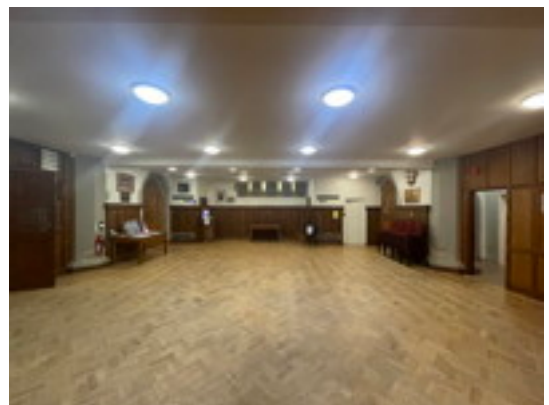
The St Andrews Hall is all in good condition.

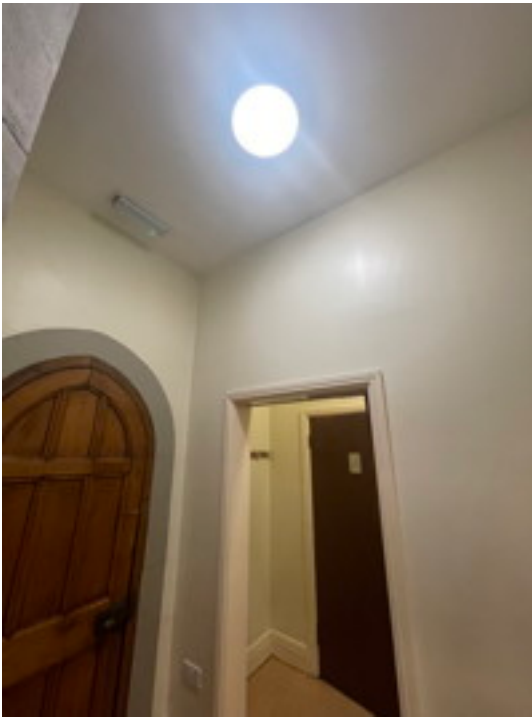
The WCs and WC lobby are all in fair condition.

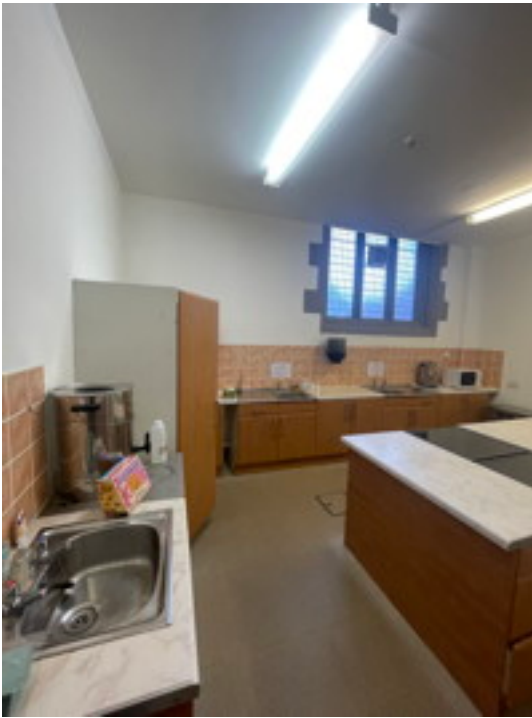
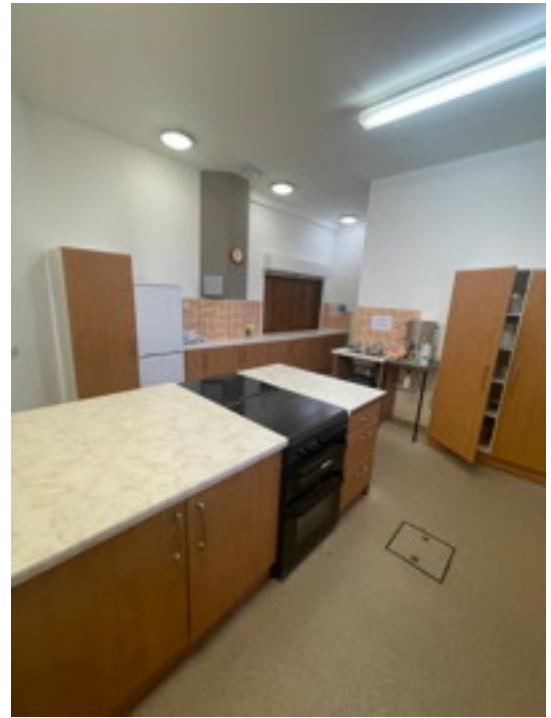
The kitchen is all in good condition.

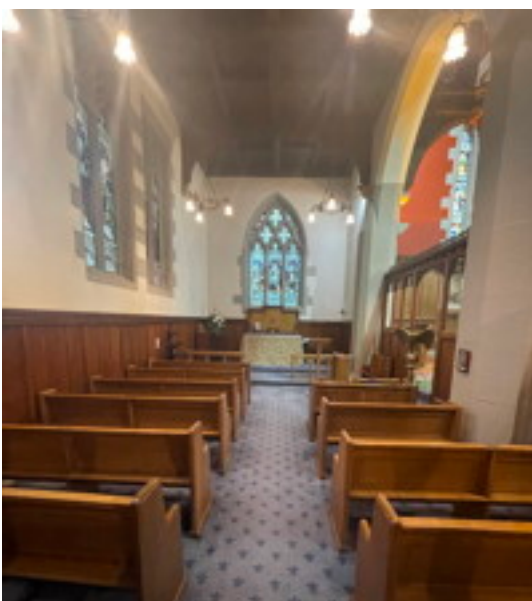
The Lady Chapel is all in good condition.

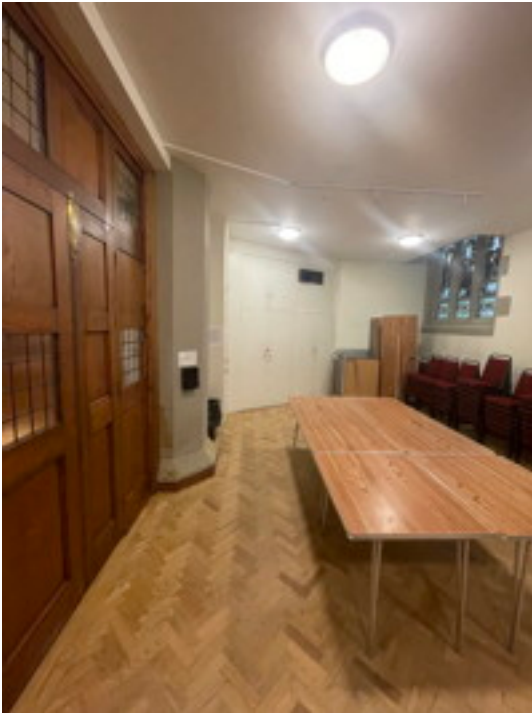
The Flagg Room is all generally in good condition except for some cracking over the doorway to the South Porch.

Monitor cracking to doorway. Cost Band 1– £0.00-£1,999.

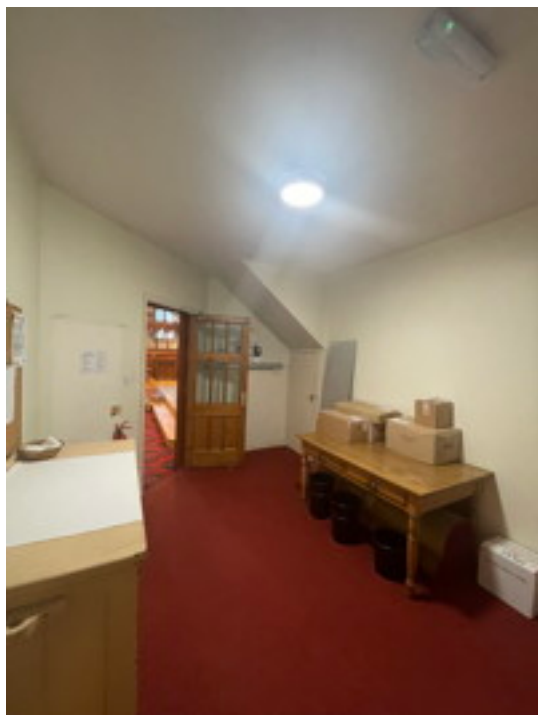
The vicars vestry lobby is generally in fair condition. Some rising damp to west wall.

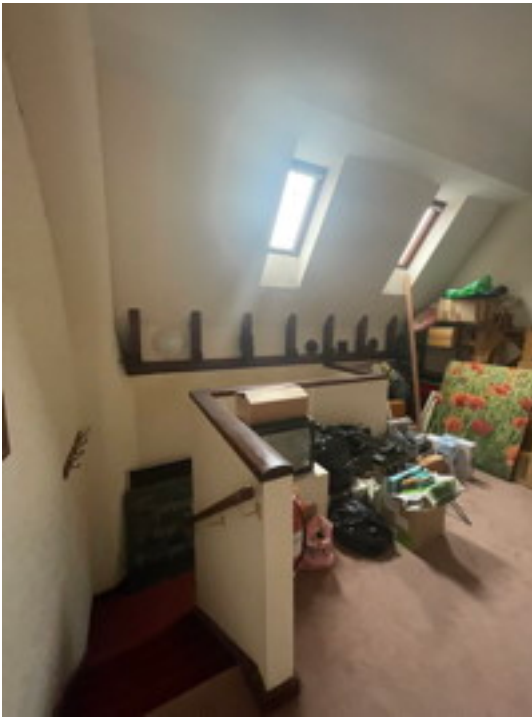
Condition is generally fair but there is a patch of mould at high level.

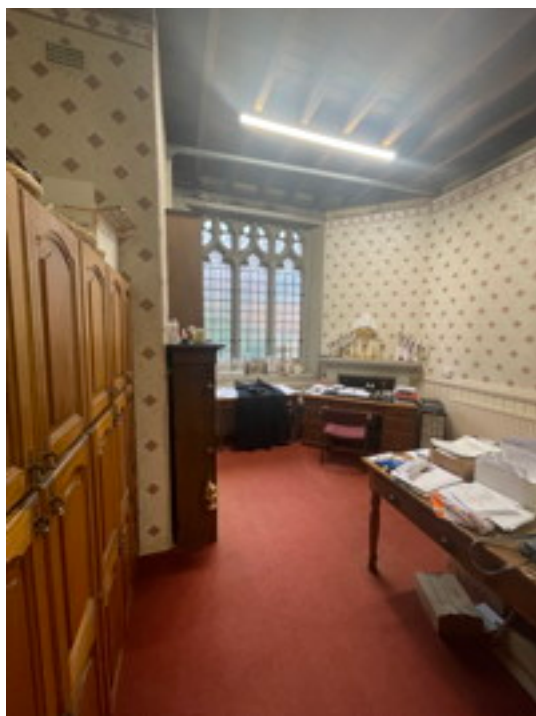
Condition is generally fair.

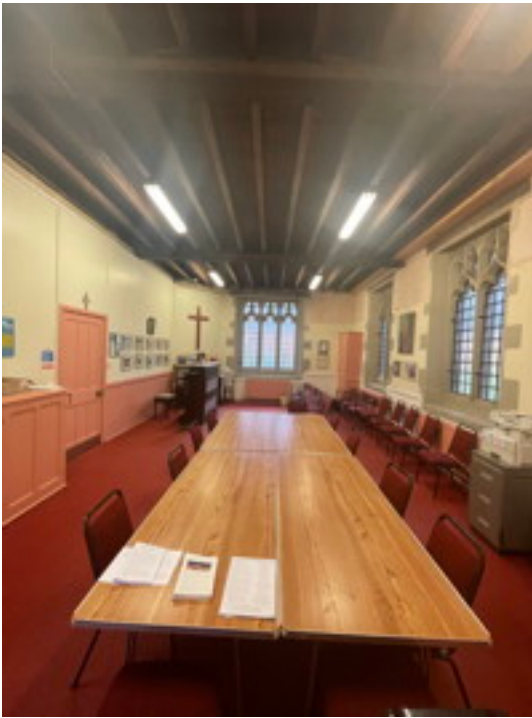
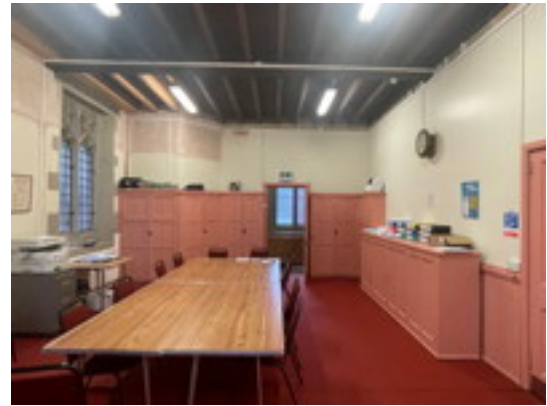
Some sections of panelling, high level plasterwork and ceiling are undecorated following repairs after an outbreak of dry rot in 2013.

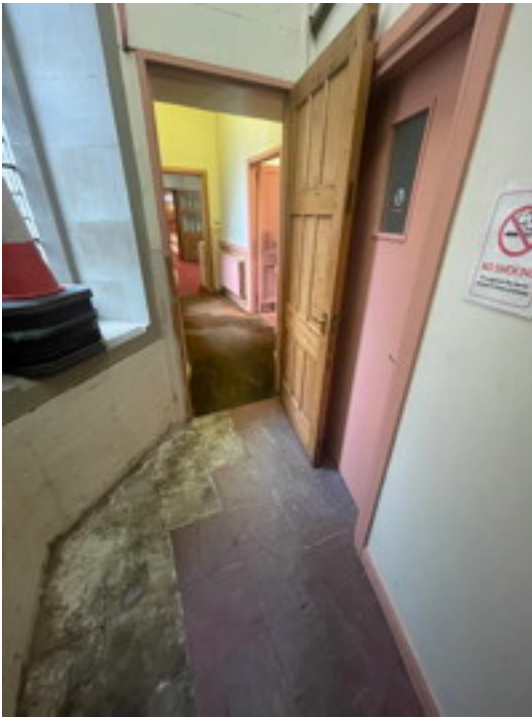
Undecorated panelling following repairs after an outbreak of dry rot in 2013 in choir vestry lobby. Flooring finish partly missing from Campanile floor. Signs of rising/penetrating damp to Campanile. Maybe penetrating through brickwork joints or related to the rainwater pipe or drains blocked with tree roots although nothing obvious. Is internal paintwork sealing in moisture and not allowing wall to breath? Is penetrating damp coming through the concrete floor?

Investigate damp issue noting comments under condition above. Cost Band 1– £0.00-£1,999.

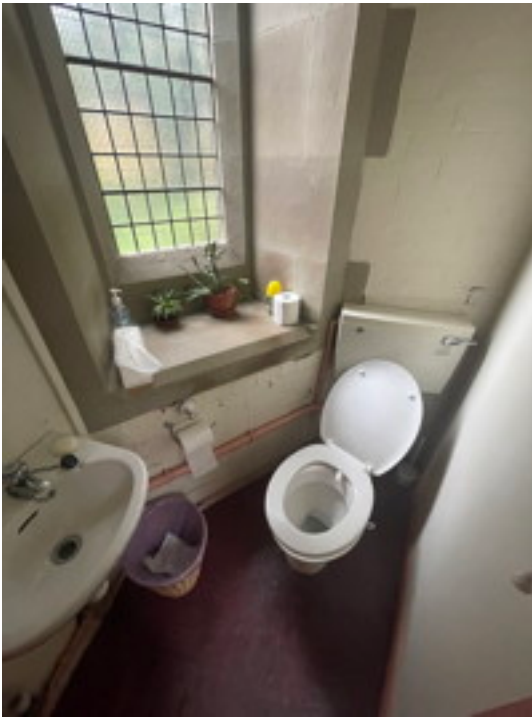
Campanile Lobby WC

Condition generally fair but vent not sealed through window and therefore extract is largely to the inside. Either seal vent to glazing or, ideally, make good to glazing and put vent through brickwork. WC internal roof requires cleaning.

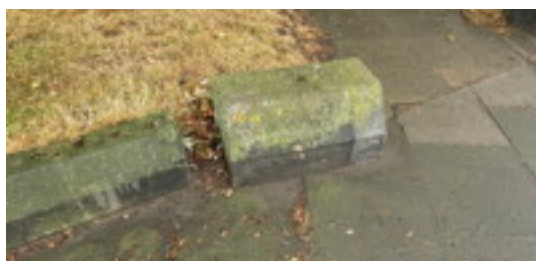
Displaced Plinth Stone

All is generally in satisfactory condition. A couple of stones to the north west corner are misaligned. The frame to gate is rotten in places.

Approach Local Authority with a view to having plinth stones rested. Repair frame to gate. Cost Band 1– £0.00-£1,999.

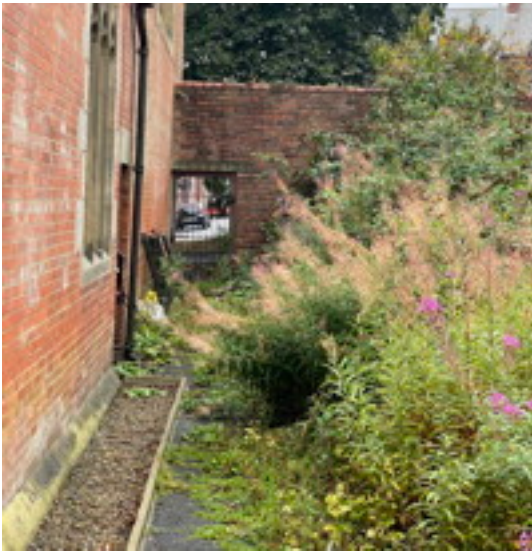
Eastern Boundary Overgrown Planting

All is generally in satisfactory condition. The overgrown planting, particularly to the eastern boundary requires maintenance.

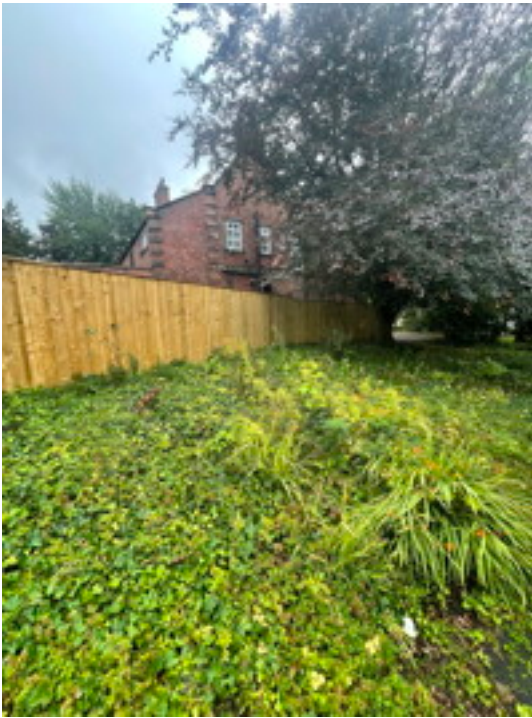
Rotten Copper Beech

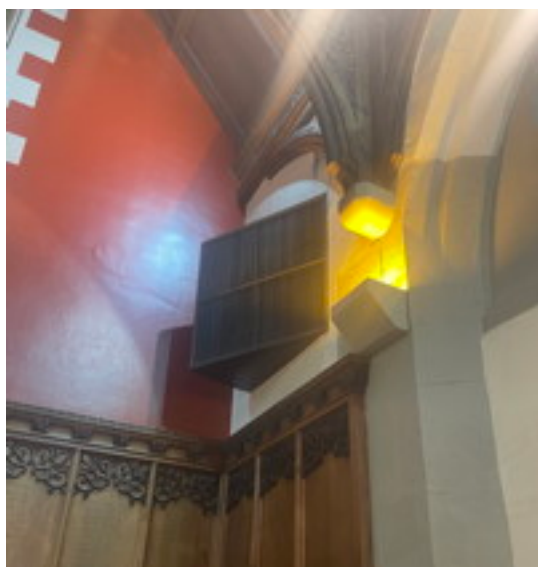
Chancel Heater Unit

Carry out a full review of warm air heating system so that in the event of failure, a replacement plan is fully in place.
