**Quinquennial Inspection Report  
St Alban's Church, Windy Nook, Gateshead  
Deanery of Gateshead  
Archdeaconry of Sunderland  
Diocese of Durham**

Report prepared by

David Jowett - Architect, BA, DipArch, RIBA  
25 Roseworth Avenue  
Gosforth  
Newcastle upon Tyne  
NE3 1NB  
Tel: 07788 710 204  
email: [david@davidjowett-architect.co.uk](mailto:david@davidjowett-architect.co.uk)

11 March 2021

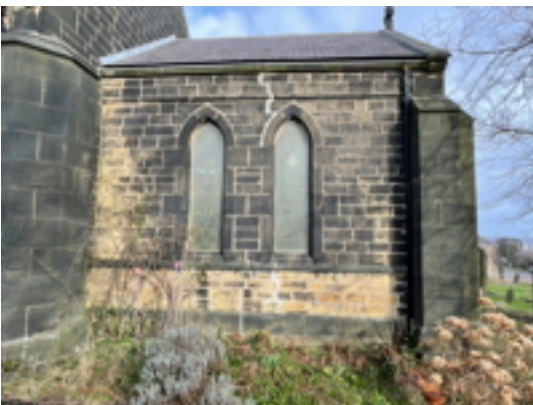
**Chancel South Wall**

Some structural movement caused by roof spread is evident in nave and chancel walls but does not appear to be ongoing. A crack to LHS of vestry door has been repointed.

Main west gable: One eroded stone at high level. Porch stonework: cracks around doorway and on rear west wall have been pointed. Nave south: distortion caused by roof spread on this elevation. Chancel south: distortion caused by roof spread on this elevation.

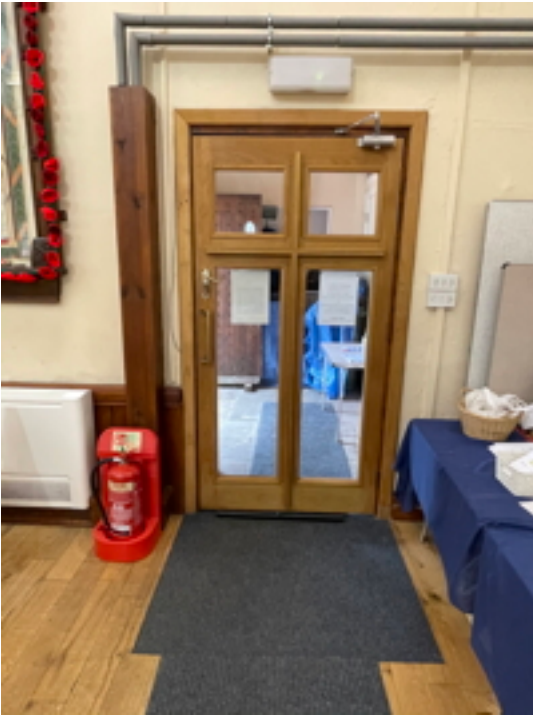
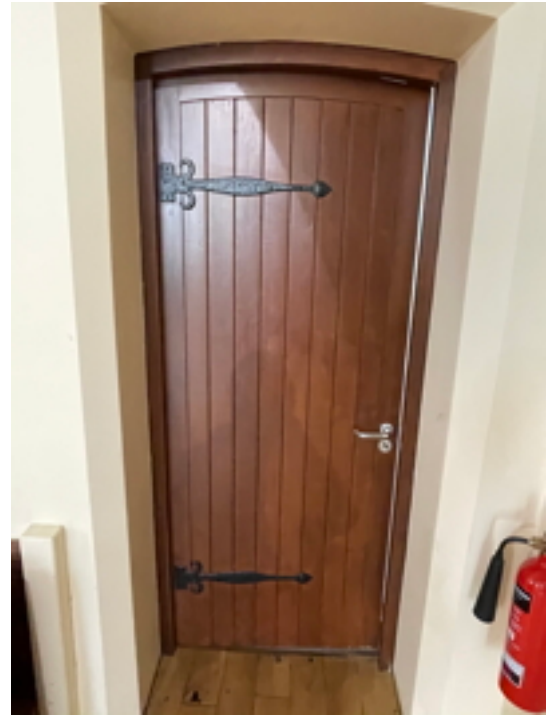
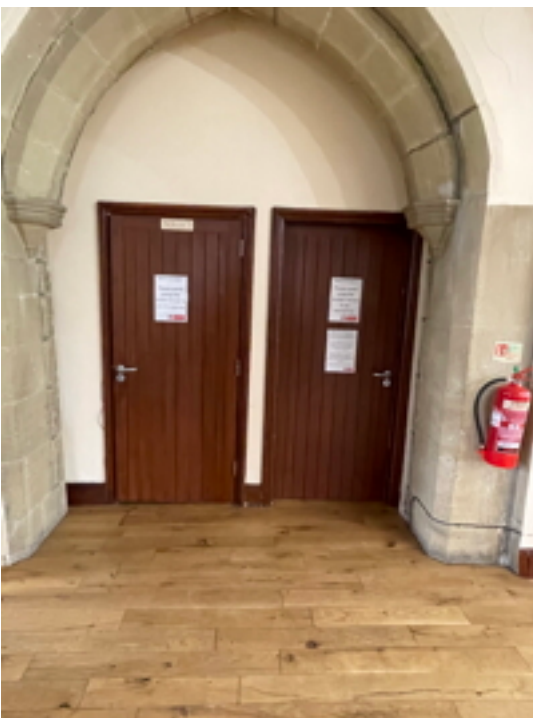
Doors and screens are all in satisfactory condition.

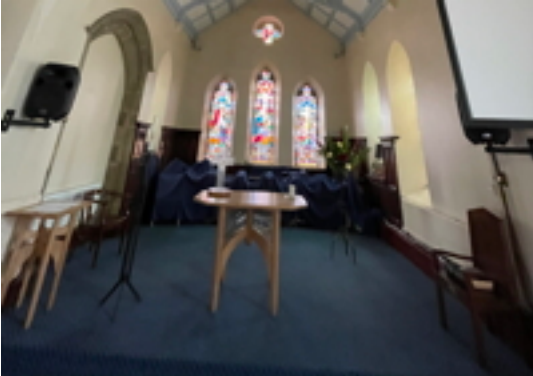
All are in generally satisfactory Condition.

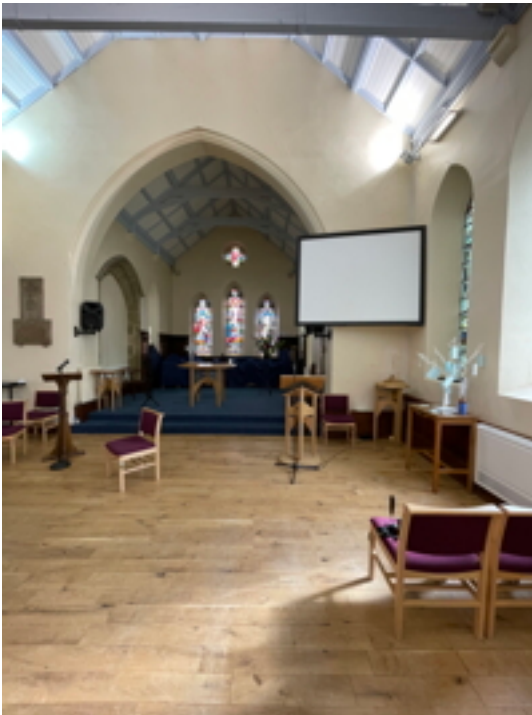
**Painted Walls to Nave**

All is in satisfactory condition except peeling paint to RHS of door to Entrance Lobby.

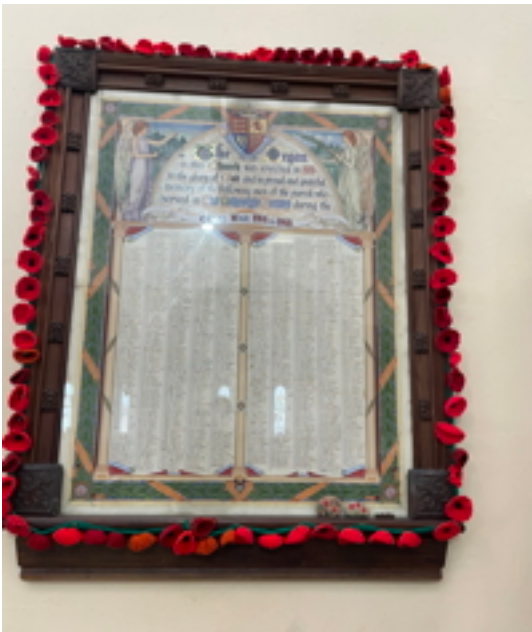
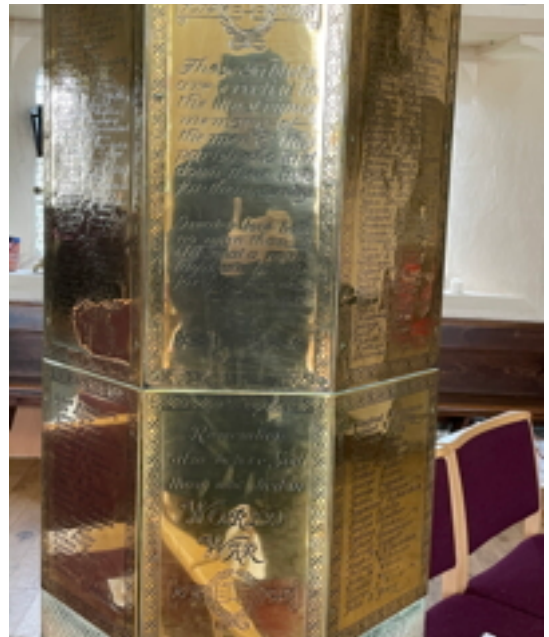
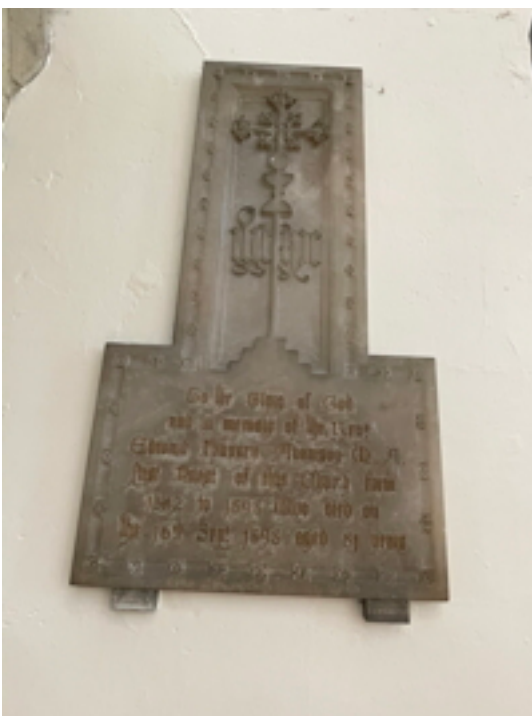
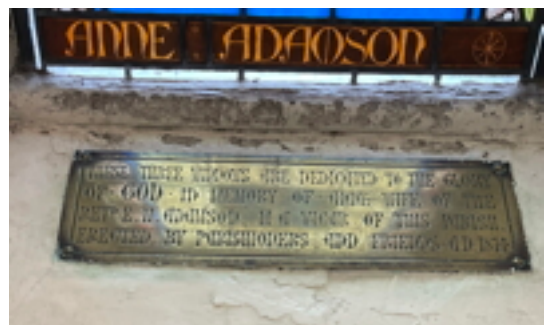
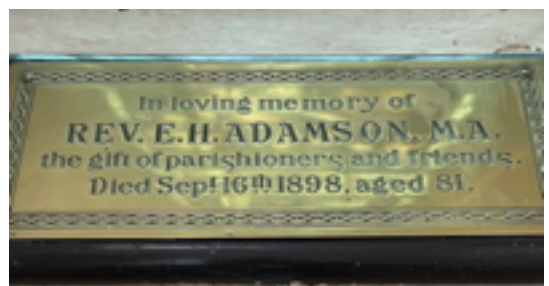
All memorials are in good condition and well cared for.

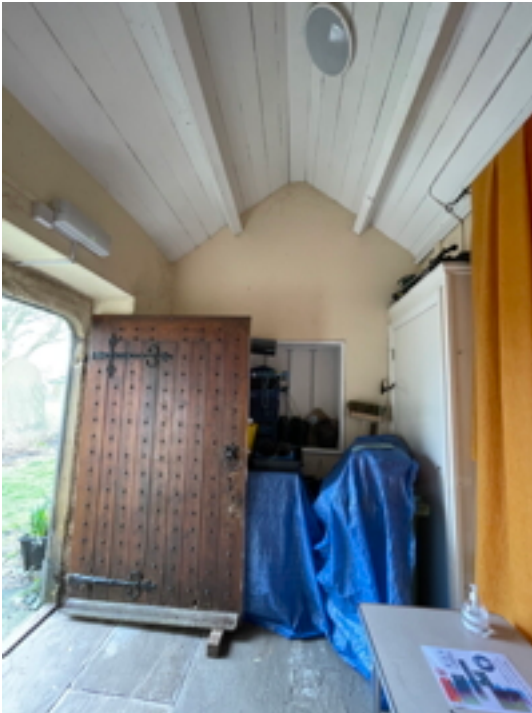
**Porch Looking South**

Decoration deteriorating and efflorescence at low level on walls and mould around door. Wheelie bin and stored material could compromise emergency escape route. The porch floor requires some pointing of joints.

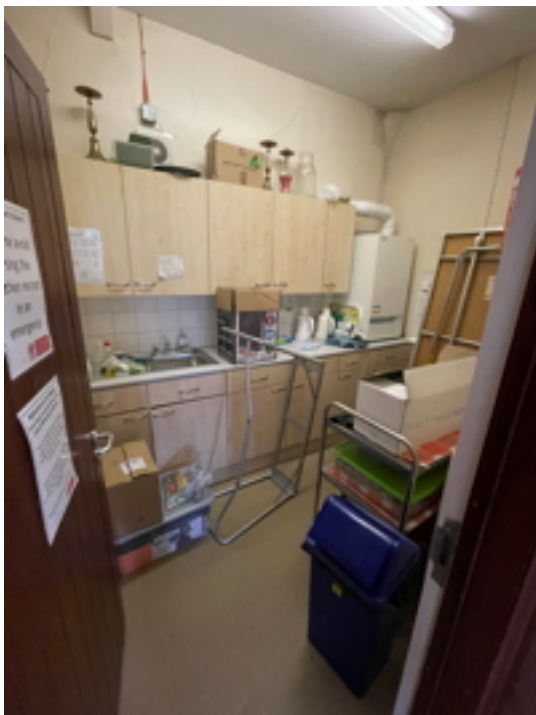
**Kitchen**

The Kitchen is all is in satisfactory condition but needs decoration. Stored material compromise the use of the space. Edge seals to flooring should be replaced to avoid washing water ingress.

Replace edge seals to vinyl flooring in Kitchen with Dow 785+ clear silicone sealant. £50.00

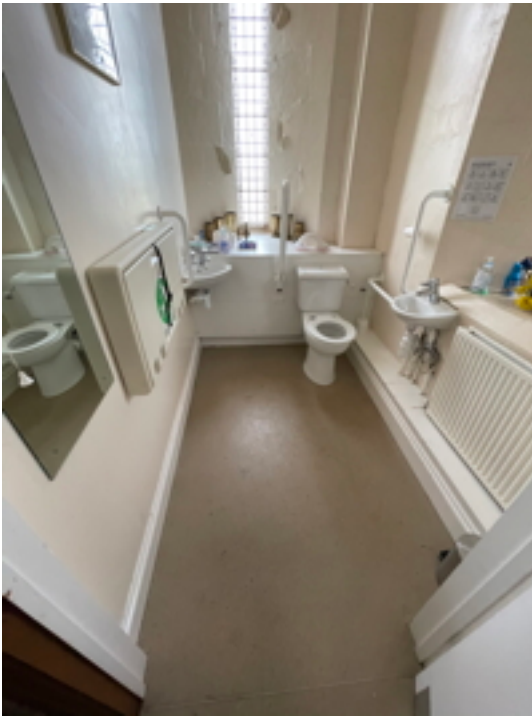
The Ground Floor Accessible WC in generally satisfactory condition but needs decoration. Edge seals to flooring should be replaced to avoid washing water ingress.

Replace edge seals to vinyl flooring in WC with Dow 785+ clear silicone sealant. £50.00

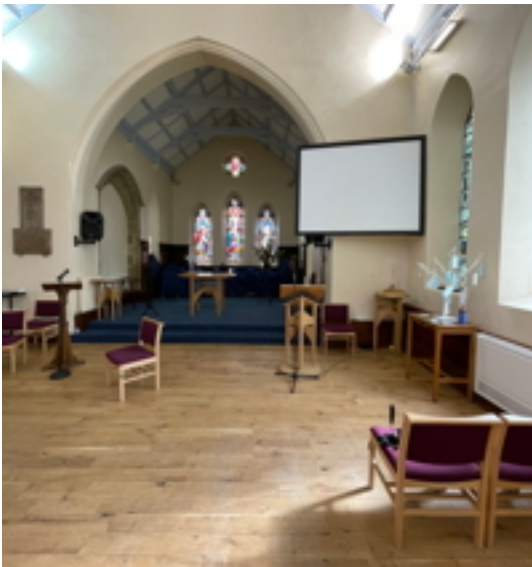
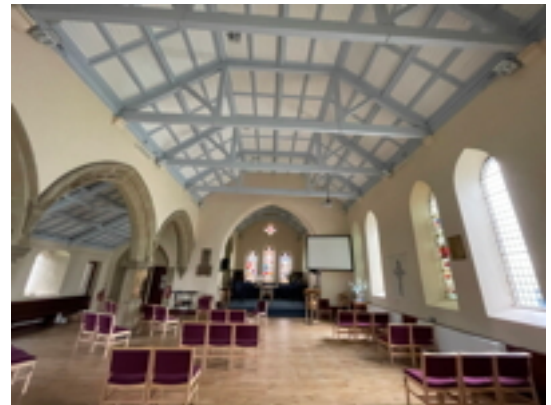
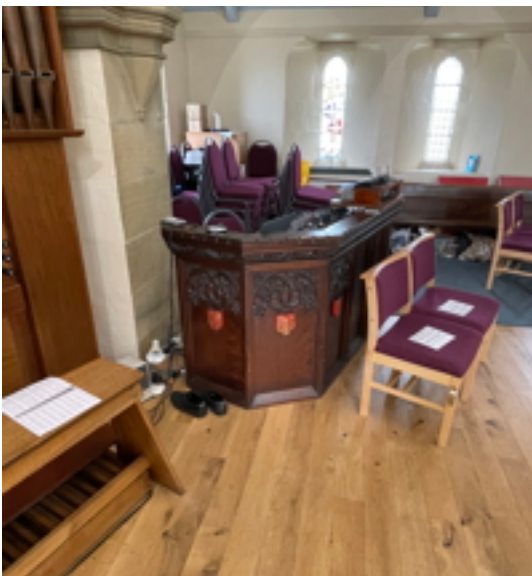
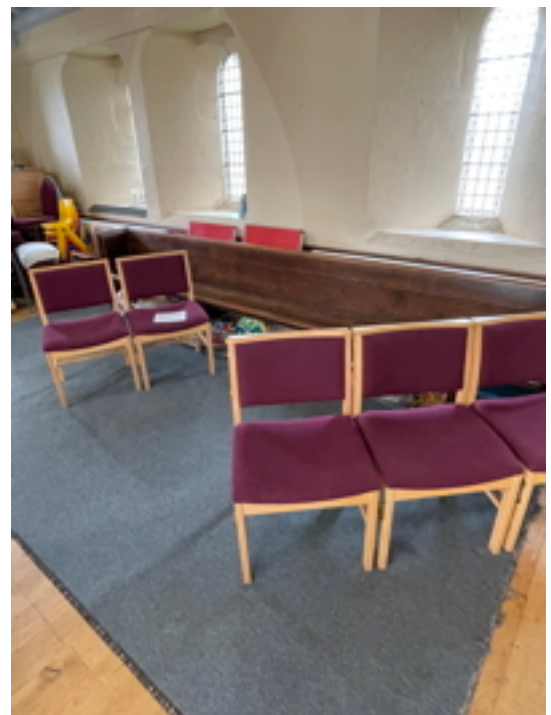
All are in satisfactory condition.

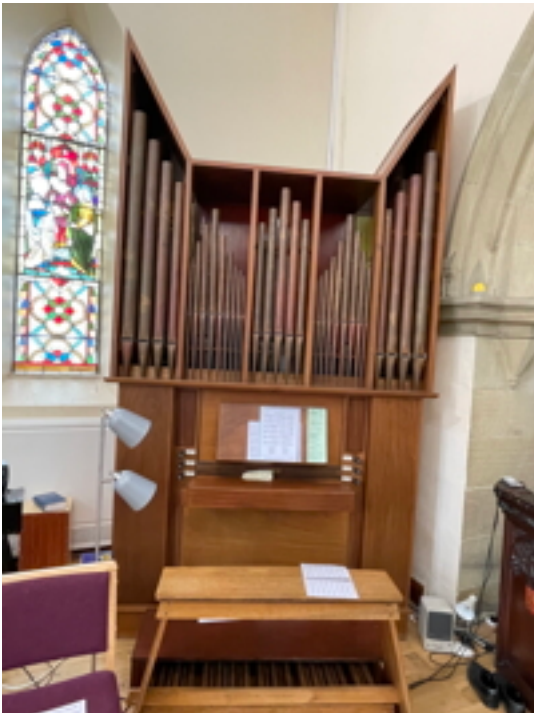
Believed to be in working order.

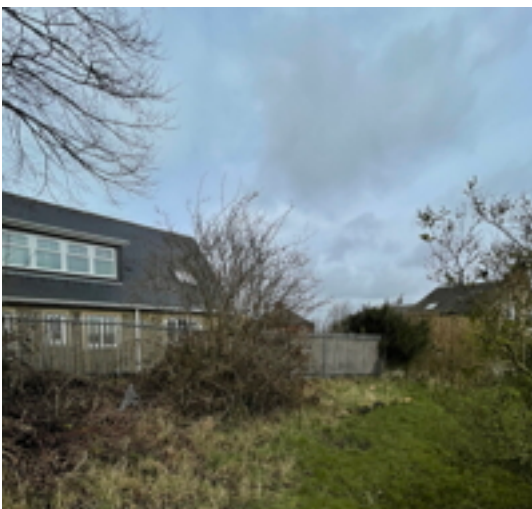
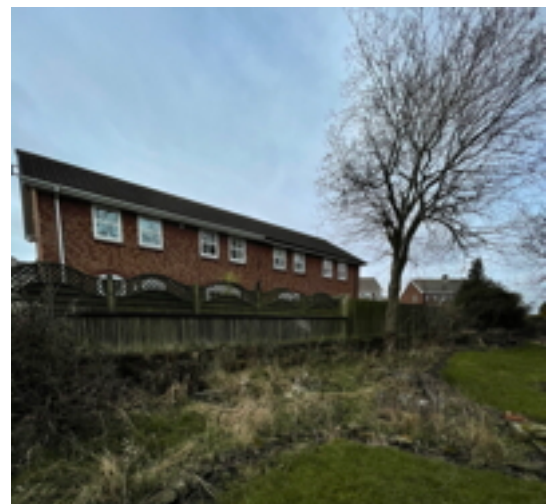
**Typical Stone Walling**

#### Condition

Generally rack out all cement mortar to boundary walls and all loose mortar and repoint as necessary £4,000.00.

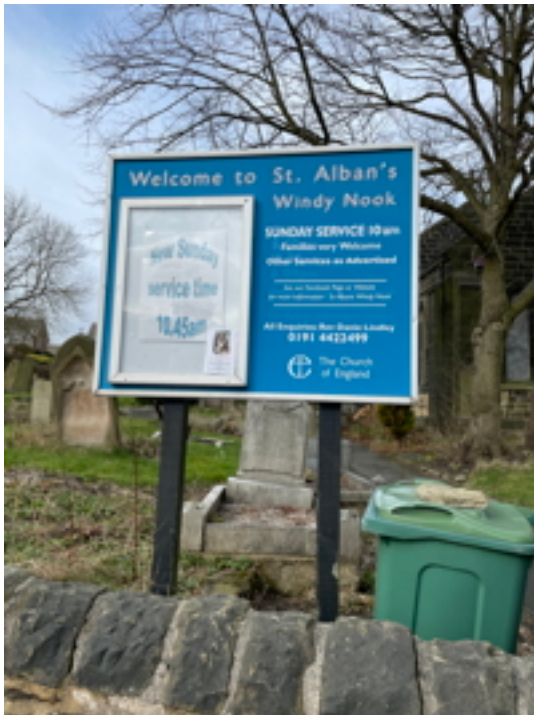
The Noticeboard is in satisfactory condition.

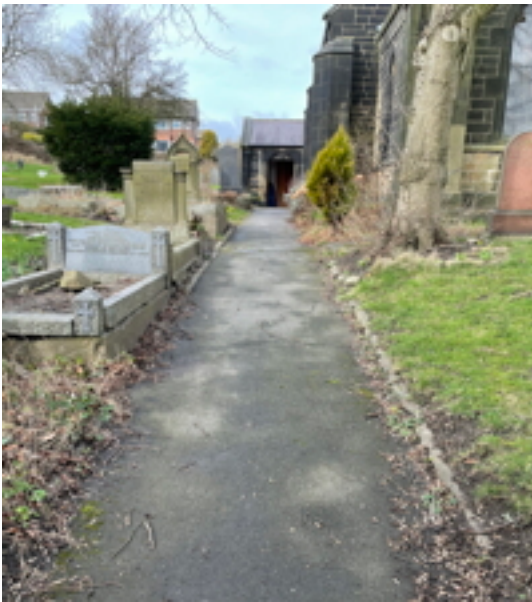
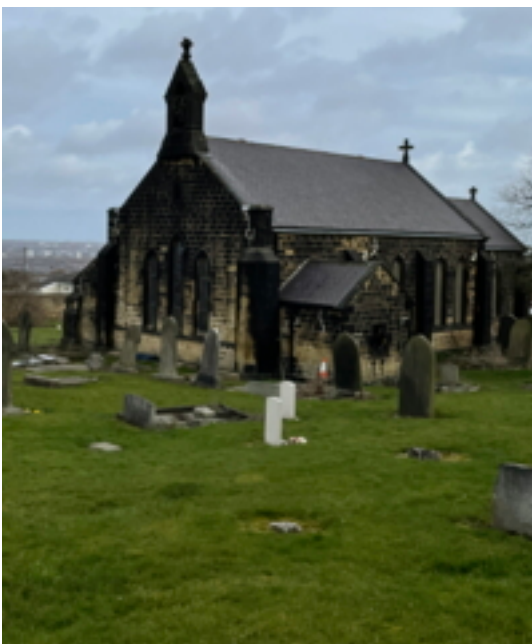
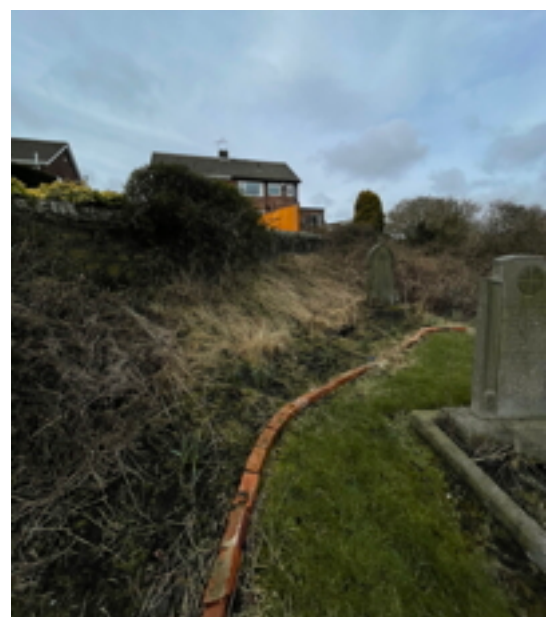
All is generally in satisfactory condition and well maintained. The north eastern corner pathway has a lot of moss making it slippery which should be cleared.

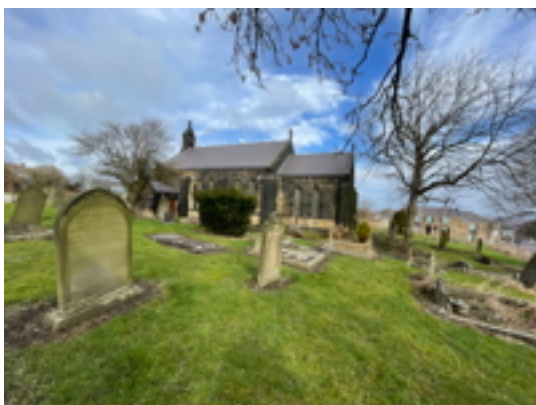
**Trees to South East and South West Corners of the Church**

The trees generally all appear is satisfactory condition. However the buddleia and other seedlings seeding should be fully removed before they cause damage to the church structure which could be significant if left. The trees should all be inspected by a qualified tree surgeon every five years and pruned in accordance with their recommendations.

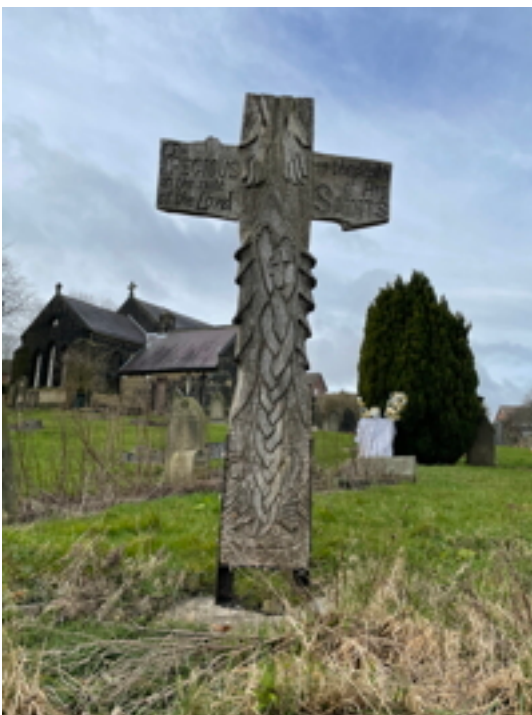
**Modern Carved Timber Cross**

The cross appears in satisfactory condition.
